## PRELIMINARY GEOTECHNICAL INVESTIGATION

**Preliminary Geotechnical Investigation,  
Dana Point Harbor Revitalization,  
Hotel Component,  
City of Dana Point, California**

September 10, 2019

GMU Project No. 17-206-01

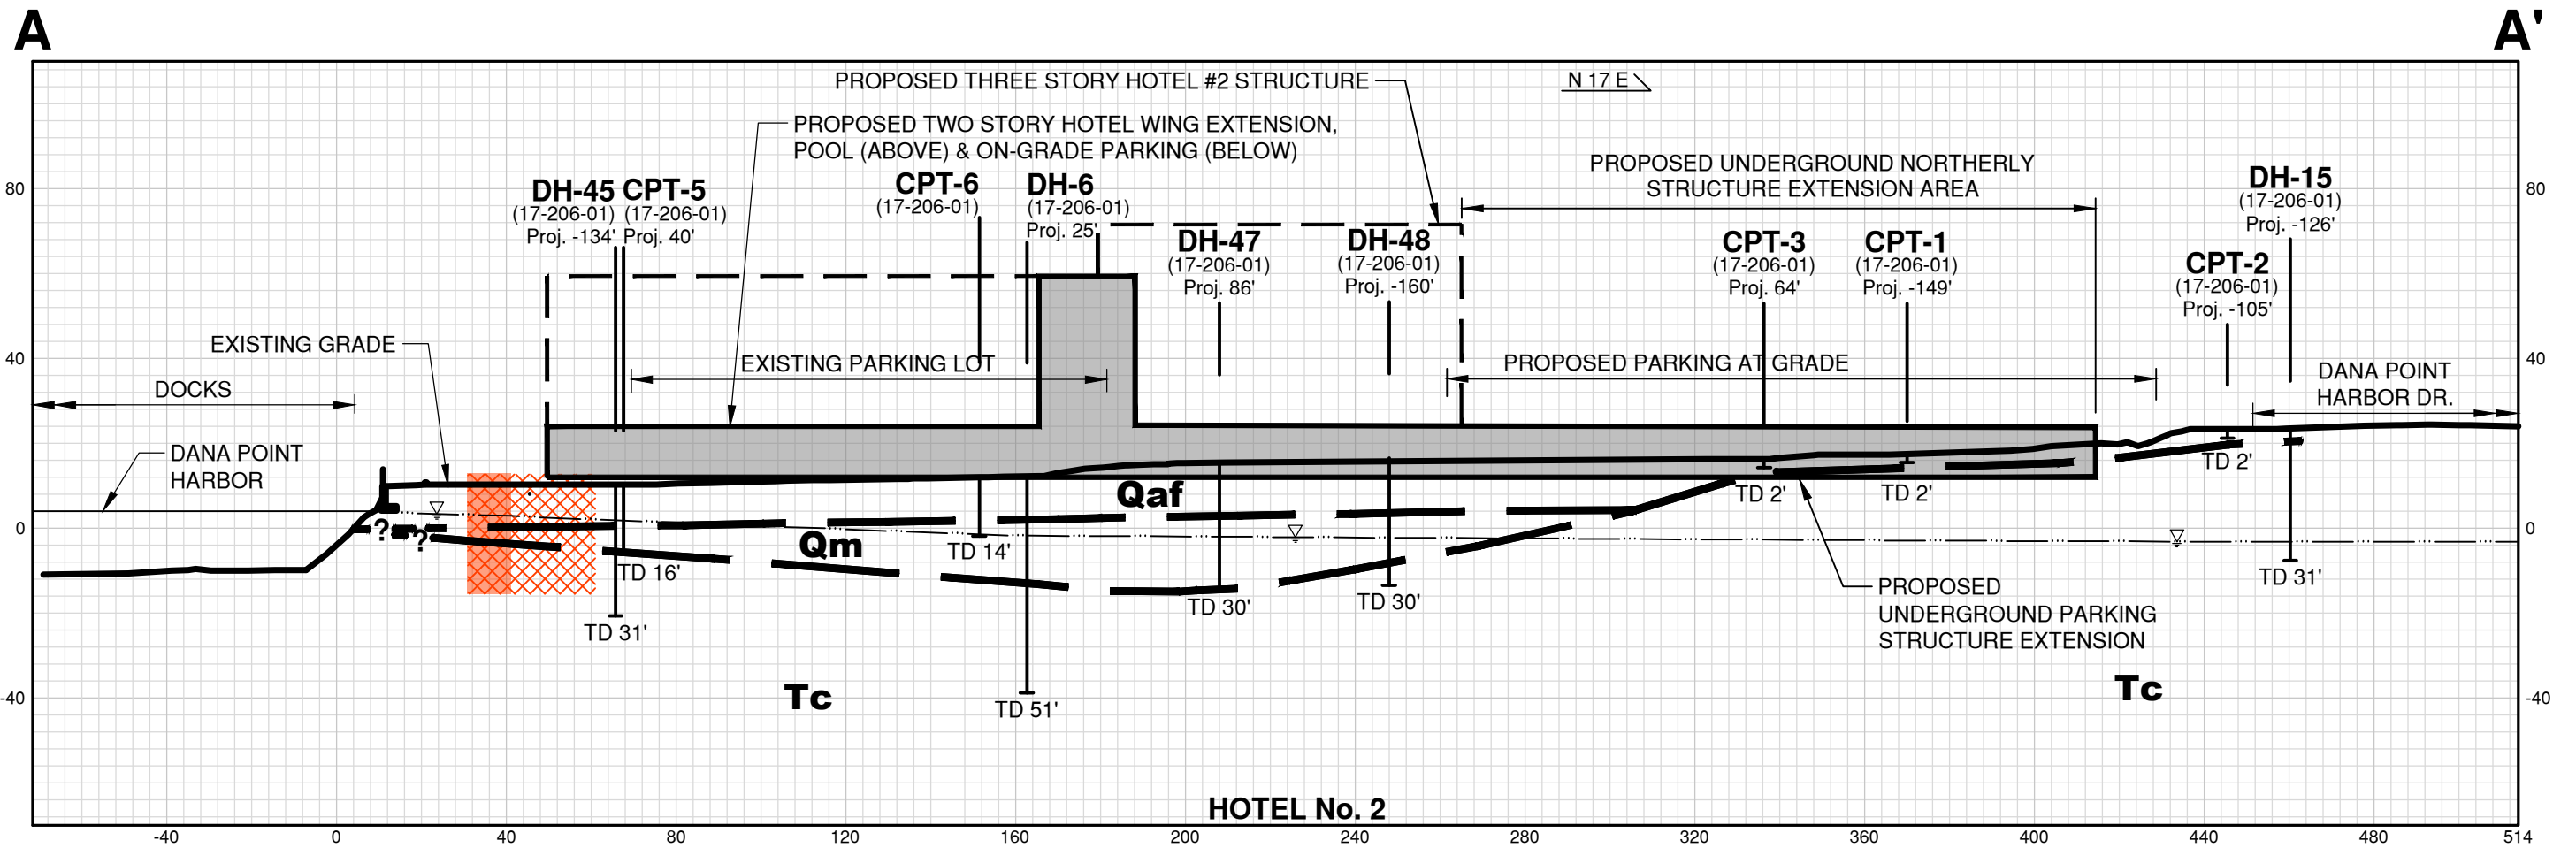
# Geotechnical Map

**DH**  
APPROXIMATE INFILTRATION TEST LOCATIONS BY GMU GEOTECHNICAL, INC., PROJECT 17-206-01

- RAMMED AGGREGATE PIERS (30 FEET WIDE)
- SOIL CEMENT COLUMNS (10 FEET WIDE)

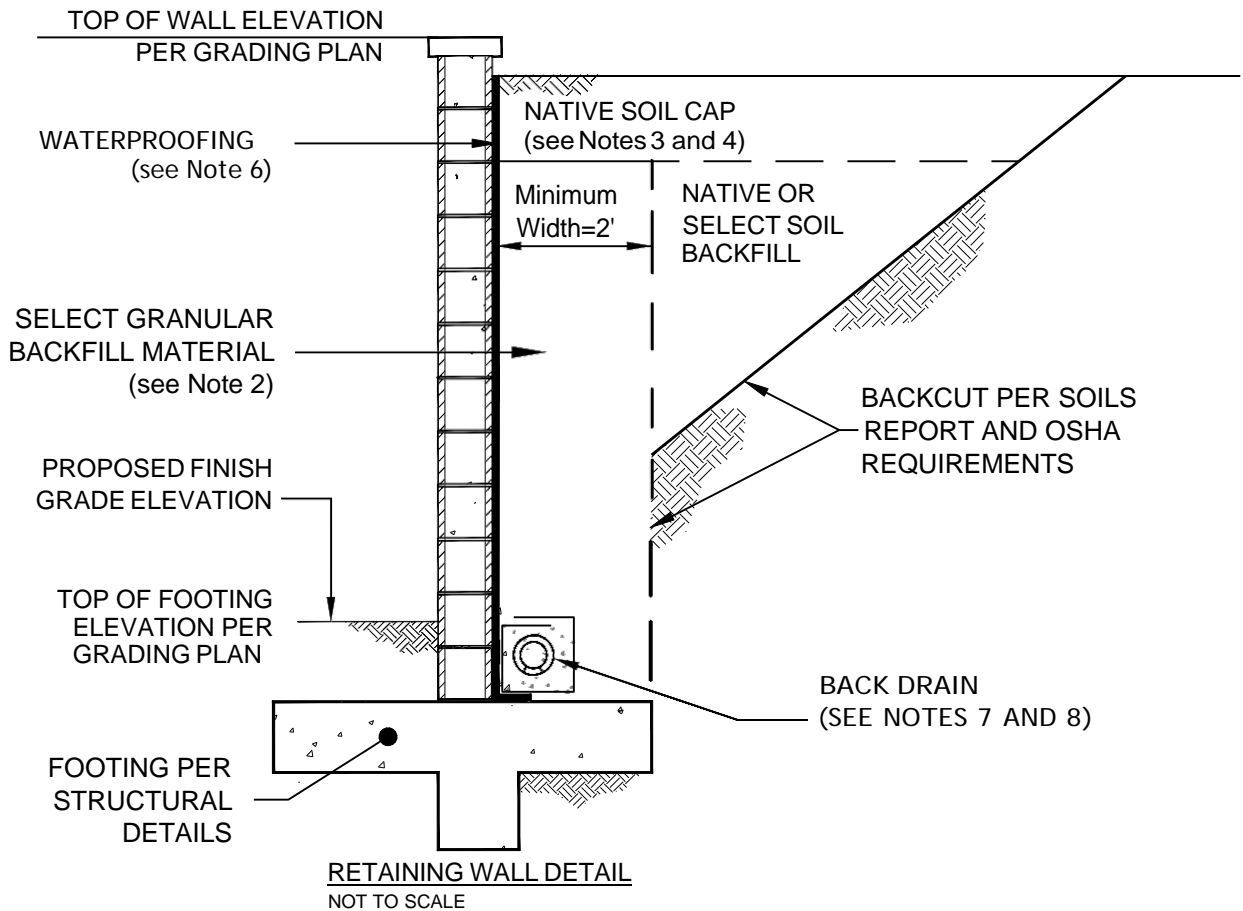
1. FINAL DETERMINATION OF THE MATERIAL TO BE USED FOR BACKFILL SHALL BE MADE BY GMU.
2. ALL SELECT BACKFILL TO WITHIN 1 TO 2 FEET OF FINAL GRADE SHOULD CONSIST OF FREE-DRAINING GRANULAR MATERIAL (I.E. SE 30 SAND, PEA GRAVEL, OR CRUSHED ROCK). CRUSHED ROCK, IF USED, SHOULD BE WRAPPED IN FILTER FABRIC (MIRAFI 140N OR EQUIVALENT) TO MINIMIZE THE POTENTIAL FOR MIGRATION OF FINES INTO THE ROCK. THE SELECT BACKFILL SHOULD BE MOISTURE CONDITIONED TO ACHIEVE OVER OPTIMUM MOISTURE CONTENT PER THE SOILS REPORT AND COMPACTED TO AT LEAST 90% RELATIVE COMPACTION AS DETERMINED BY ASTM TEST METHOD D 1557.

3. FINE-GRAINED NATIVE SOILS SHOULD BE USED TO CAP THE SELECT BACKFILL ZONE.
4. ALL NATIVE OR SELECT SOIL WALL BACKFILL SHOULD BE MOISTURE CONDITIONED AS NECESSARY TO OVER OPTIMUM MOISTURE CONTENT PER THE SOILS REPORT AND COMPACTED TO AT LEAST 90% RELATIVE COMPACTION AS DETERMINED BY ASTM TEST METHOD D 1557.

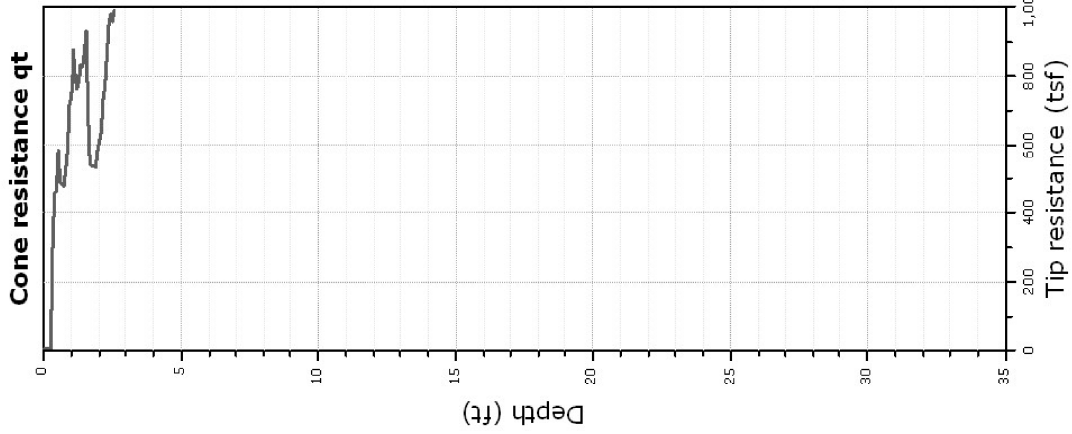
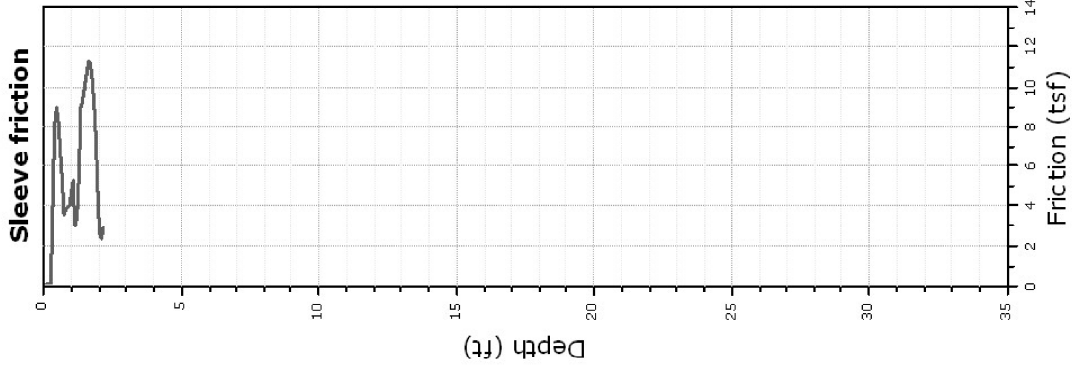
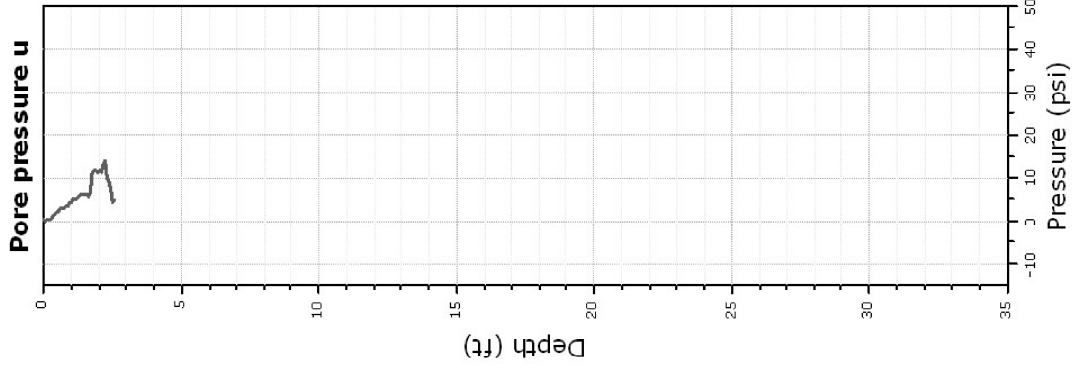
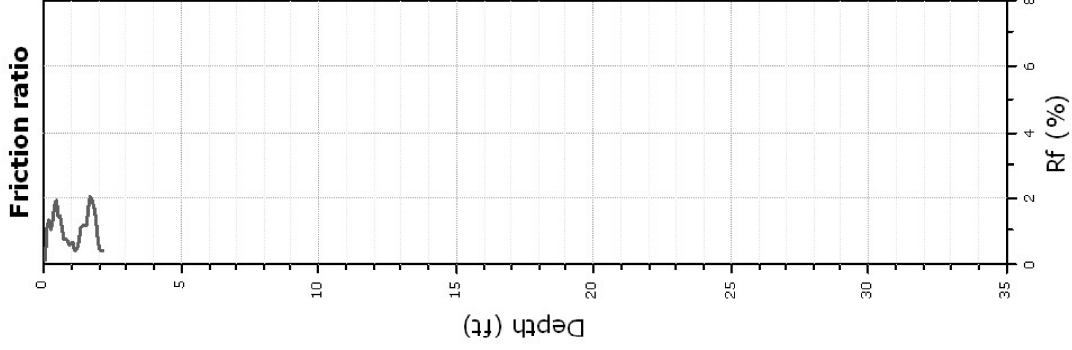
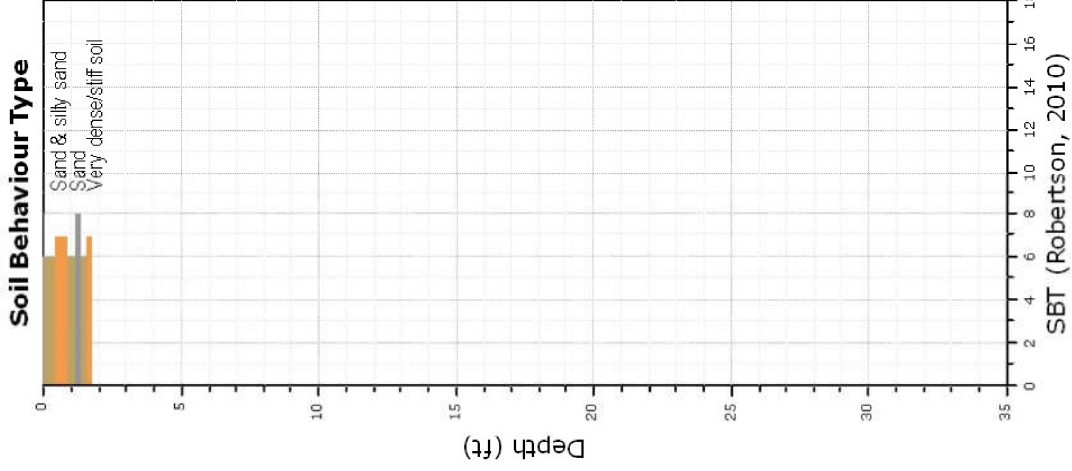
Total depth: 2.56 ft, Date: 9/12/2018

Cone Type: Vertek

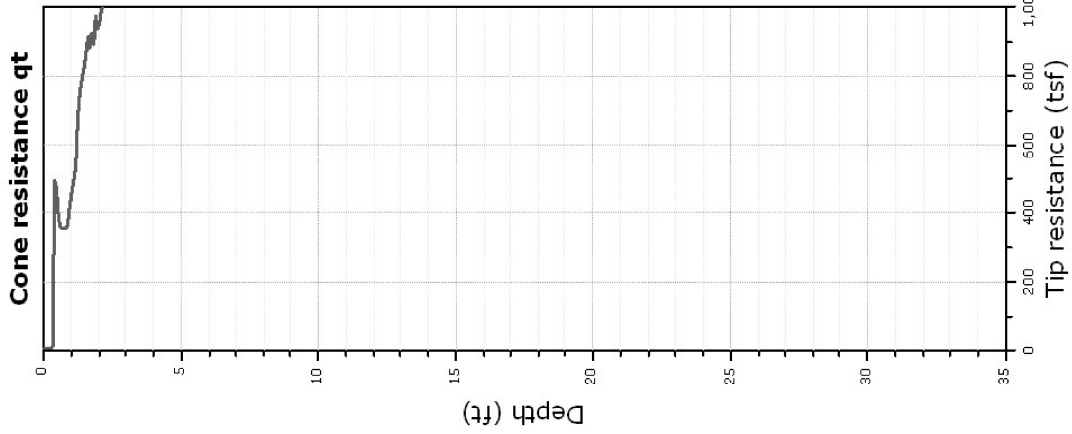
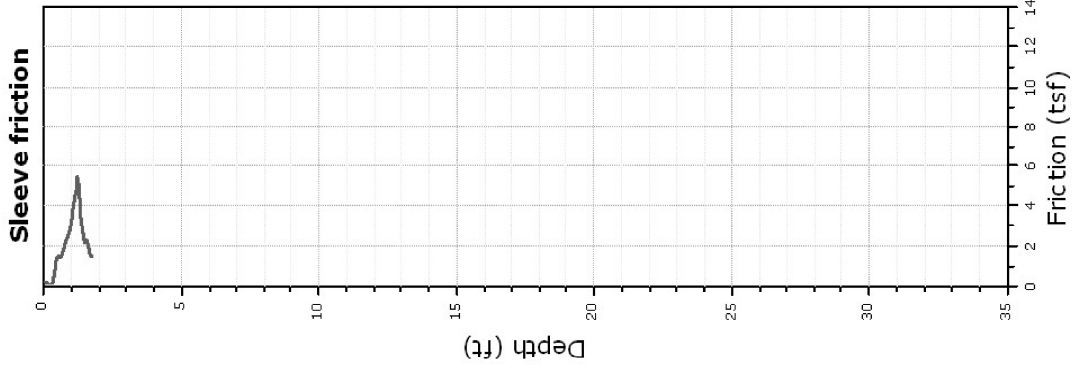
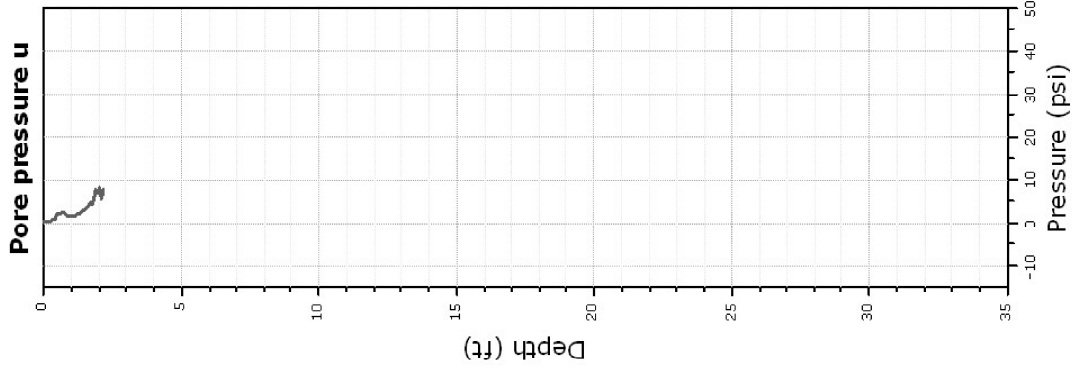
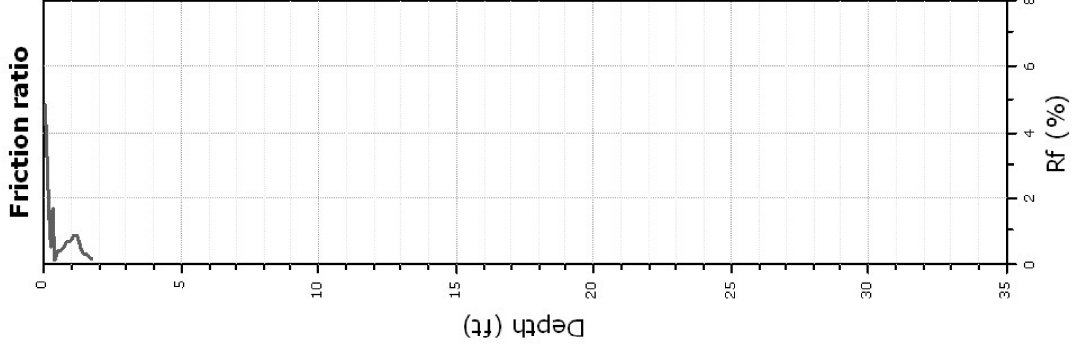
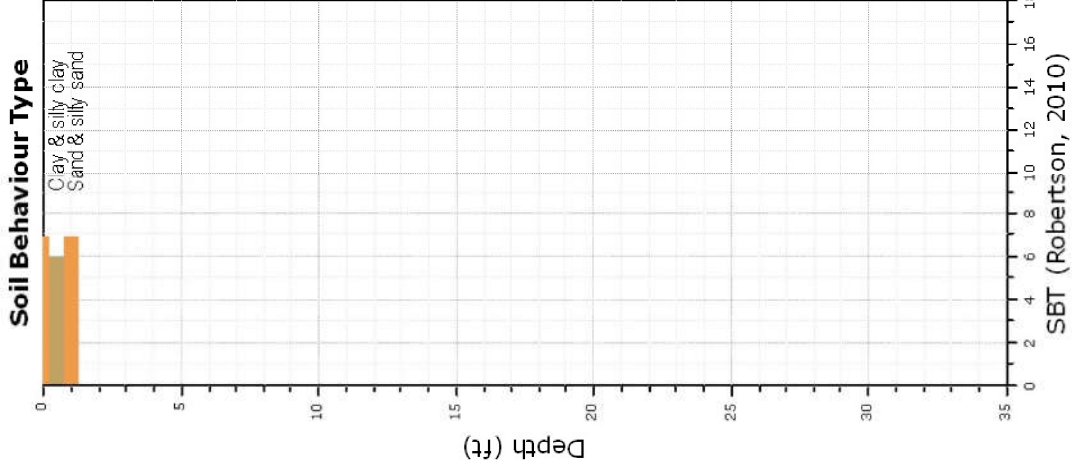
**CPT-2**

Total depth: 2.18 ft, Date: 9/12/2018  
Cone Type: Vertek

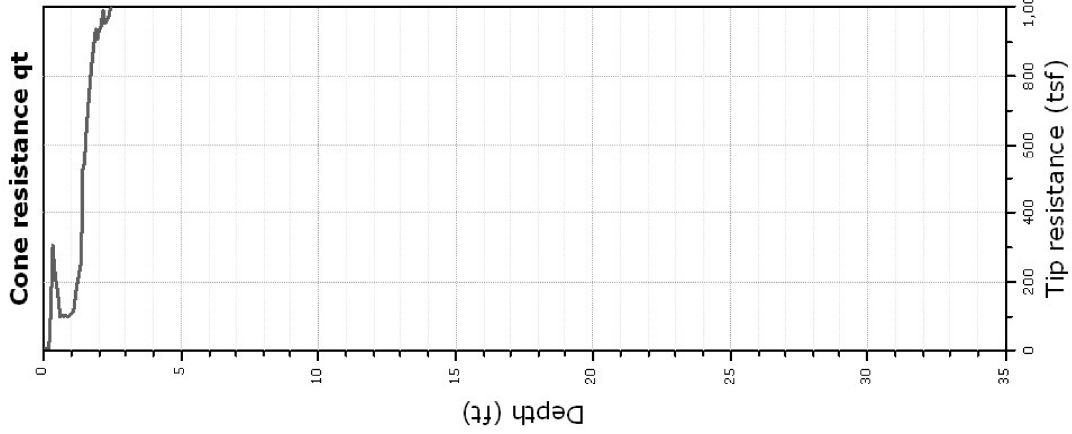
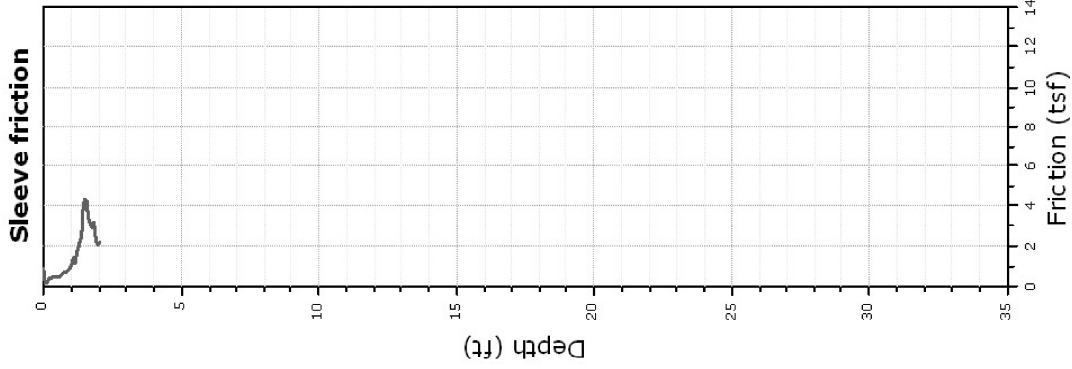
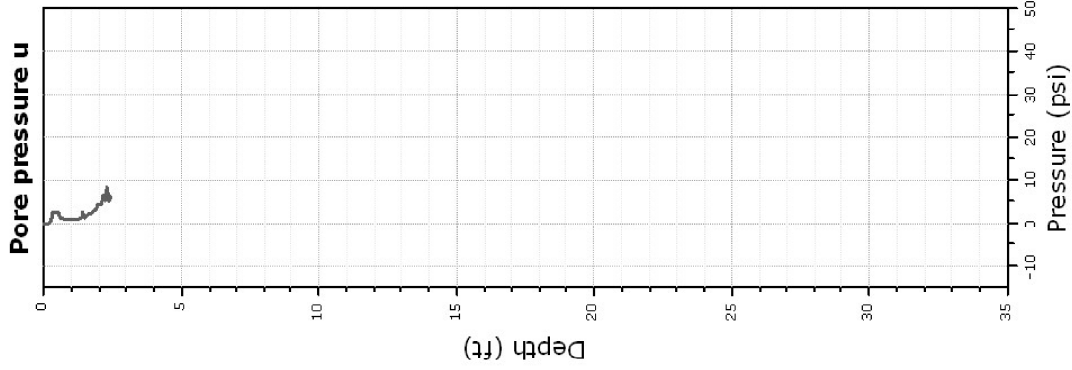
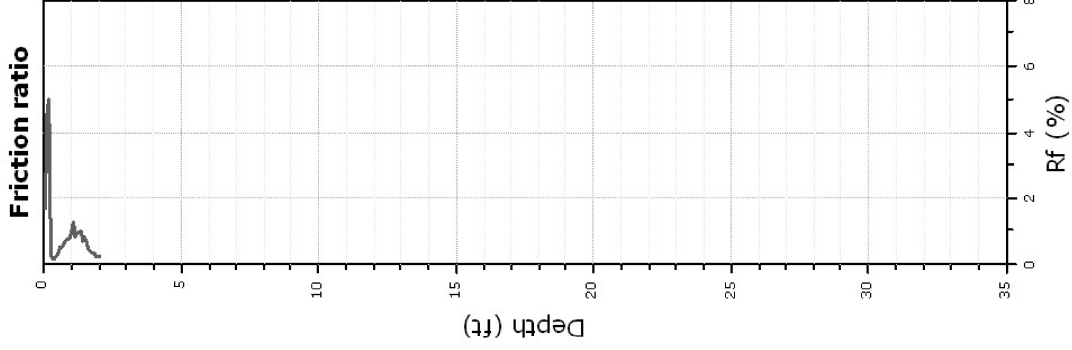
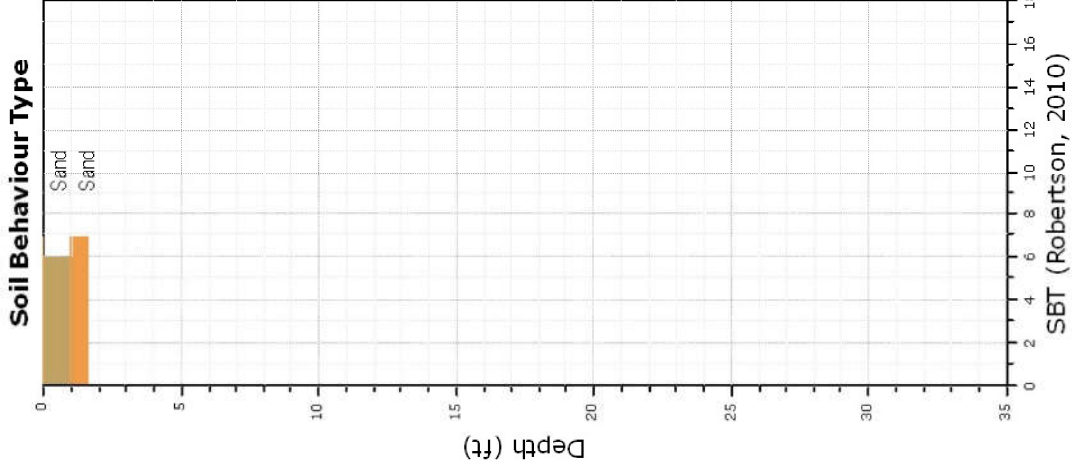
**CPT-3**

Total depth: 2.43 ft, Date: 9/12/2018  
Cone Type: Vertek

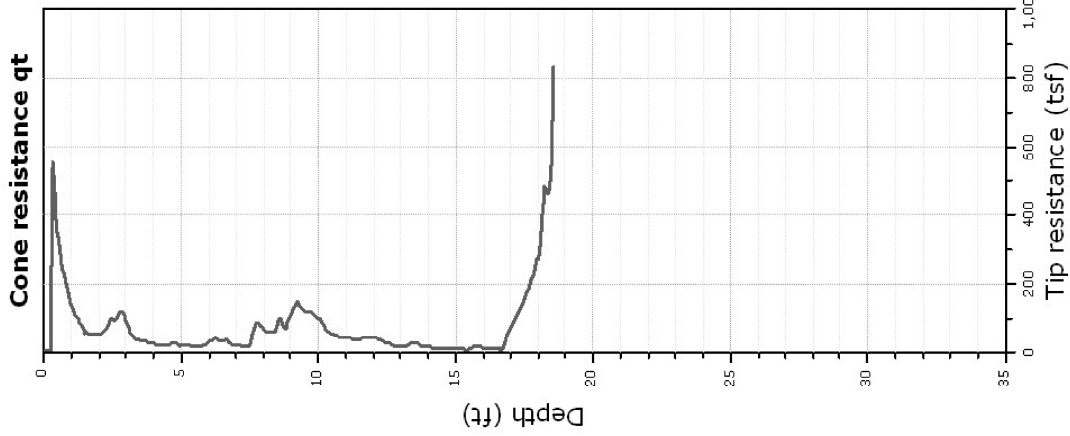
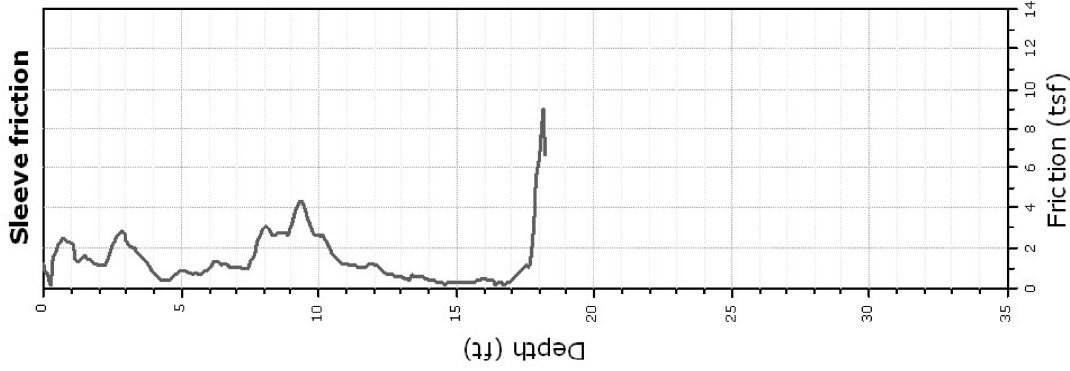
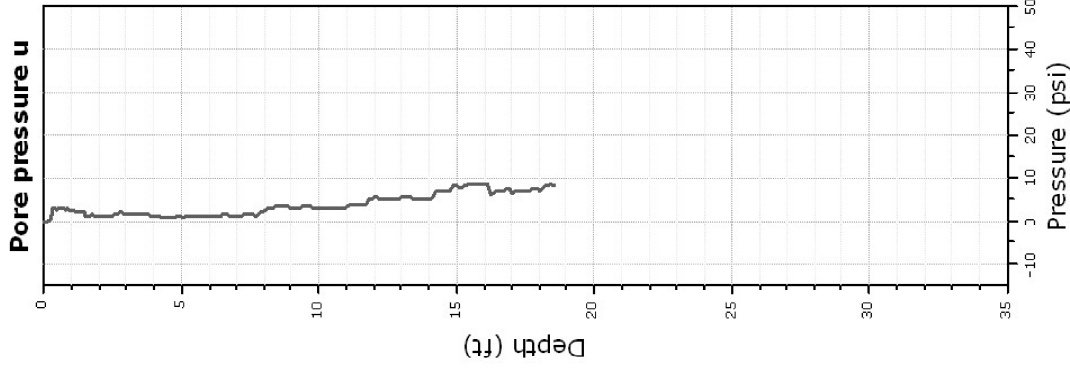
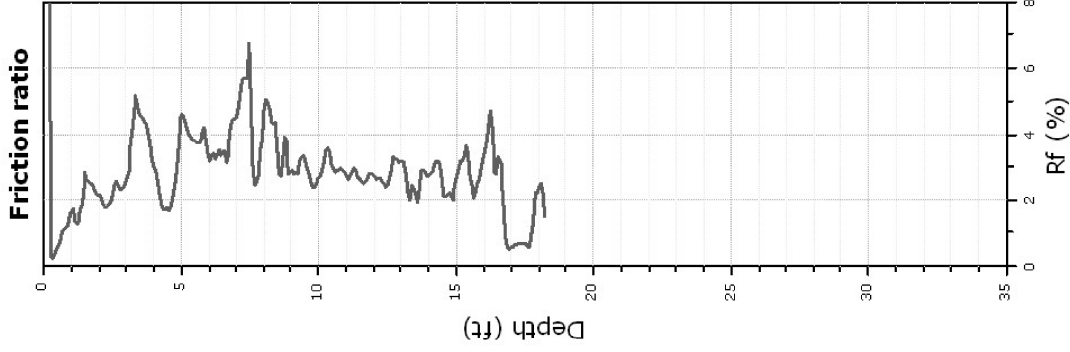
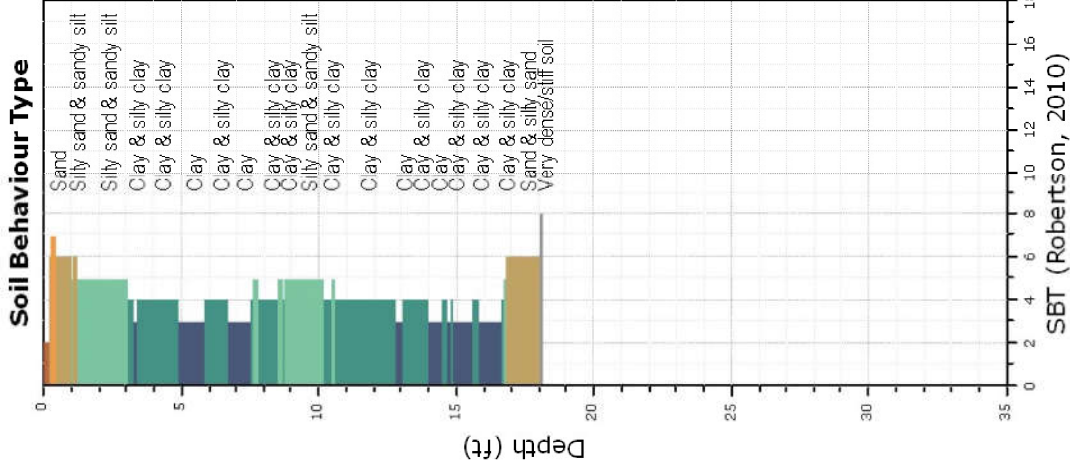
Total depth: 18.57 ft, Date: 9/12/2018

Cone Type: Vertek

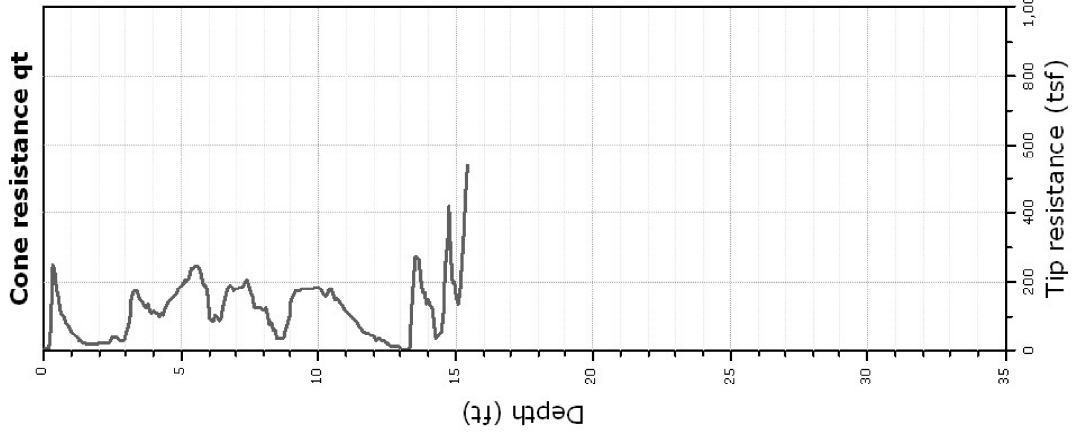
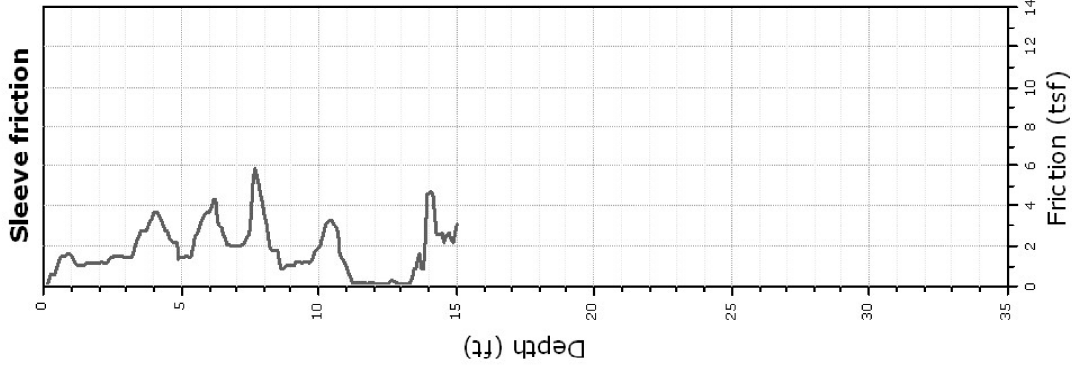
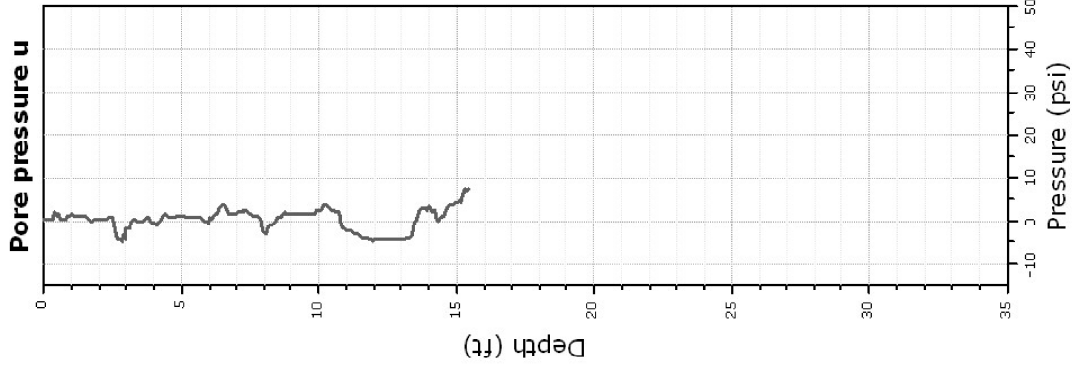
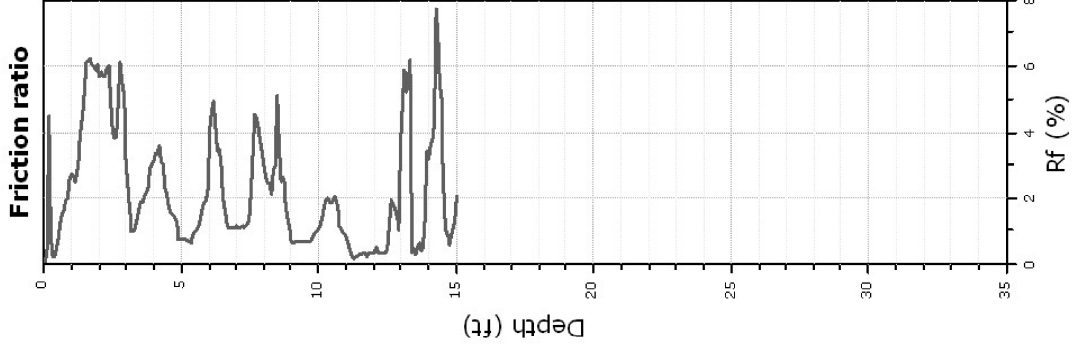
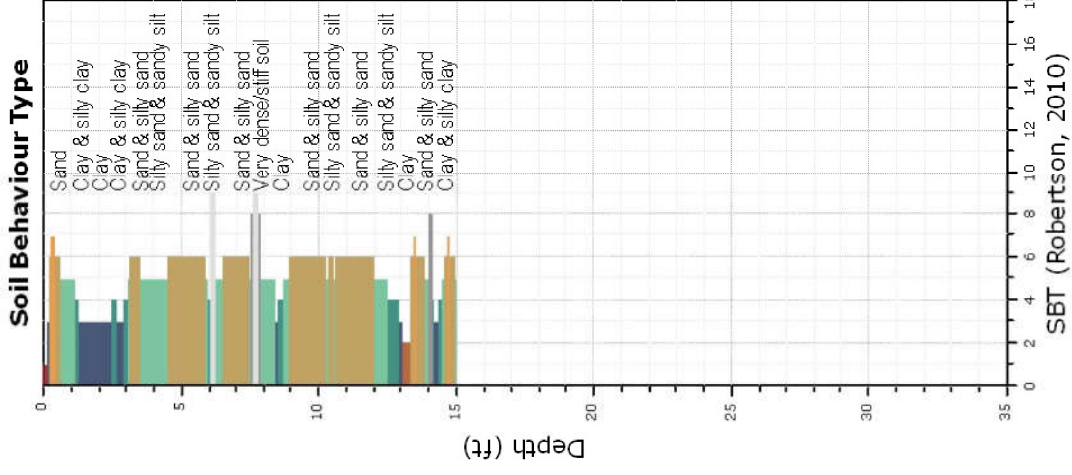
Total depth: 15.42 ft, Date: 9/12/2018

Cone Type: Vertek

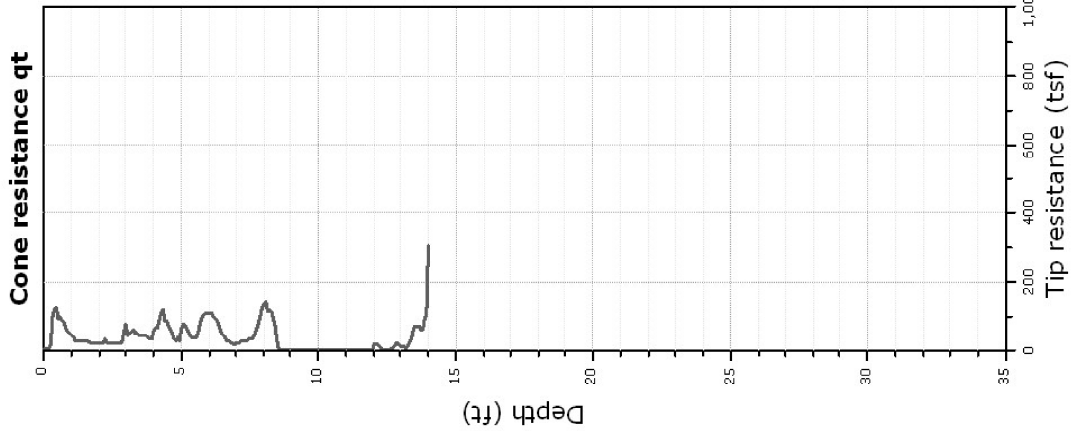
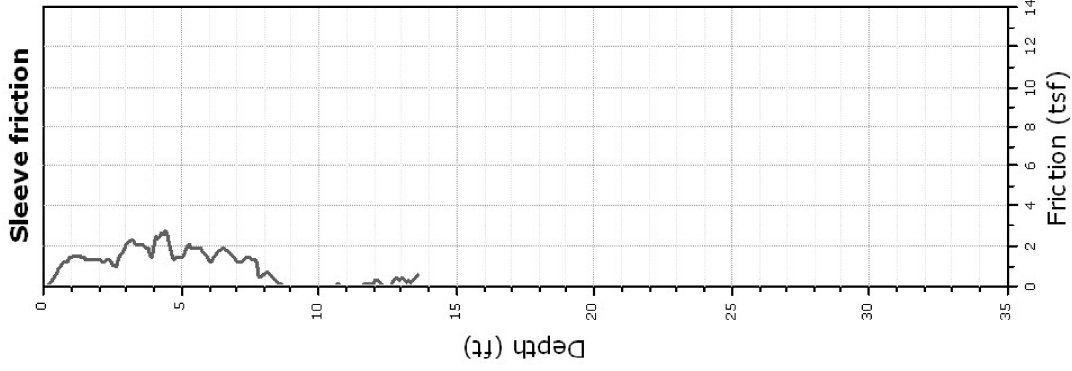
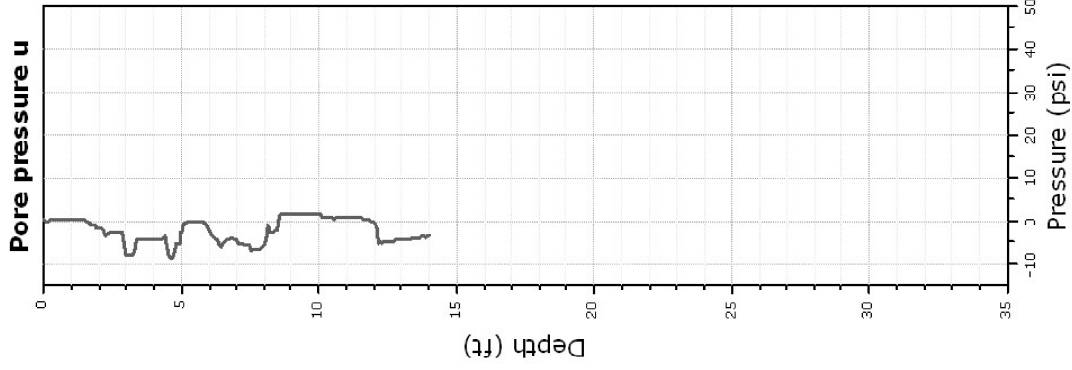
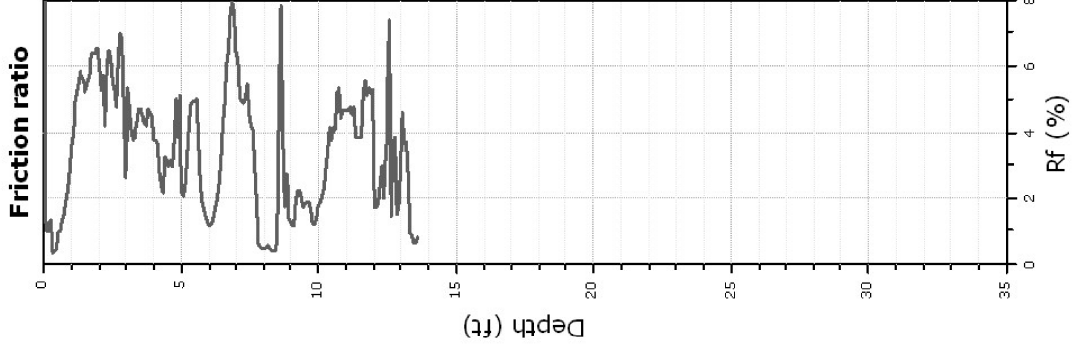
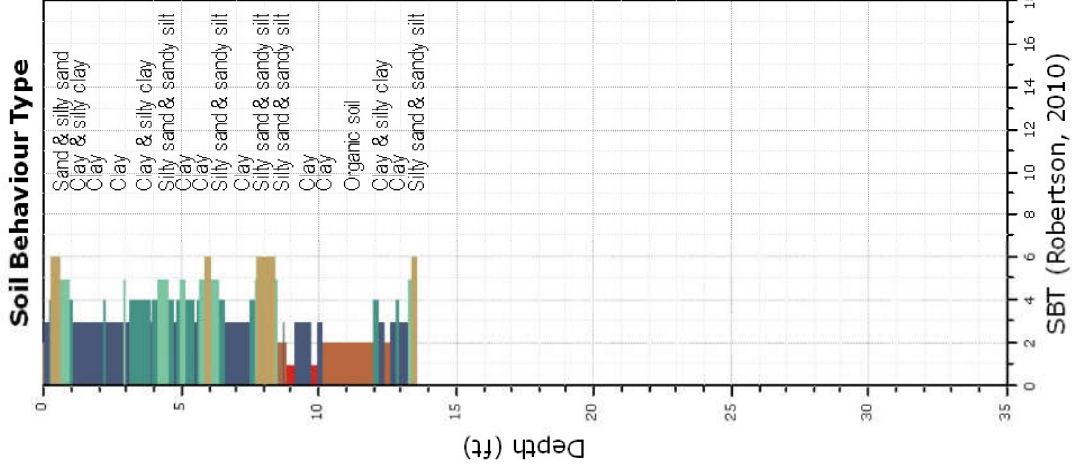
Total depth: 13.98 ft, Date: 9/12/2018

Cone Type: Vertek

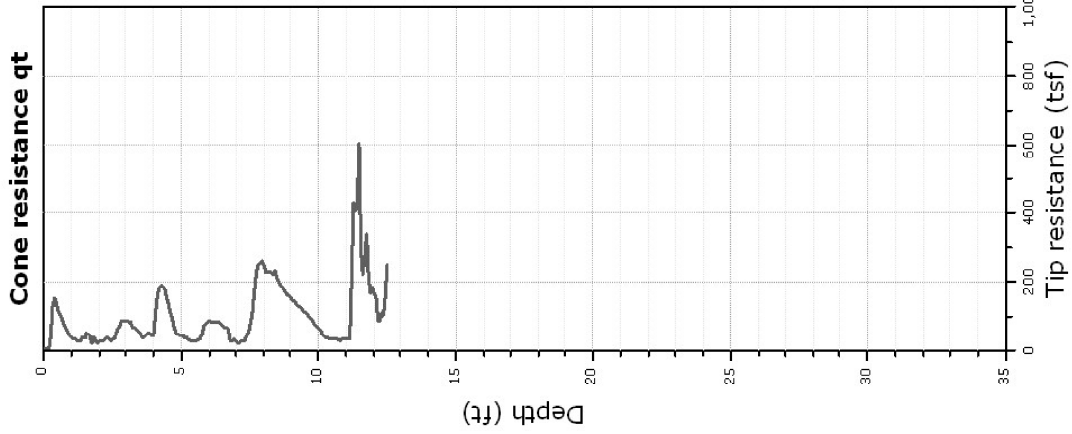
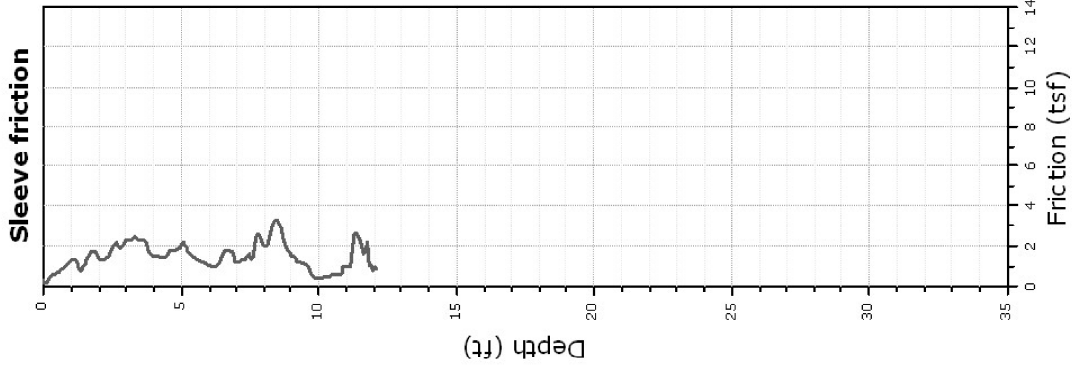
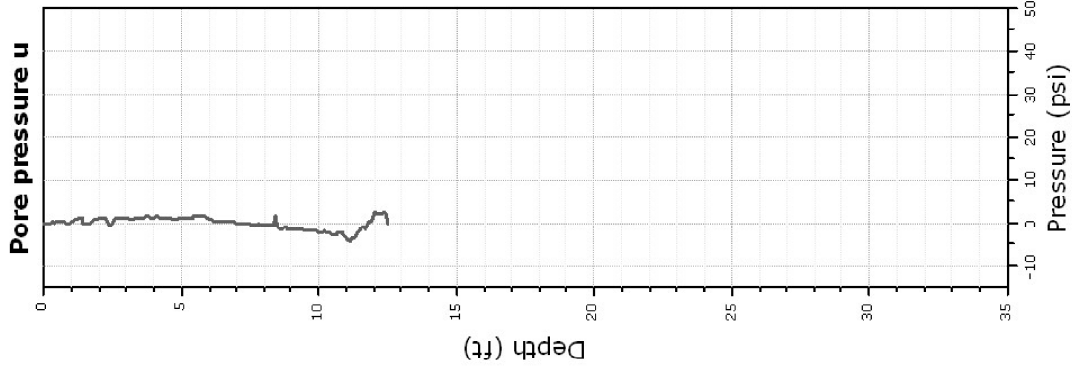
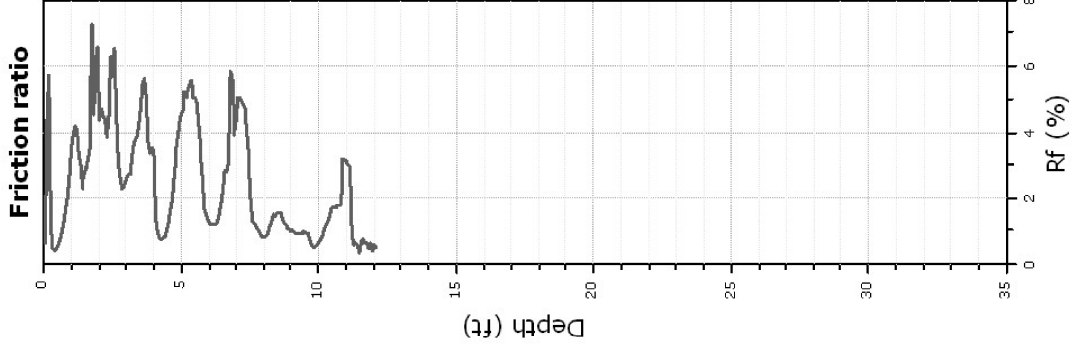
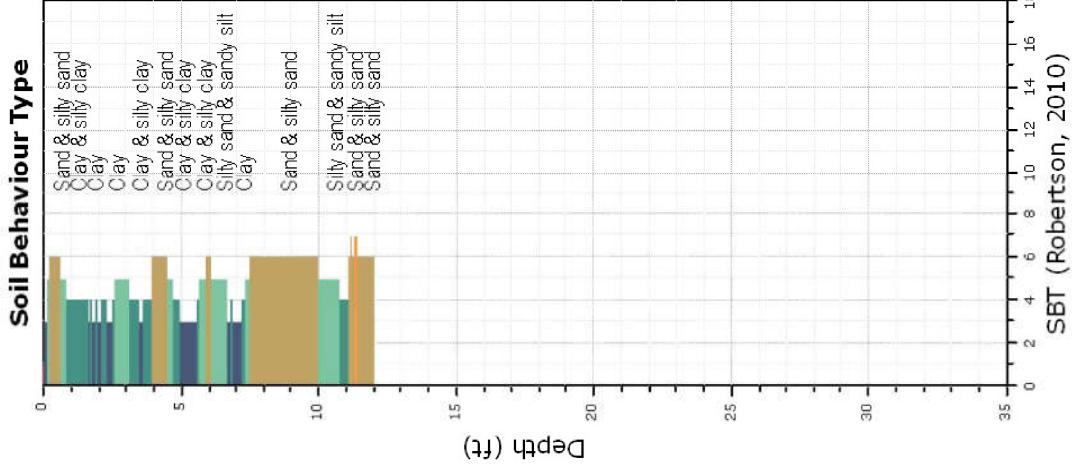
**CPT-6A**

Total depth: 12.47 ft, Date: 9/12/2018  
Cone Type: Vertek

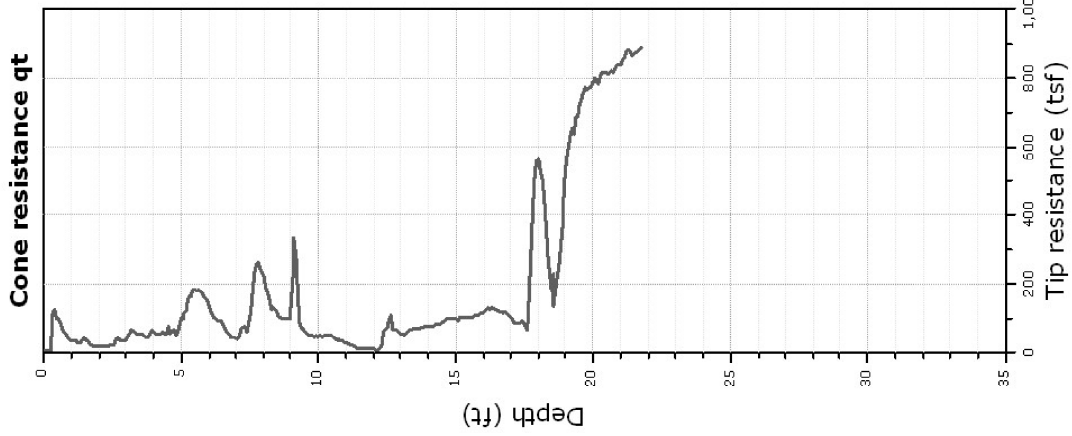
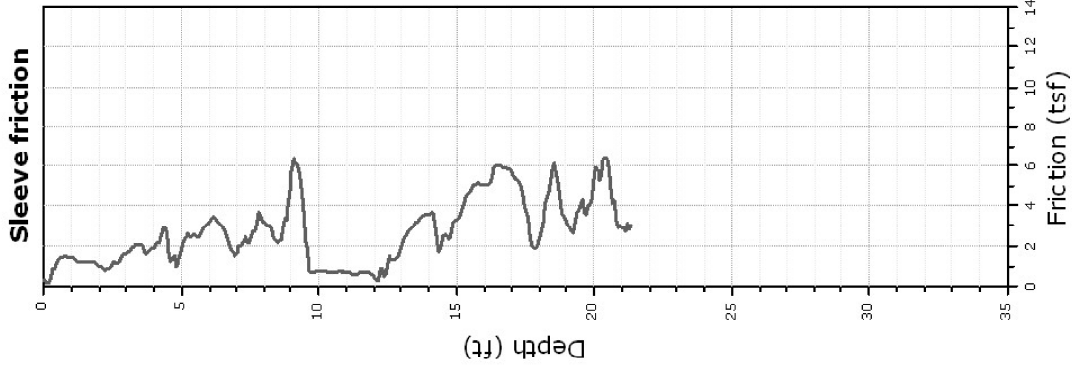
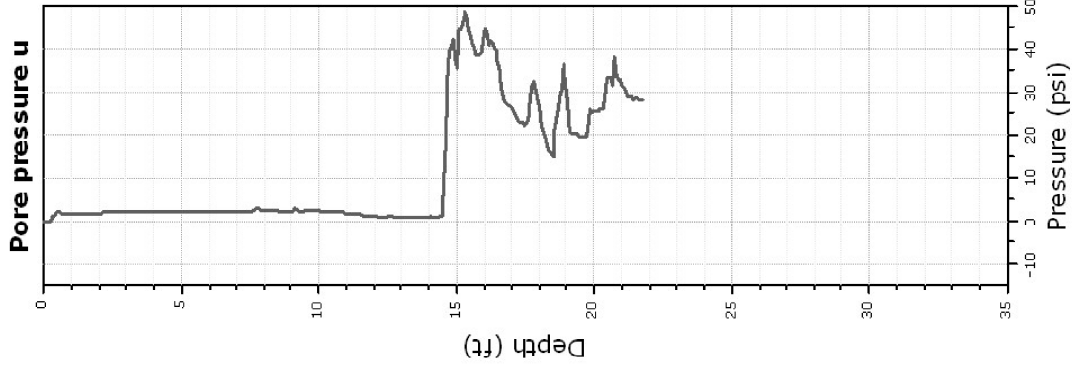
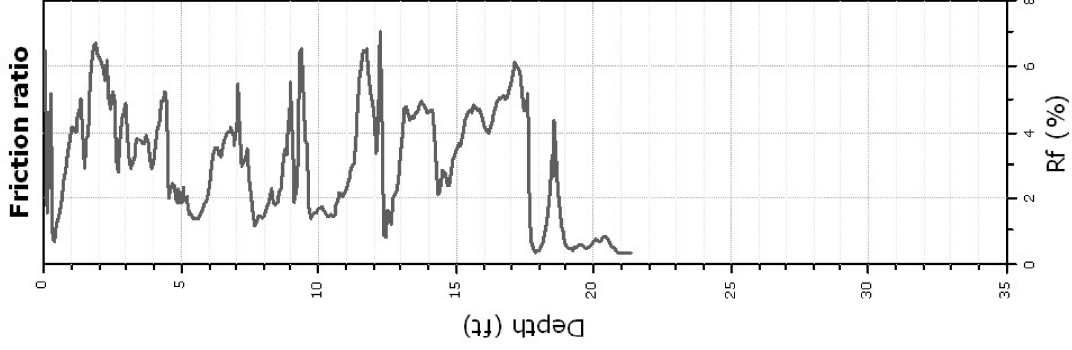
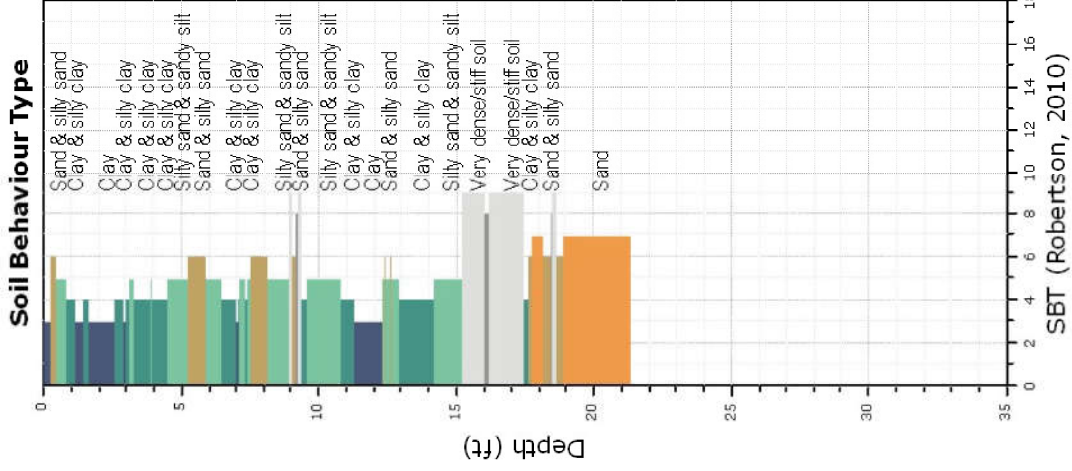
**CPT-6B**

Total depth: 21.73 ft, Date: 9/12/2018  
 Cone Type: Vertek

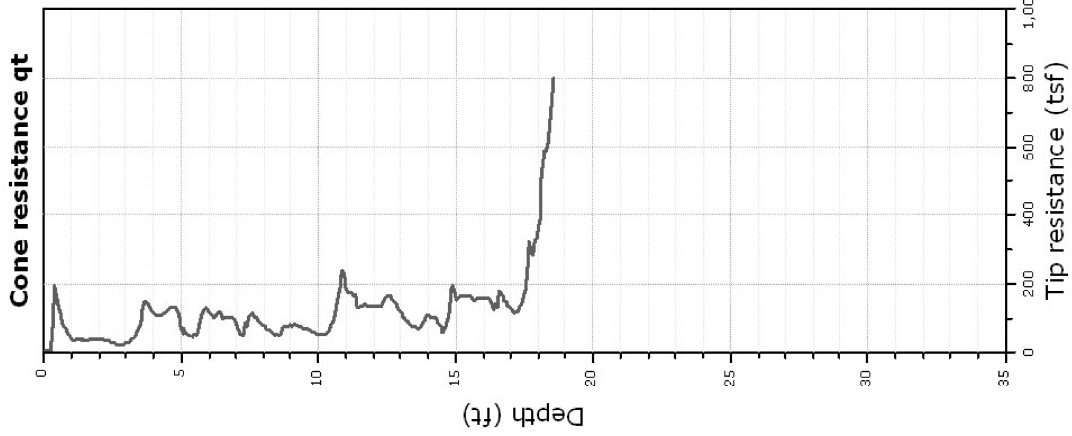
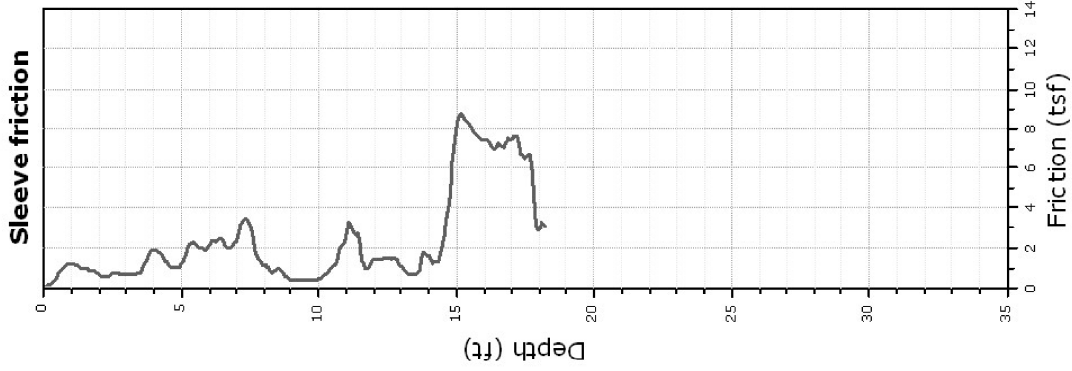
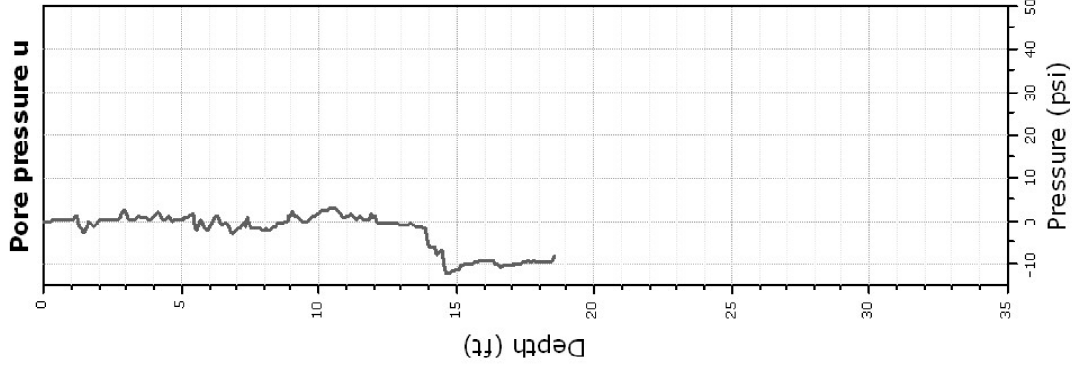
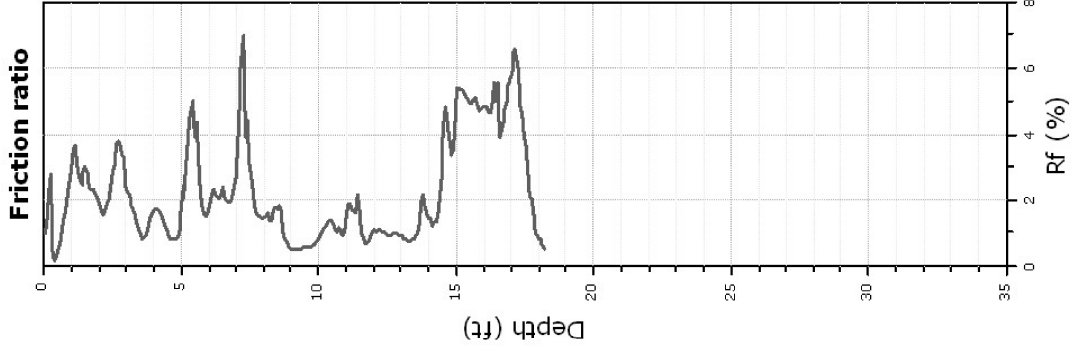
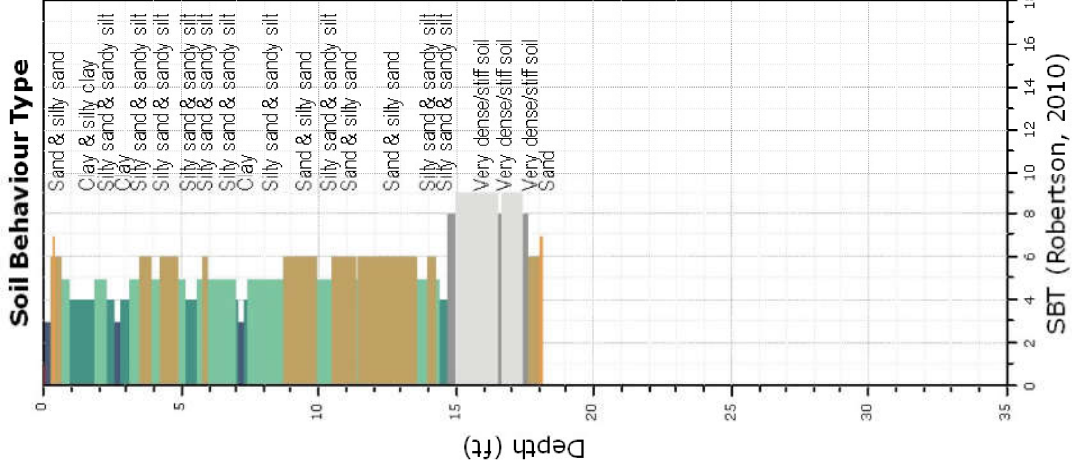
**CPT-7**

Total depth: 18.57 ft, Date: 9/12/2018  
Cone Type: Vertek
