## PRELIMINARY GEOTECHNICAL INVESTIGATION

**Preliminary Geotechnical Investigation,  
Dana Point Harbor Revitalization,  
Hotel Component,  
City of Dana Point, California**

September 10, 2019

GMU Project No. 17-206-01

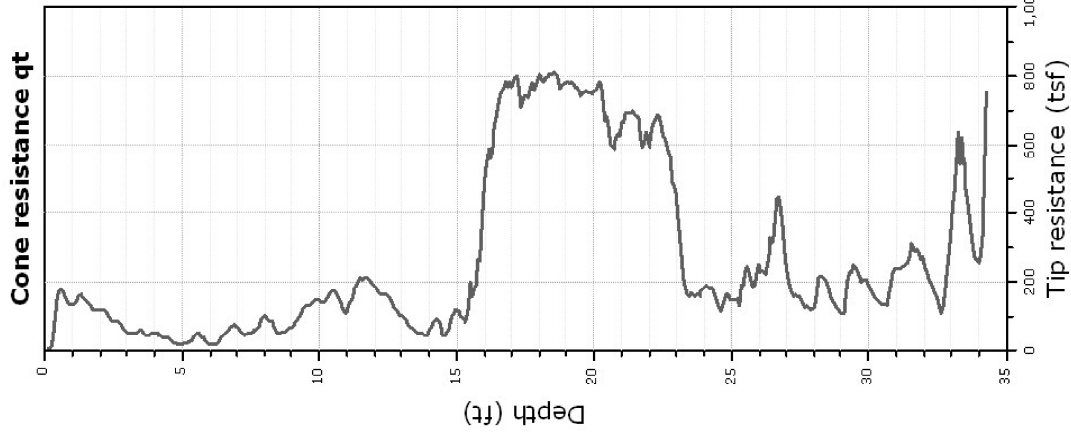
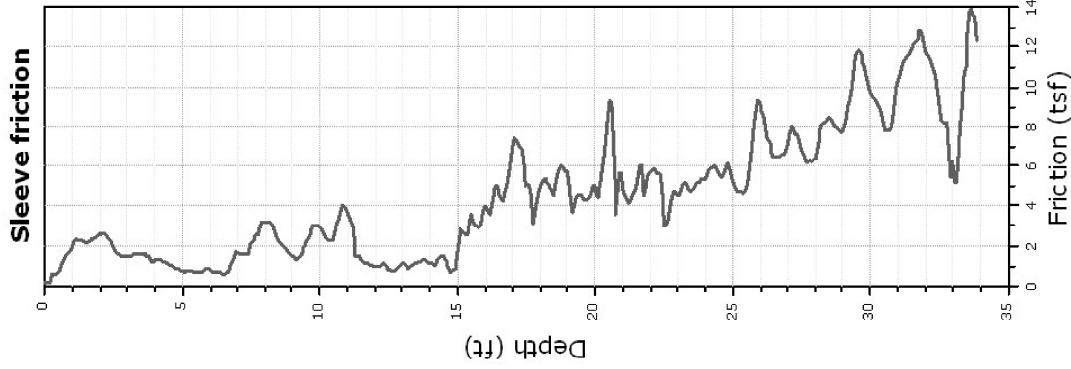
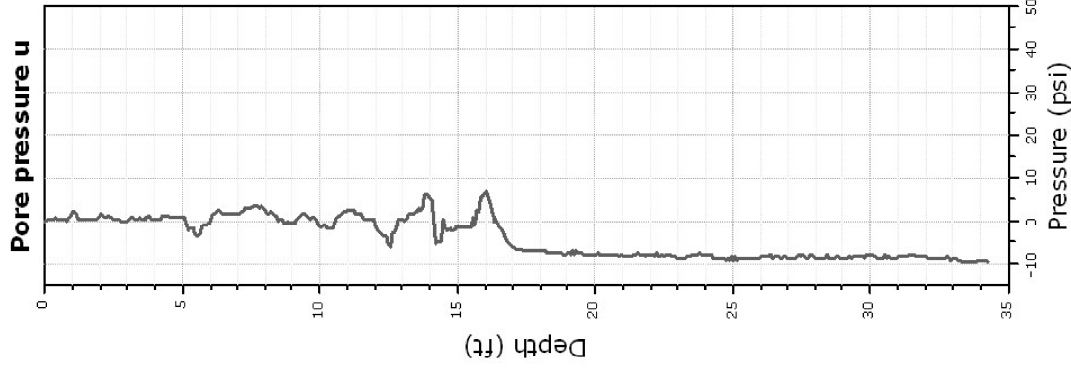
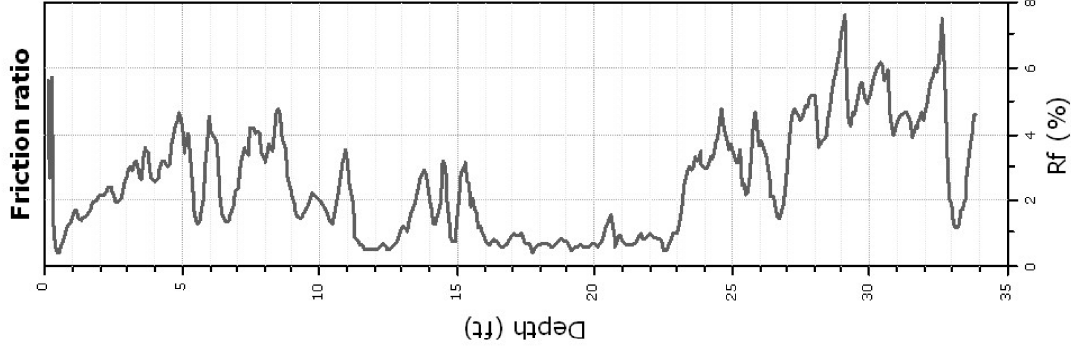
Total depth: 34.26 ft, Date: 9/12/2018

Cone Type: Vertek

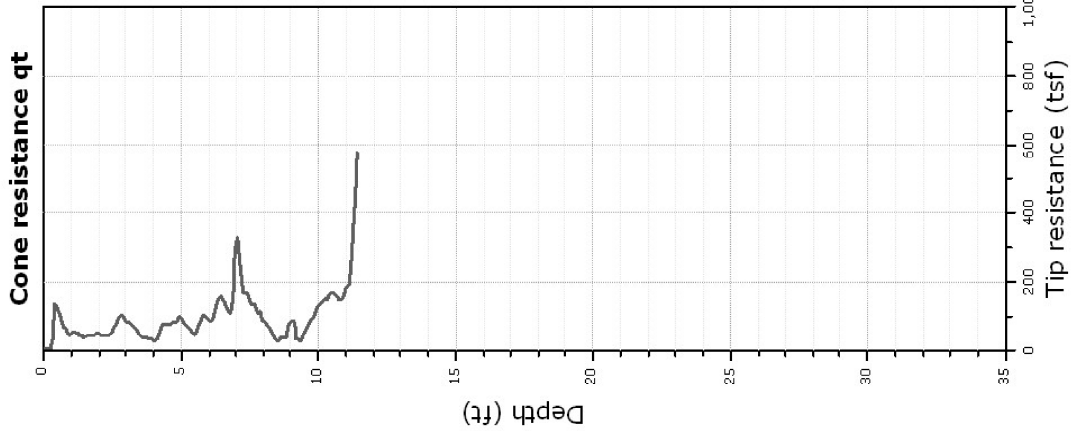
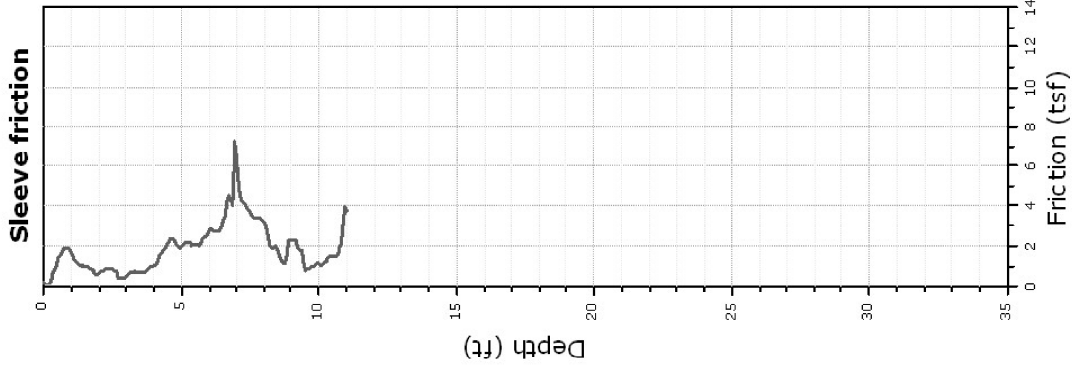
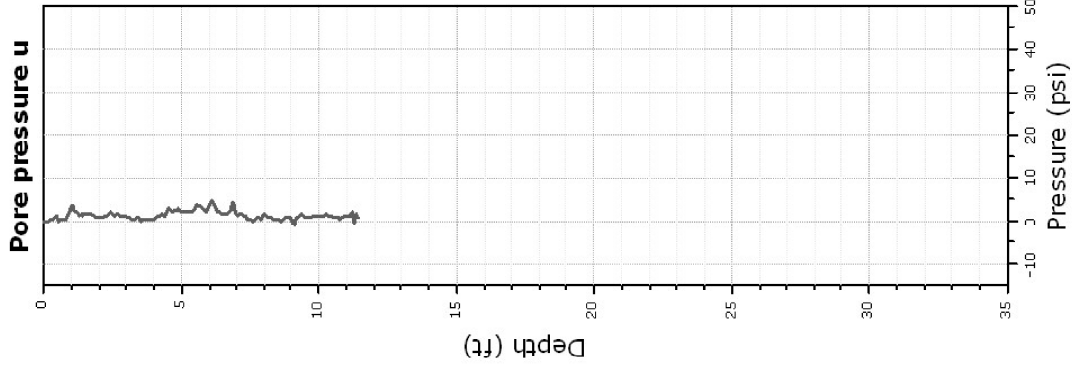
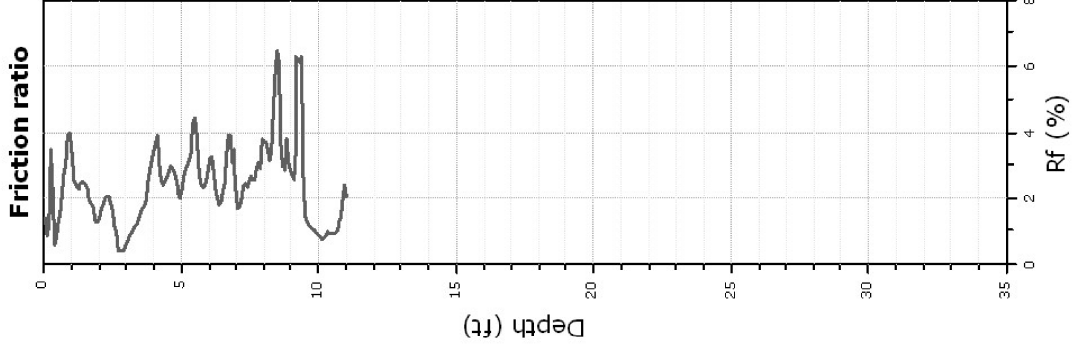
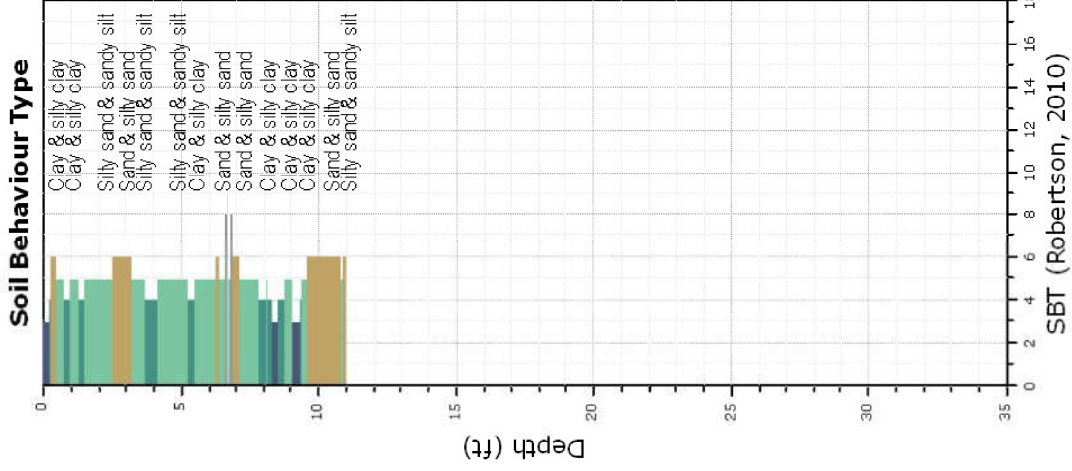
**CPT-9**

Total depth: 11.42 ft, Date: 9/12/2018  
Cone Type: Vertek

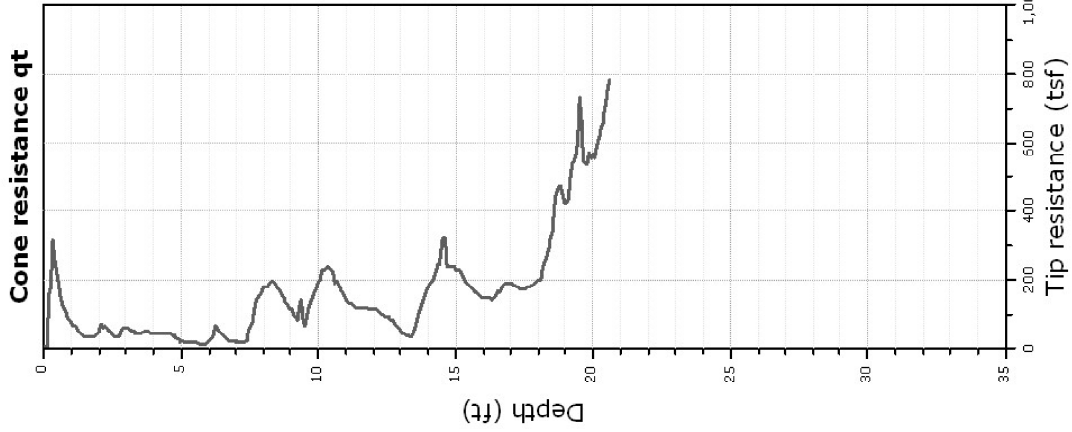
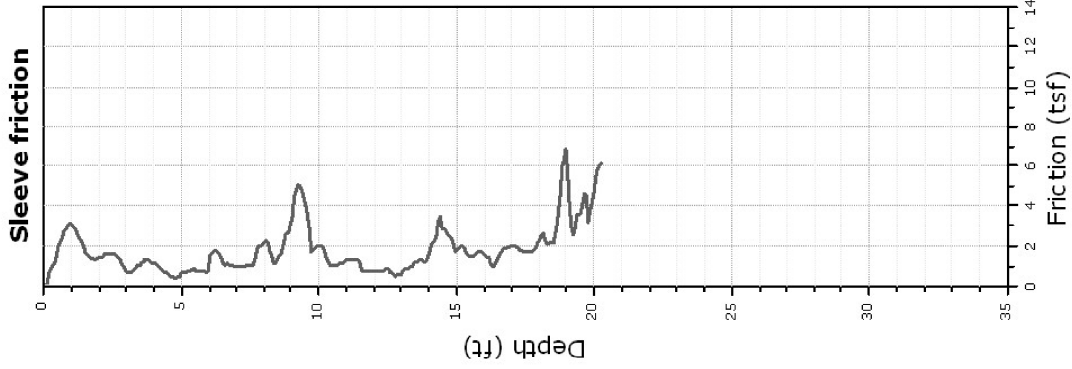
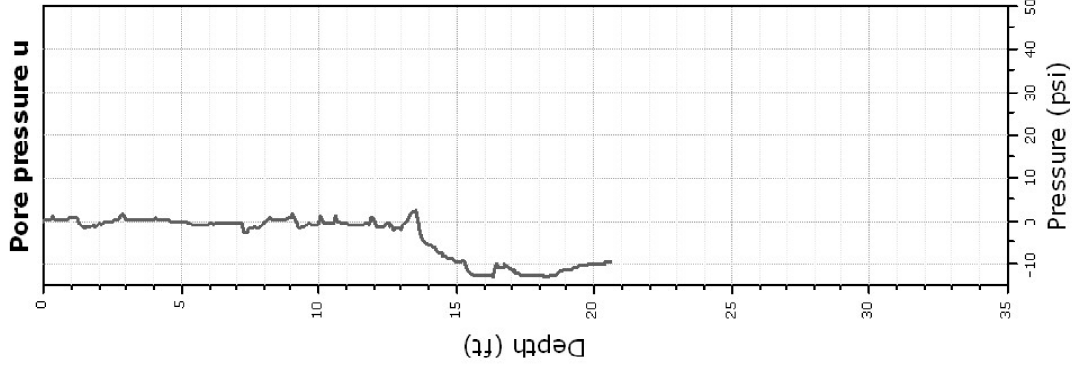
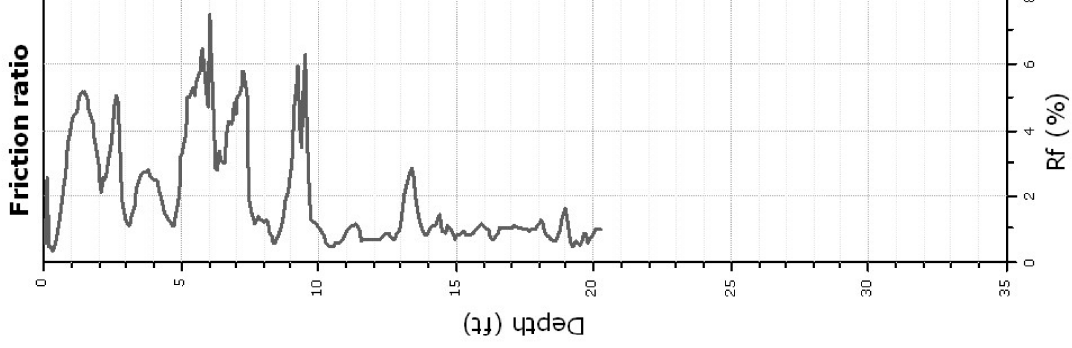
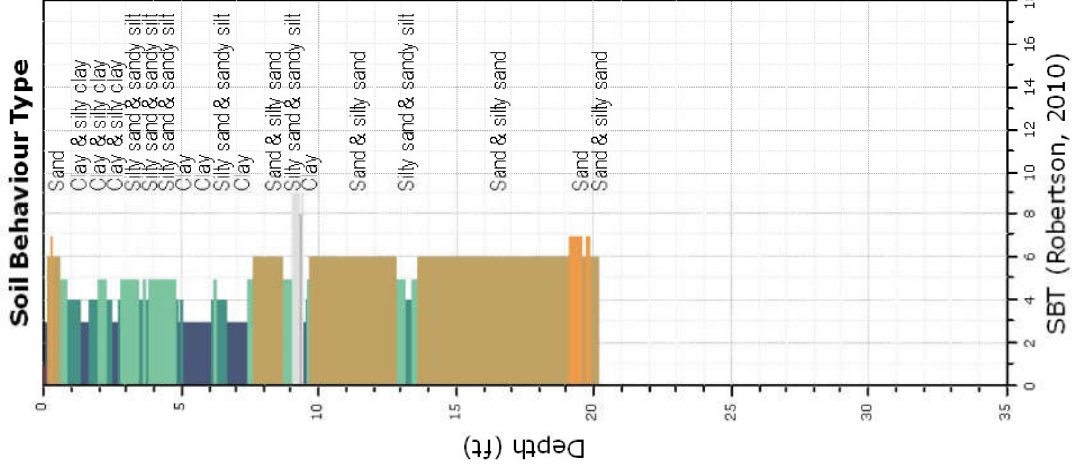
**CPT-10**

Total depth: 20.61 ft, Date: 9/12/2018  
 Cone Type: Vertek

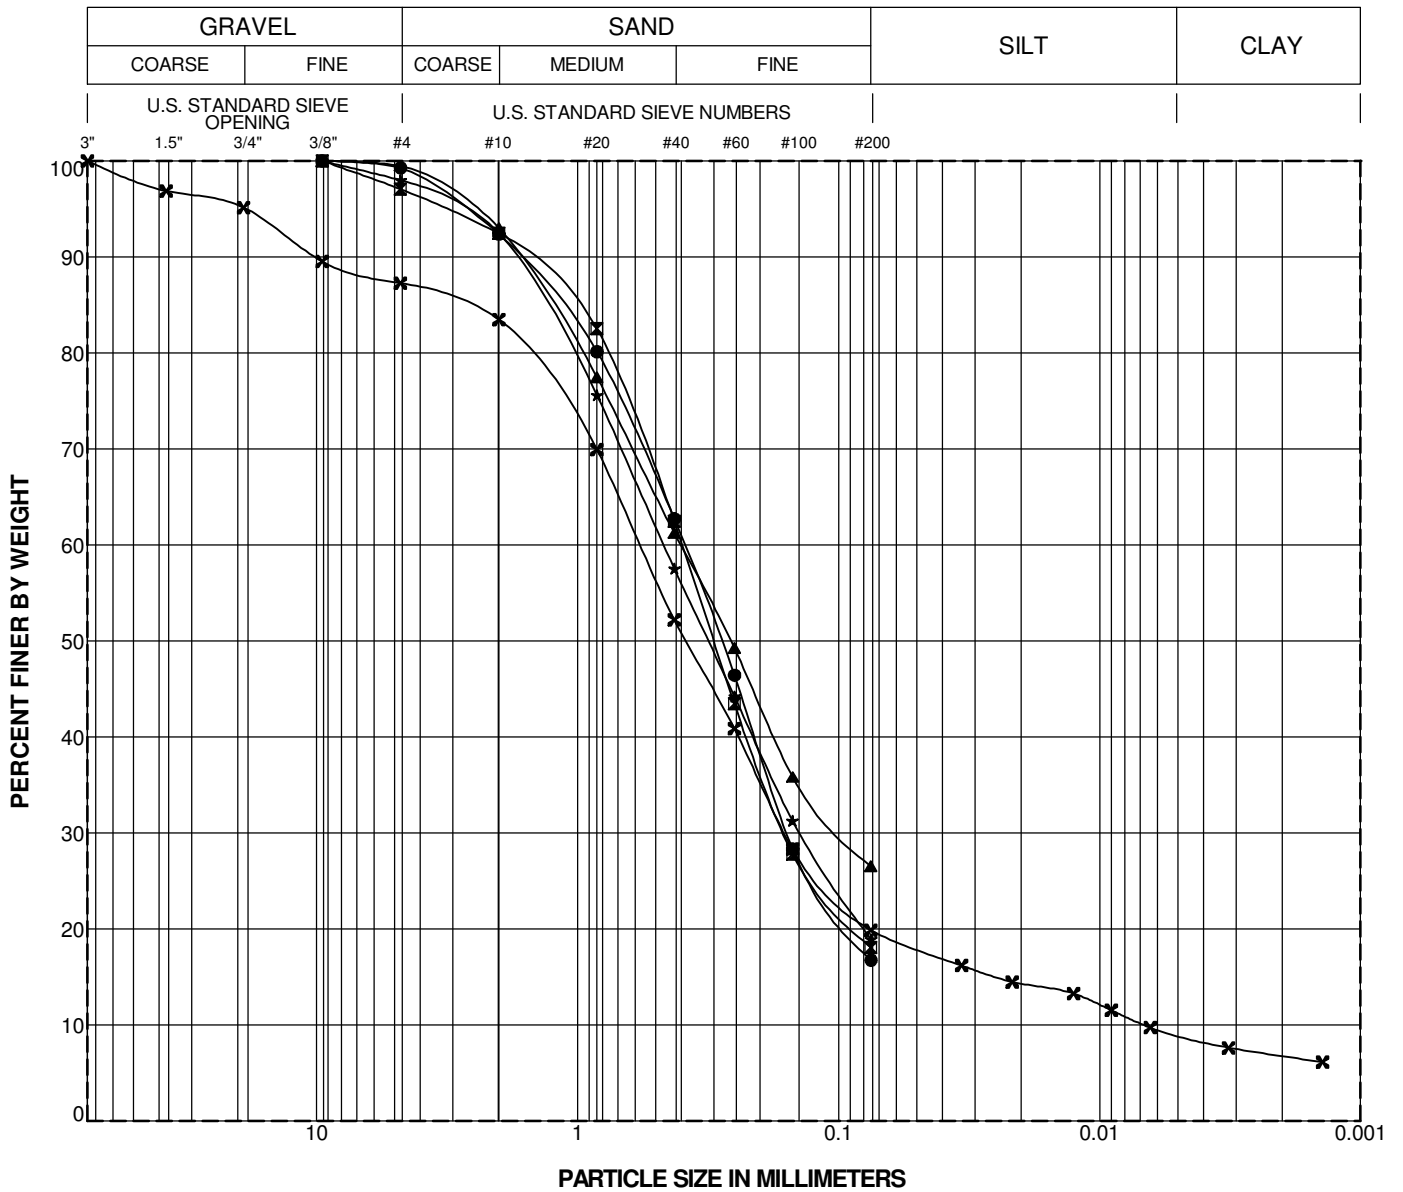
## PARTICLE SIZE DISTRIBUTION

Boring Number	Depth (feet)	Geologic Unit	Symbol	LL	PI	Classification
DH- 1	2.5	Qaf	●			SILTY CLAYEY SAND (SC)
DH- 1	15.0	Qaf	⊠			SILTY SAND (SM)
DH- 6	10.0	Qaf	▲			SILTY SAND TO CLAYEY SAND (SC)
DH-42	7.5	Qaf	★			CLAYEY SAND (SC)
DH-44	0.0	Qaf	✕	26	5	SILTY CLAYEY SAND (SC)

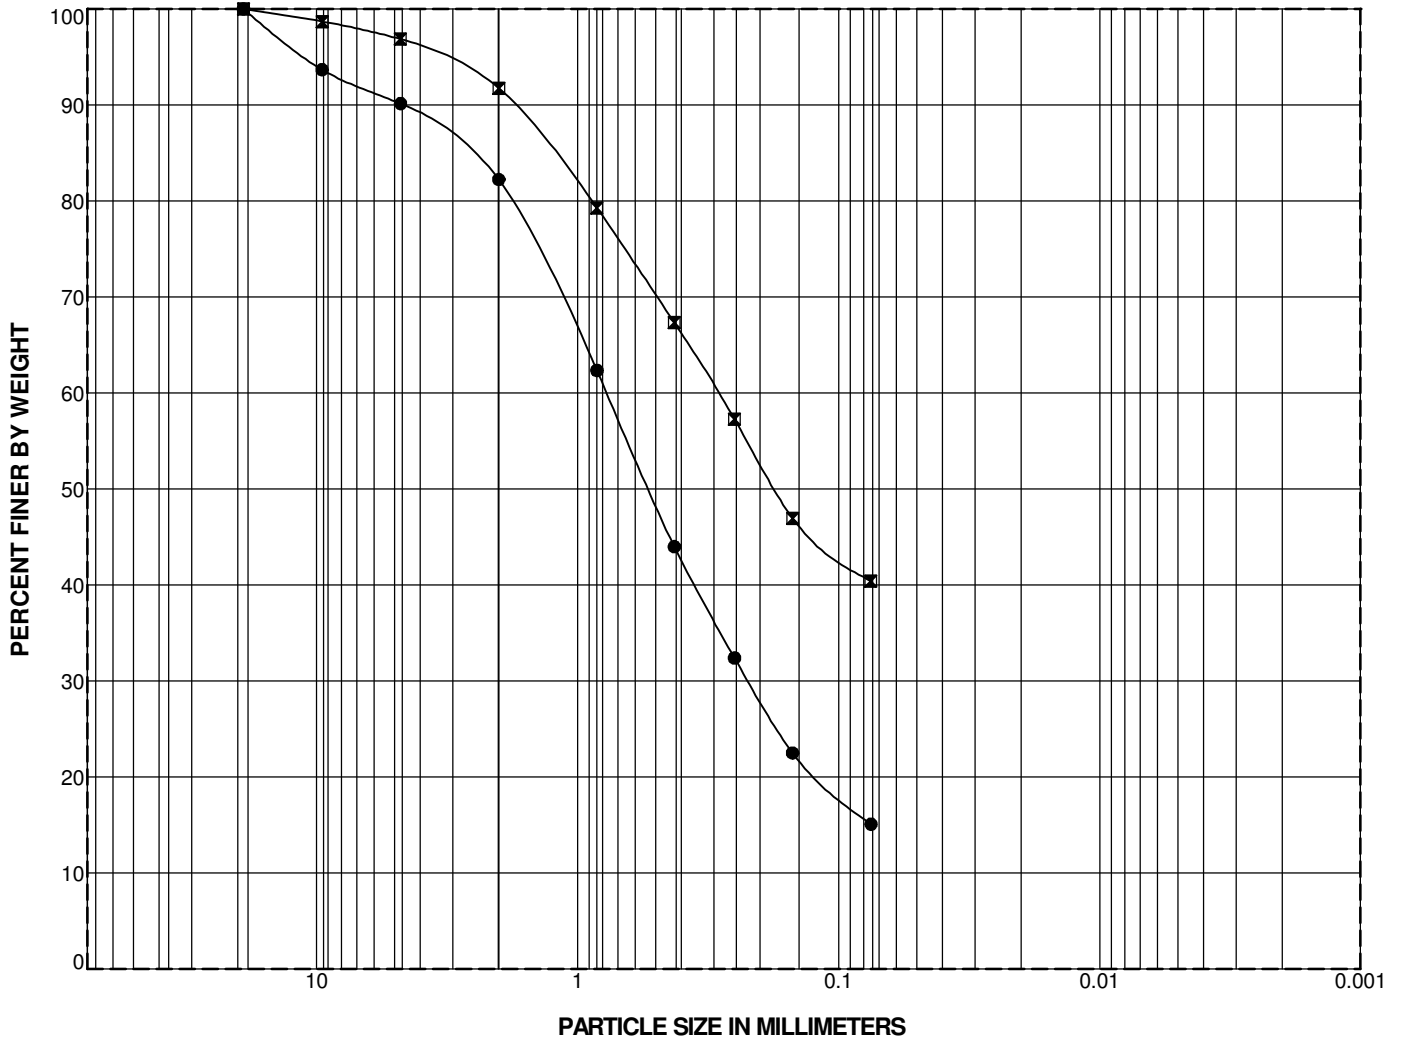
## PARTICLE SIZE DISTRIBUTION

Boring Number	Depth (feet)	Geologic Unit	Symbol	LL	PI	Classification
DH-44	12.5	Qm	●			SILTY SAND (SM)
DH-45	7.5	Qaf	⊠			CLAYEY SAND (SC)

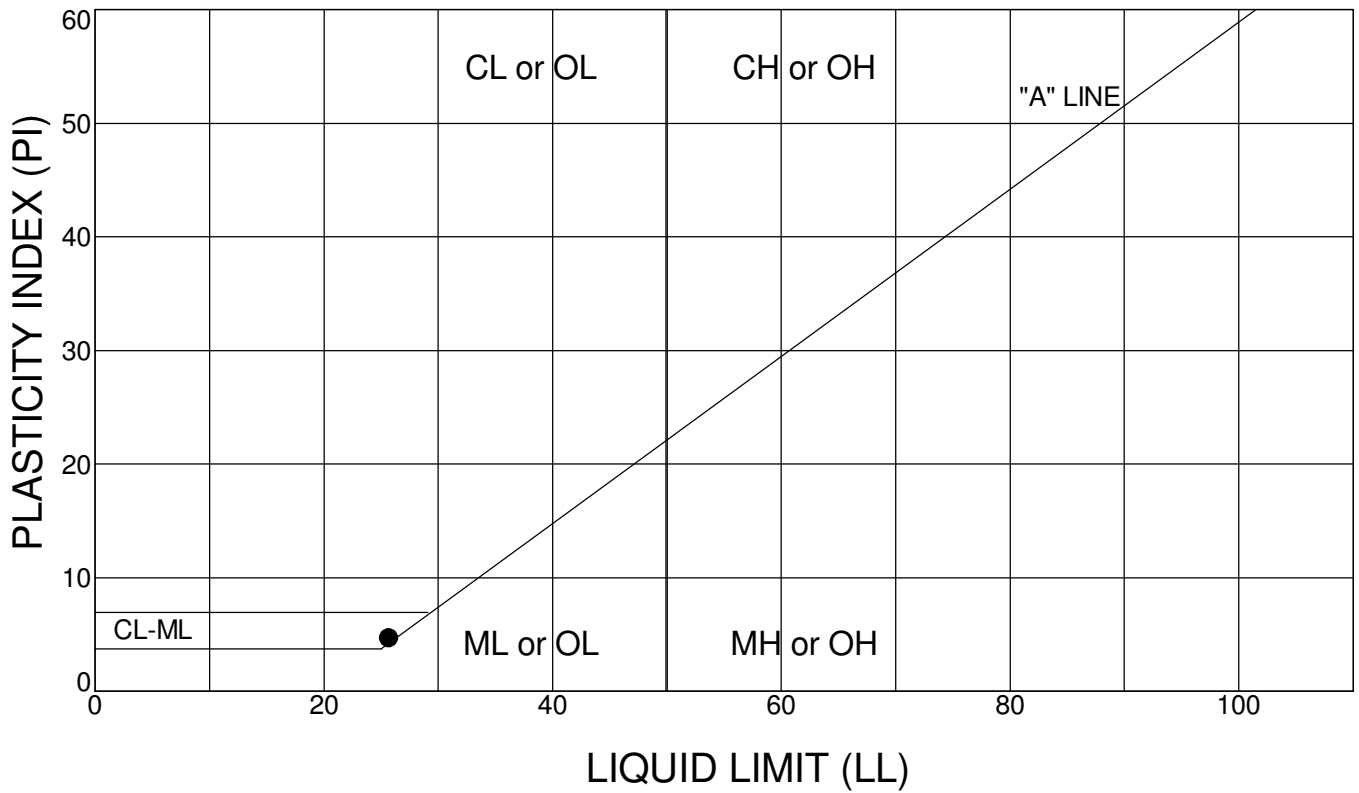
Boring Number	Depth (feet)	Geologic Unit	Test Symbol	Insitu Water Content (%)	LL	PL	PI	Classification
DH-44	0.0	Qaf	●	9	26	21	5	SILTY CLAYEY SAND (SC)

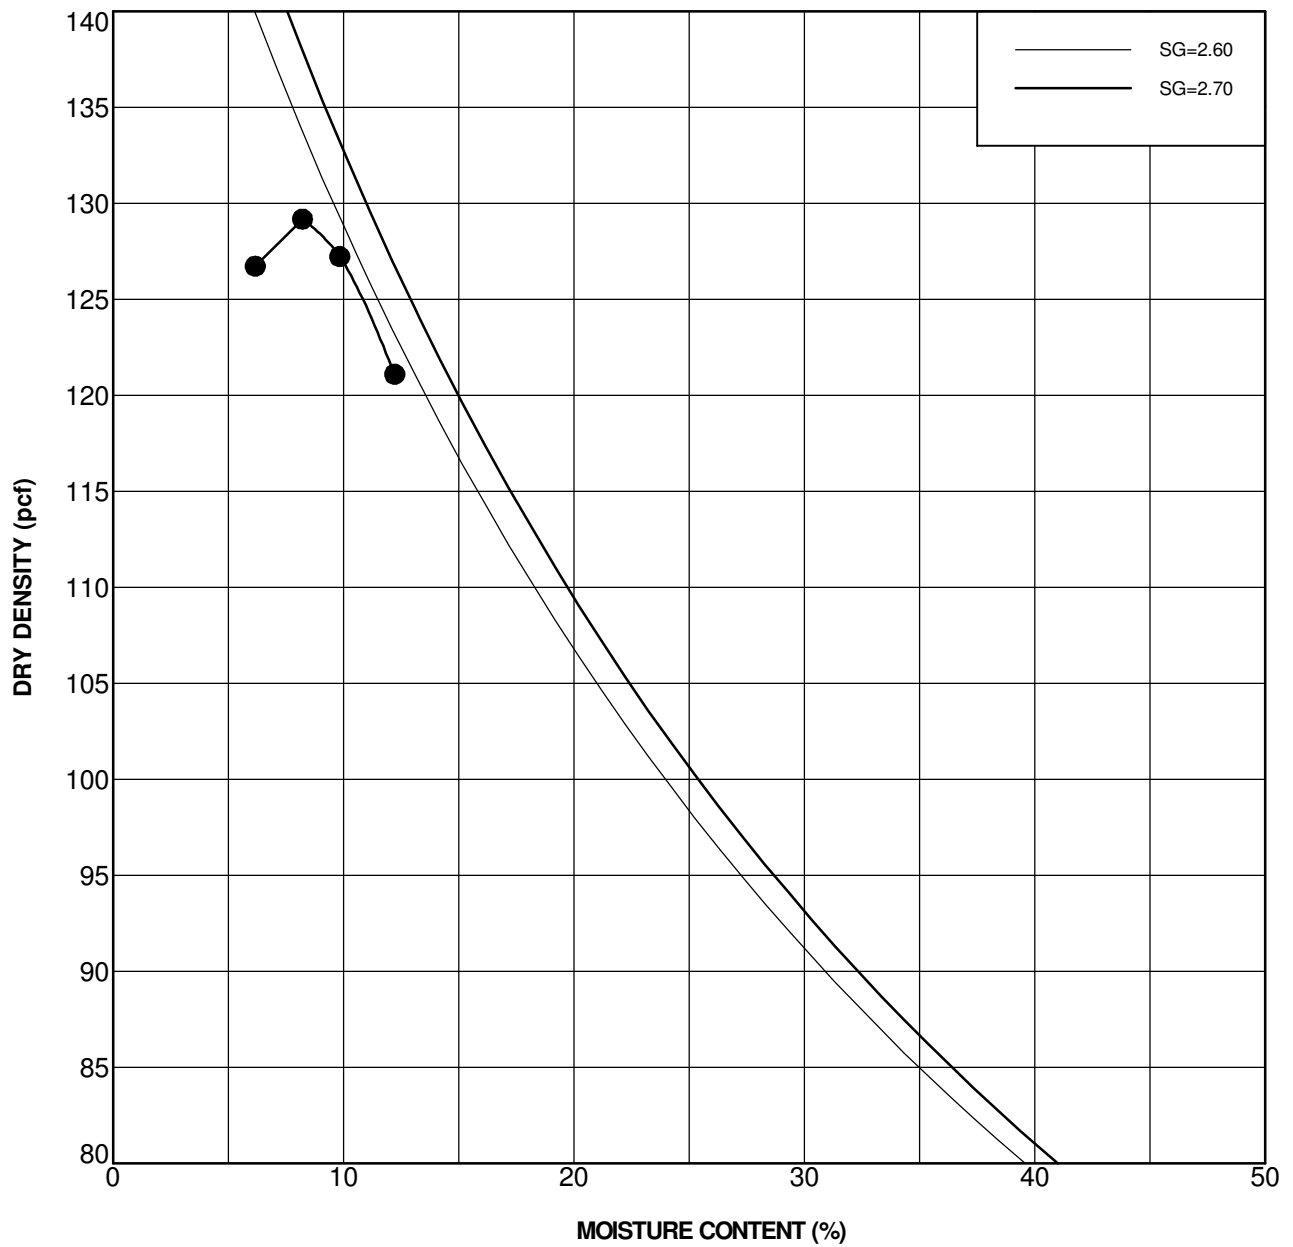
## COMPACTION TEST DATA

Boring Number	Depth (feet)	Geologic Unit	Symbol	Maximum Dry Density, pcf	Optimum Moisture Content, %	Classification
DH-43	0.0	Qaf	●	132.5	8	CLAYEY SAND (SC)

Bulk samples representative of the on-site materials were tested to determine the maximum dry density and optimum moisture content of the soil. These compactive characteristics were determined in general accordance with ASTM Test Method D 1557. The results of this test are contained in this Appendix B and also Table B-1.

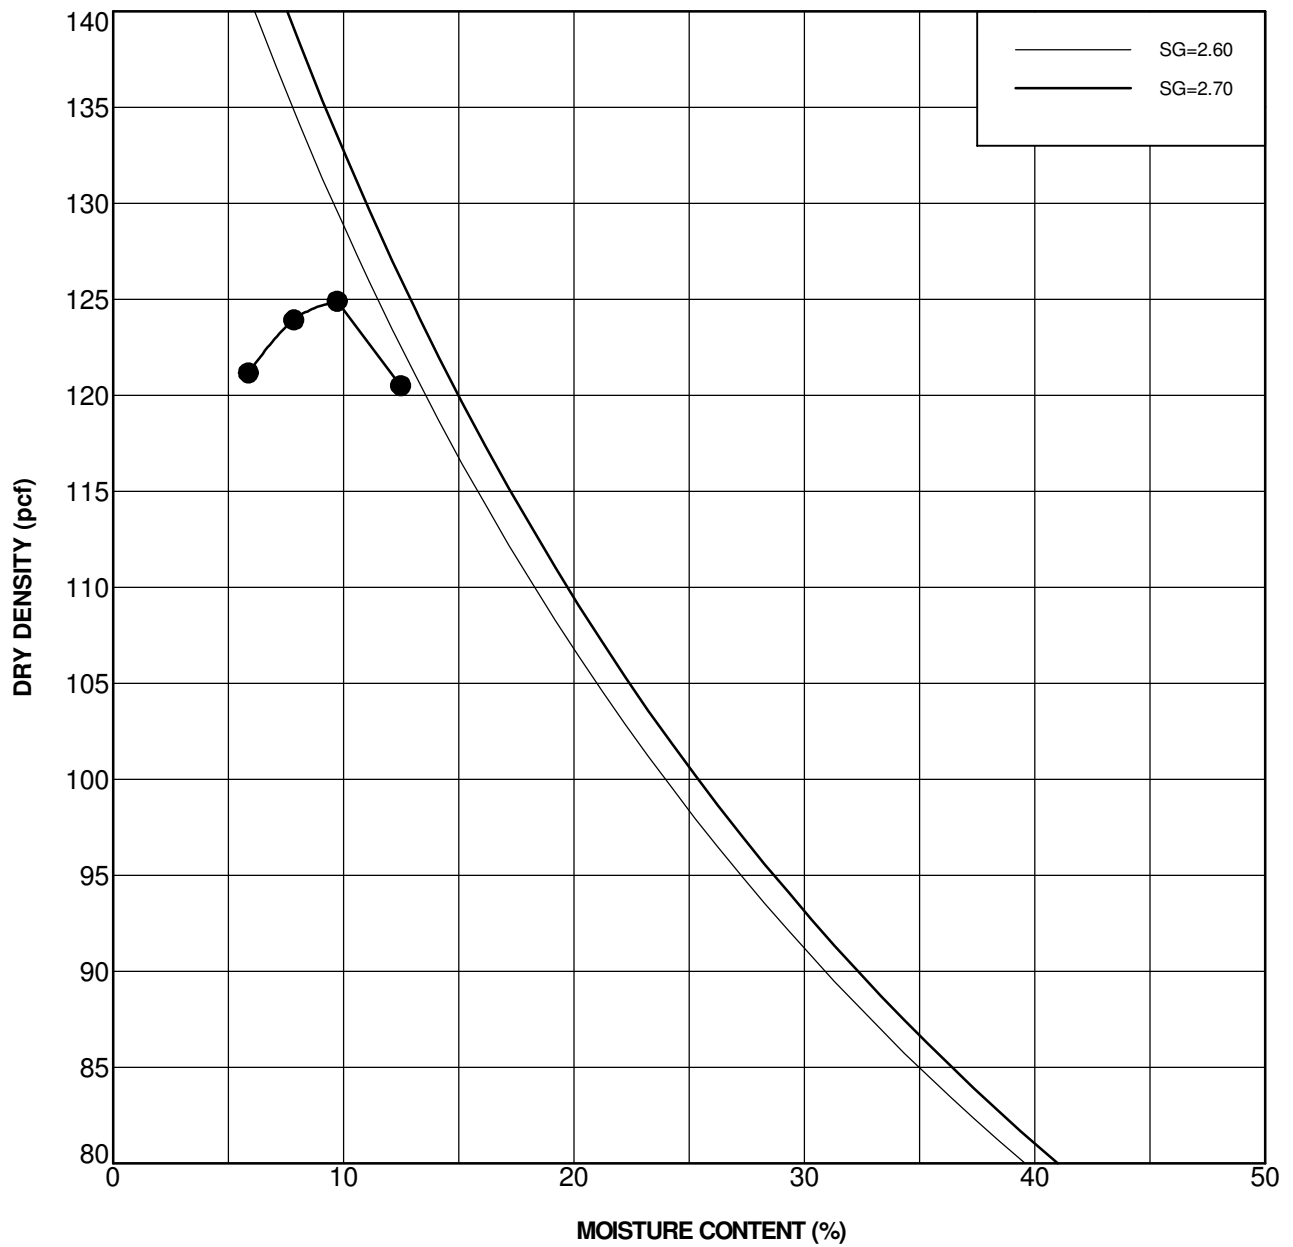
## COMPACTION TEST DATA

Boring Number	Depth (feet)	Geologic Unit	Symbol	Maximum Dry Density, pcf	Optimum Moisture Content, %	Classification
DH-44	0.0	Qaf	●	127	8.5	SILTY CLAYEY SAND (SC)

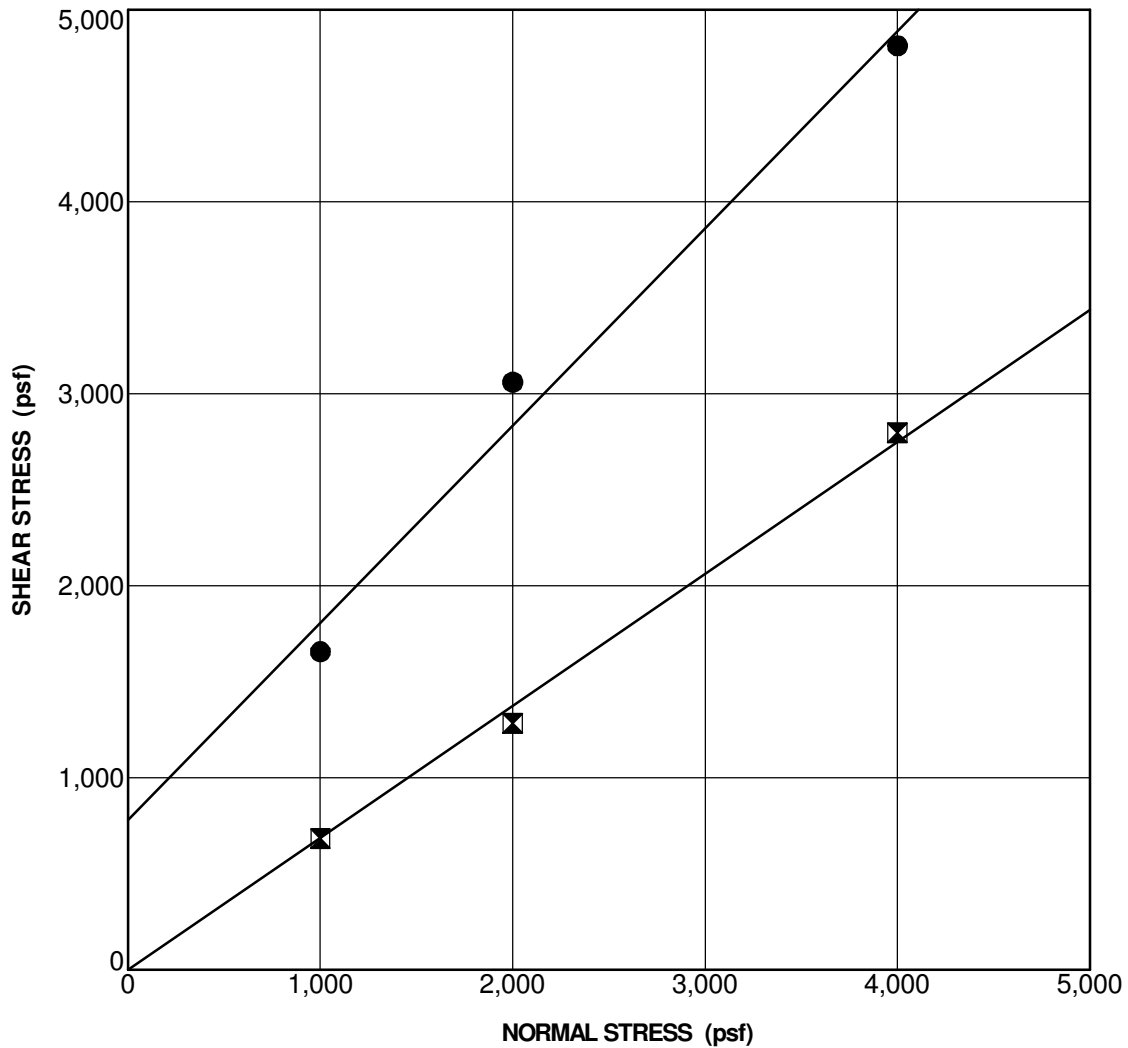
SAMPLE AND TEST DESCRIPTION		
<b>Sample Location:</b> DH- 1 @ 5.0 ft	<b>Geologic Unit:</b> Qaf	<b>Classification:</b> CLAYEY SAND (SC)
<b>Strain Rate (in/min):</b> 0.005	<b>Sample Preparation:</b> Undisturbed	
<b>Notes:</b> Sample saturated prior and during shearing

STRENGTH PARAMETERS		
STRENGTH TYPE	COHESION (psf)	FRICITION ANGLE (degrees)
● Peak Strength	780	46.0
⊠ Ultimate Strength	0	35.0

Direct shear tests were performed on typical on-site materials. The general philosophy and procedure of the tests were in accord with ASTM Test Method D 3080 - "Direct Shear Tests for Soils Under Consolidated Drained Conditions".

The tests are single shear tests and are performed using a sample diameter of 2.416 inches and a height of 1.00 inch. The normal load is applied by a vertical dead load system. A constant rate of strain is applied to the upper one-half of the sample until failure occurs. Shear stress is monitored by a strain gauge-type precision load cell and deflection is measured with a digital dial indicator. This data is transferred electronically to data acquisition software which plots shear strength vs. deflection. The shear strength plots are then interpreted to determine either peak or ultimate shear strengths. Residual strengths were obtained through multiple shear box reversals. A strain rate compatible with the grain size distribution of the soils was utilized. The interpreted results of these tests are shown in this Appendix B.

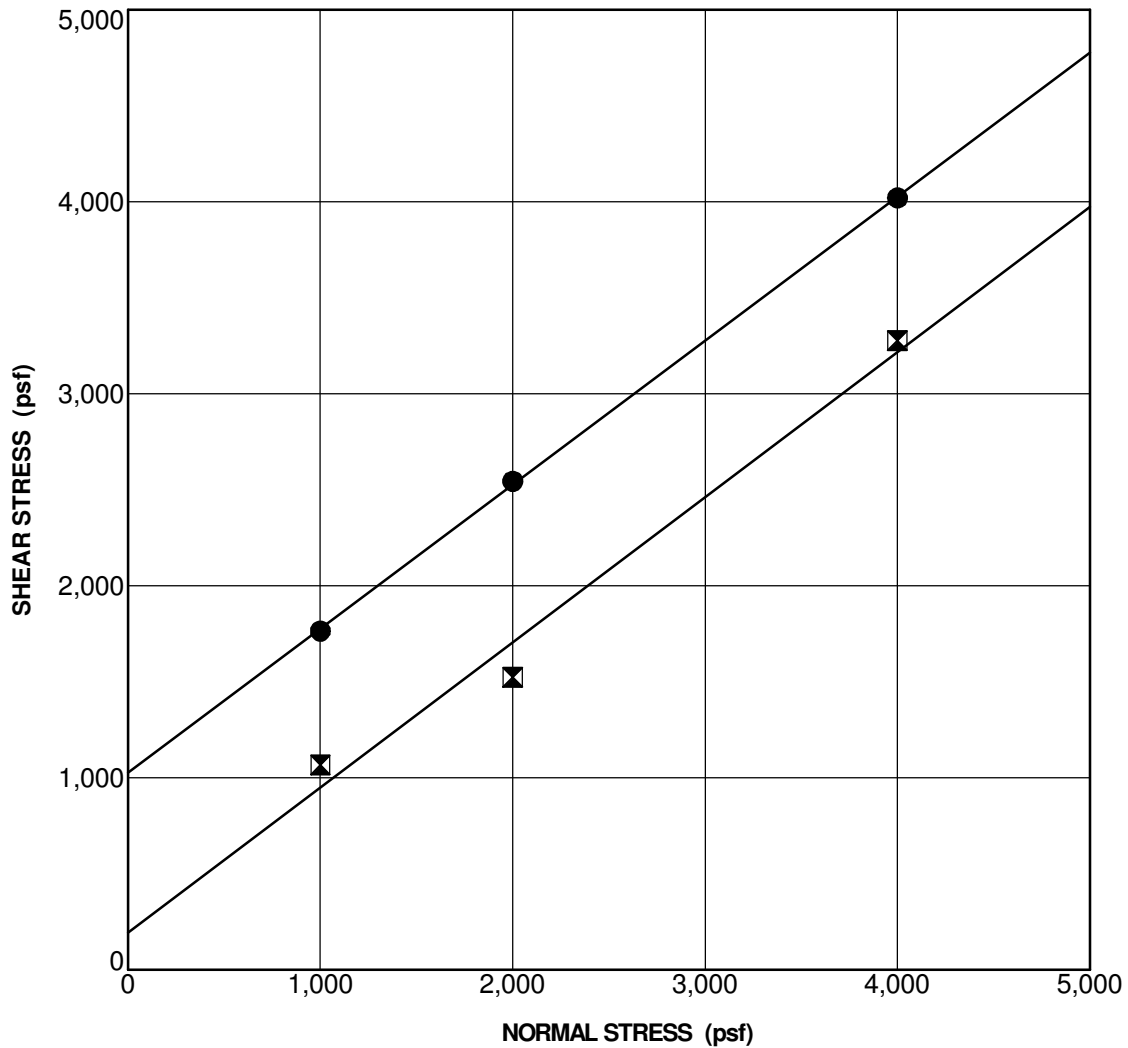
**Sample Location:** DH- 1 @ 30.0 ft **Geologic Unit:** Tc **Classification:** SANDSTONE (SP)  
**Strain Rate (in/min):** 0.005 **Sample Preparation:** Undisturbed  
**Notes:** Sample saturated prior and during shearing

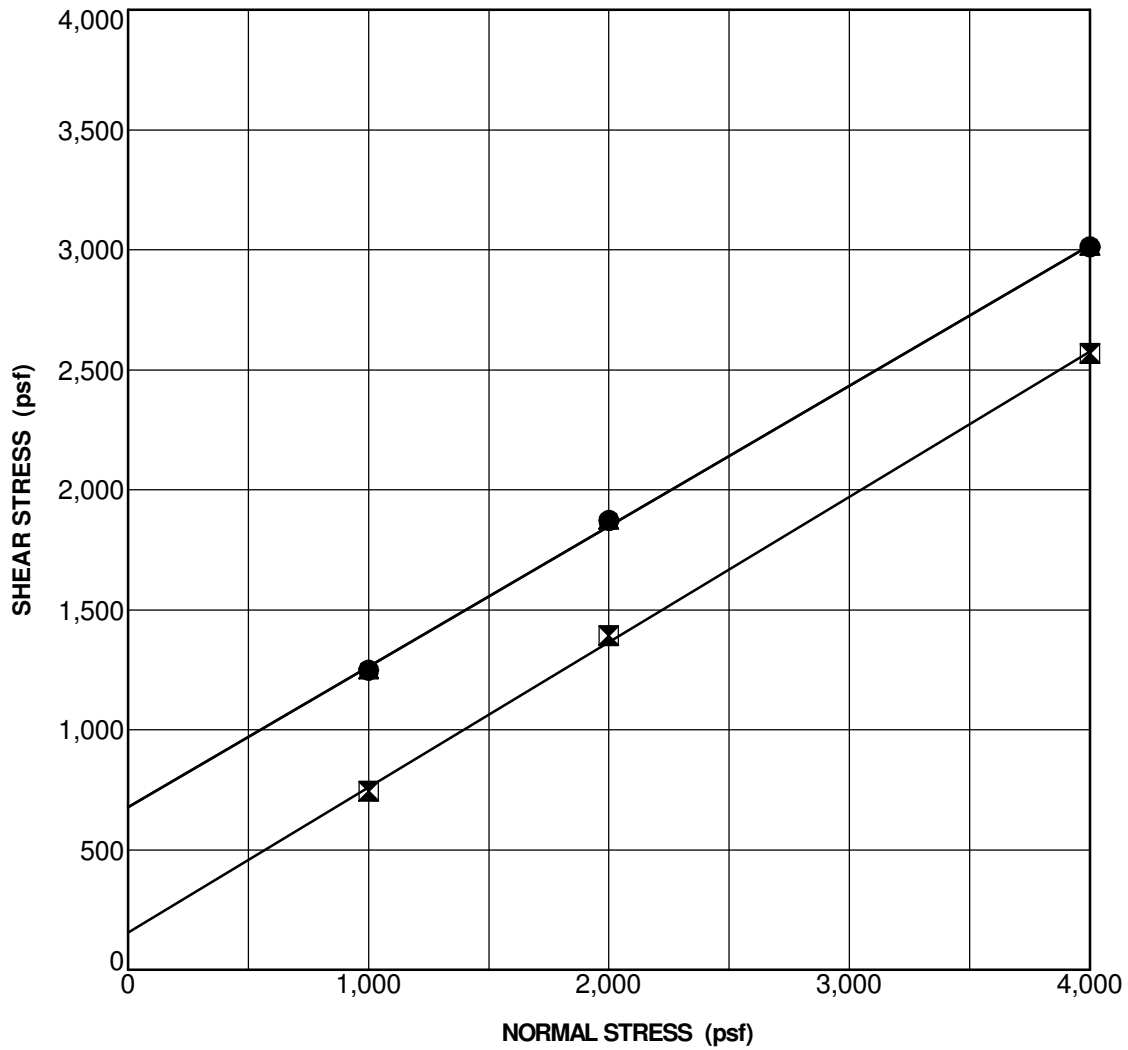
**Sample Location:** DH-15 @ 5.0 ft    **Geologic Unit:** Tc    **Classification:** SANDSTONE (SP)  
**Strain Rate (in/min):** 0.005    **Sample Preparation:** Undisturbed  
**Notes:** Sample saturated prior and during shearing

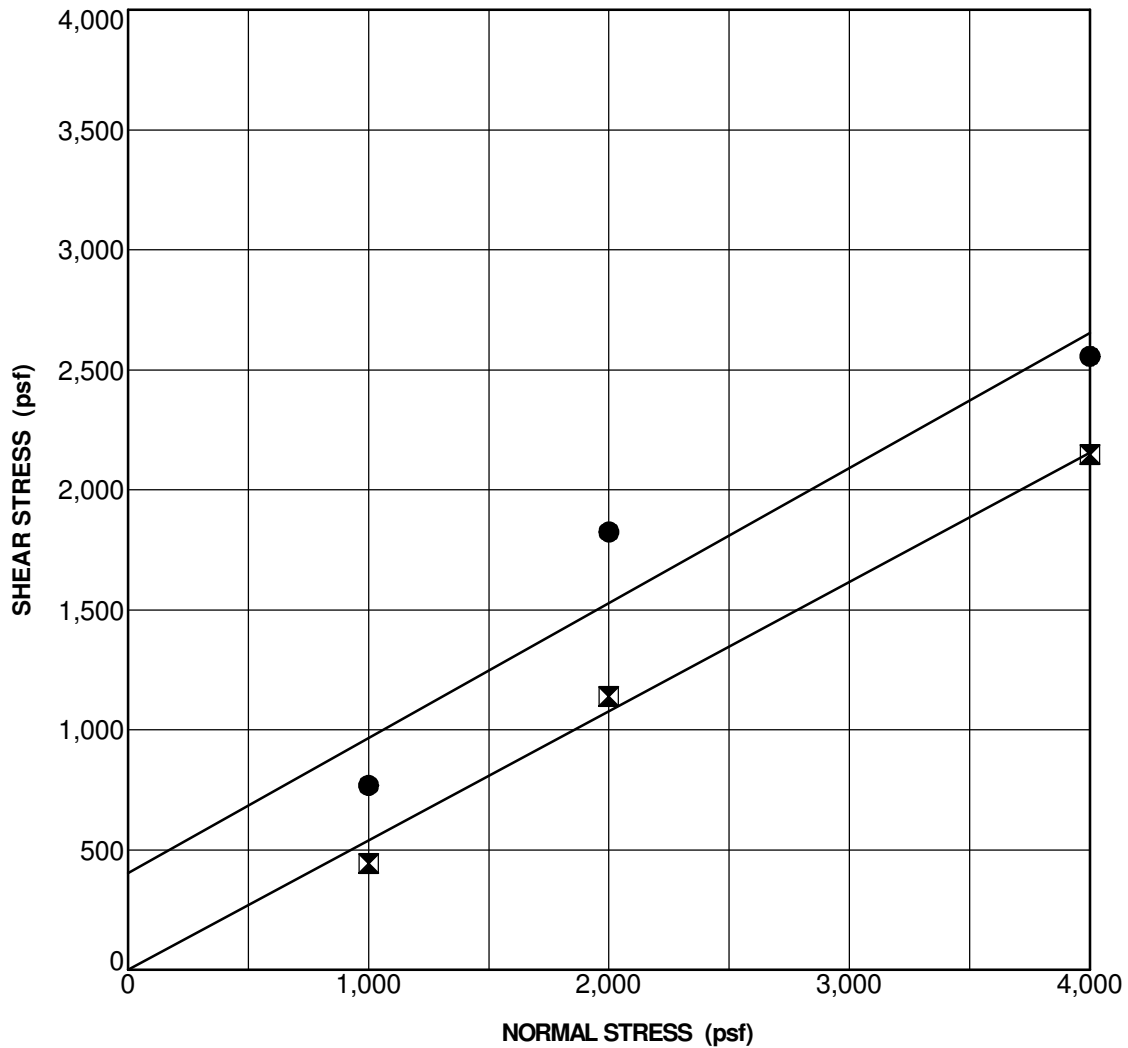
**Sample Location:** DH-43 @ 0.0 ft    **Geologic Unit:** Qaf    **Classification:** CLAYEY SAND (SC)  
**Strain Rate (in/min):** 0.005    **Sample Preparation:** Remolded  
**Notes:** Remolded 90% compaction at optimum

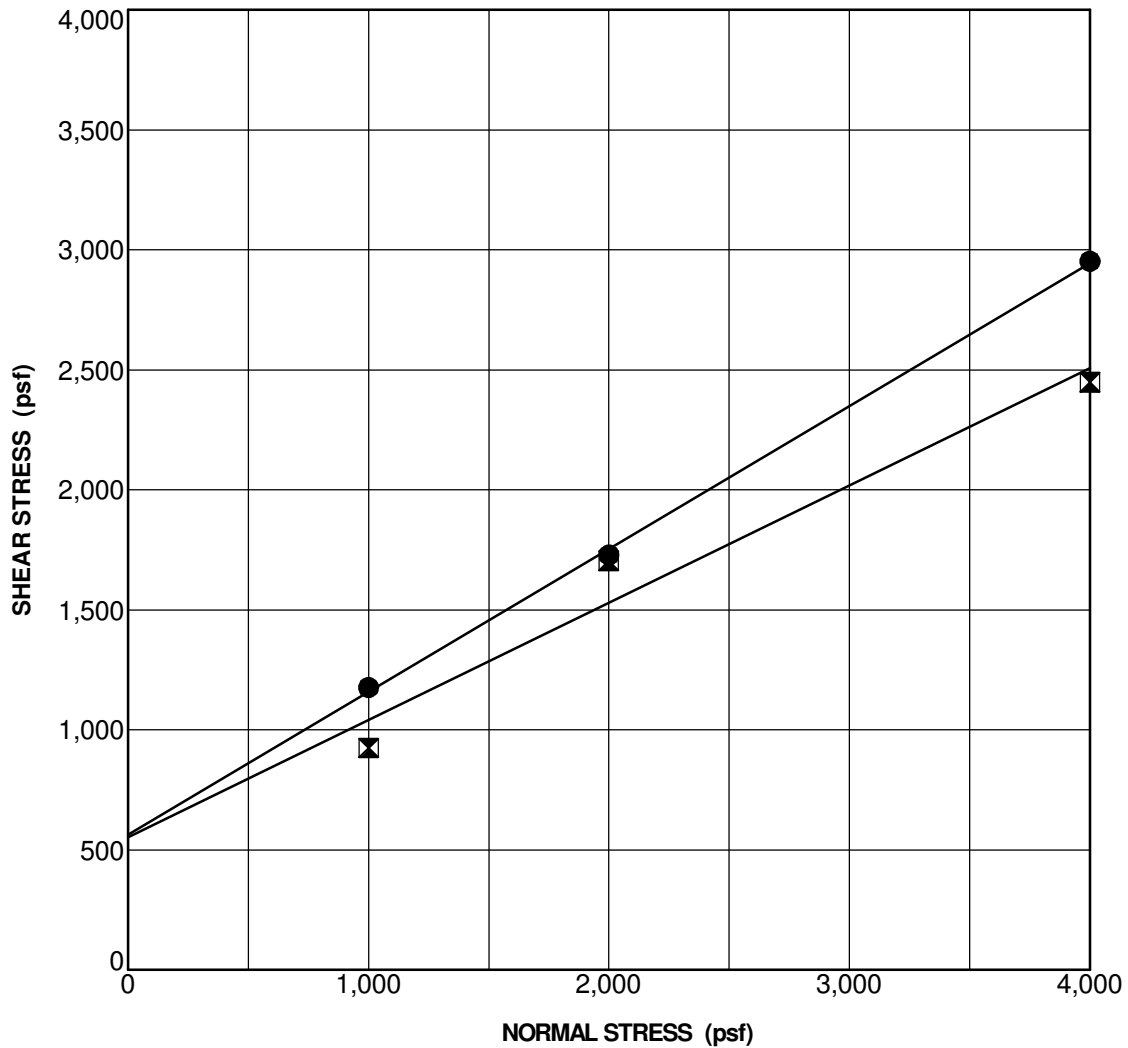
SAMPLE AND TEST DESCRIPTION		
<b>Sample Location:</b>	DH-43 @ 5.0 ft	<b>Geologic Unit:</b> Qaf
<b>Strain Rate (in/min):</b>	0.005	<b>Sample Preparation:</b> Undisturbed
<b>Notes:</b> Sample saturated prior and during shearing

STRENGTH PARAMETERS		
STRENGTH TYPE	COHESION (psf)	FRICTION ANGLE (degrees)
● Peak Strength	564	31.0
⊠ Ultimate Strength	552	26.0

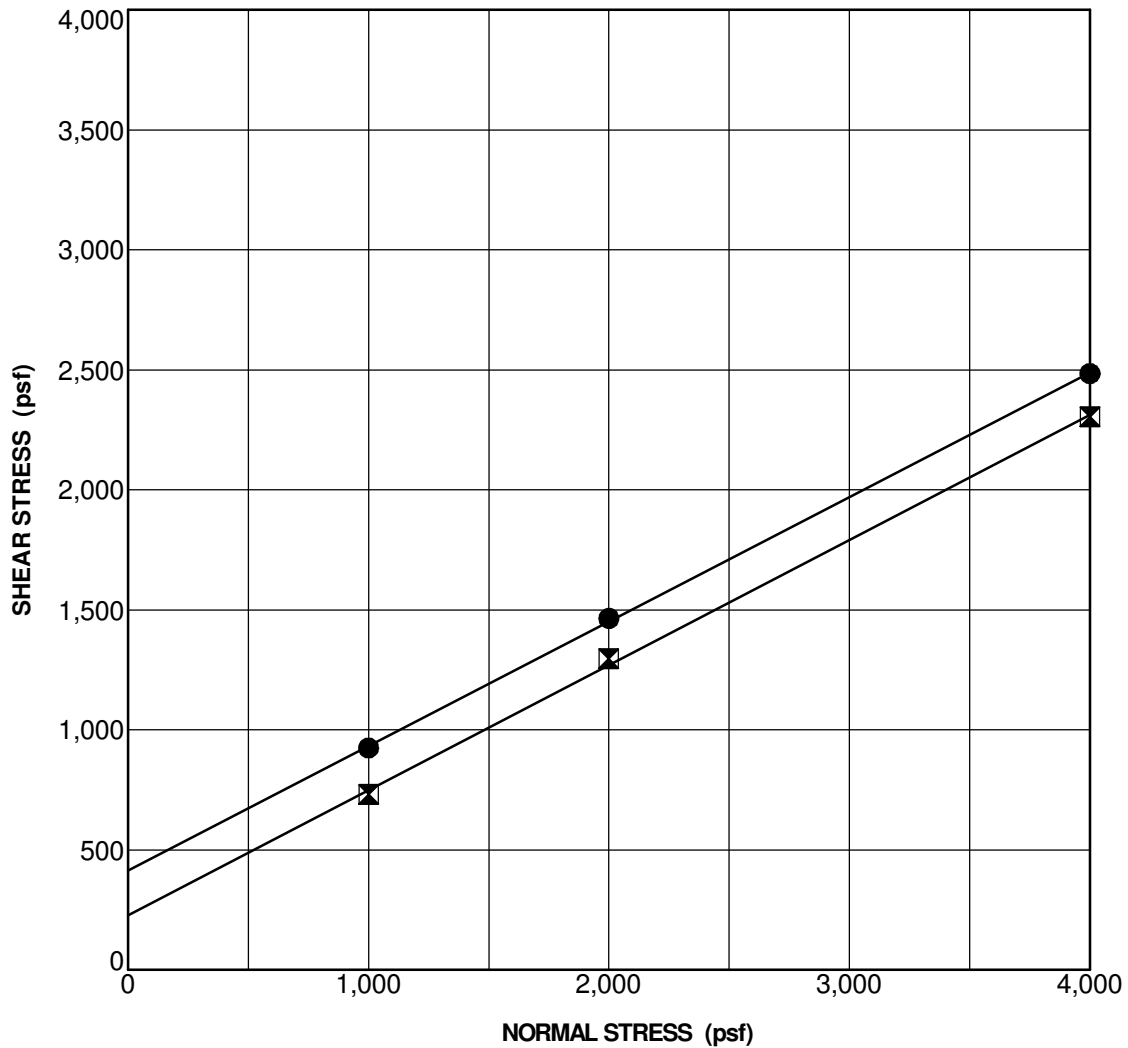
SAMPLE AND TEST DESCRIPTION		
<b>Sample Location:</b> DH-44 @ 0.0 ft	<b>Geologic Unit:</b> Qaf	<b>Classification:</b> SILTY CLAYEY SAND (SC)
<b>Strain Rate (in/min):</b> 0.005	<b>Sample Preparation:</b> Remolded	
<b>Notes:</b> 90% compaction at optimum

STRENGTH PARAMETERS		
STRENGTH TYPE	COHESION (psf)	FRICTION ANGLE (degrees)
● Peak Strength	414	27.0
⊠ Ultimate Strength	228	28.0
