## PRELIMINARY GEOTECHNICAL INVESTIGATION

**Preliminary Geotechnical Investigation,  
Dana Point Harbor Revitalization,  
Hotel Component,  
City of Dana Point, California**

September 10, 2019

GMU Project No. 17-206-01

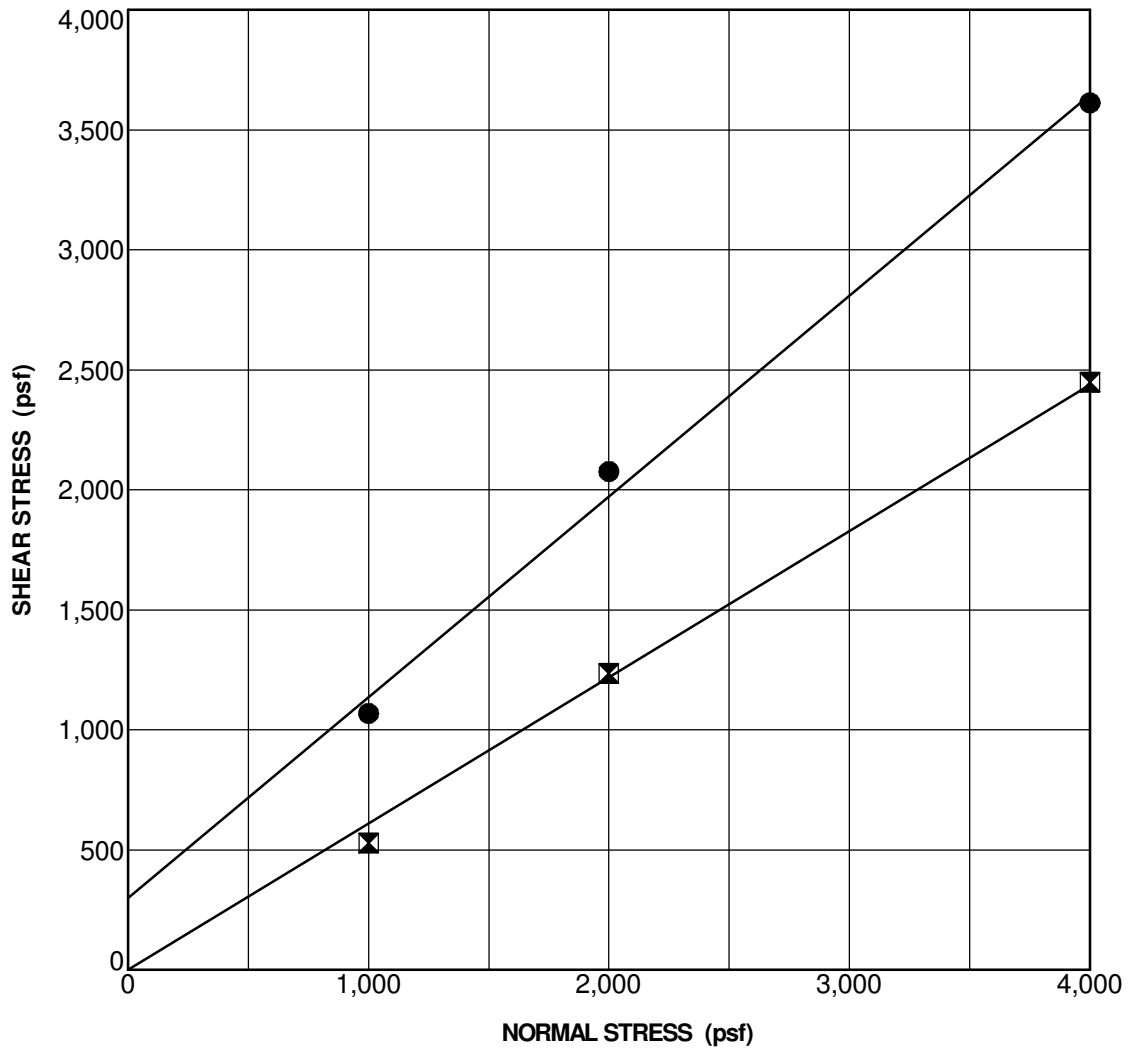
SAMPLE AND TEST DESCRIPTION		
<b>Sample Location:</b> DH-44 @ 5.0 ft	<b>Geologic Unit:</b> Qaf	<b>Classification:</b> SILTY CLAYEY SAND (SC)
<b>Strain Rate (in/min):</b> 0.005	<b>Sample Preparation:</b> Undisturbed	
<b>Notes:</b> Sample saturated prior and during shearing

STRENGTH PARAMETERS		
STRENGTH TYPE	COHESION (psf)	FRICITION ANGLE (degrees)
● Peak Strength	300	40.0
⊠ Ultimate Strength	0	31.0

Direct shear tests were performed on typical on-site materials. The general philosophy and procedure of the tests were in accord with ASTM Test Method D 3080 - "Direct Shear Tests for Soils Under Consolidated Drained Conditions".

The tests are single shear tests and are performed using a sample diameter of 2.416 inches and a height of 1.00 inch. The normal load is applied by a vertical dead load system. A constant rate of strain is applied to the upper one-half of the sample until failure occurs. Shear stress is monitored by a strain gauge-type precision load cell and deflection is measured with a digital dial indicator. This data is transferred electronically to data acquisition software which plots shear strength vs. deflection. The shear strength plots are then interpreted to determine either peak or ultimate shear strengths. Residual strengths were obtained through multiple shear box reversals. A strain rate compatible with the grain size distribution of the soils was utilized. The interpreted results of these tests are shown in this Appendix B.

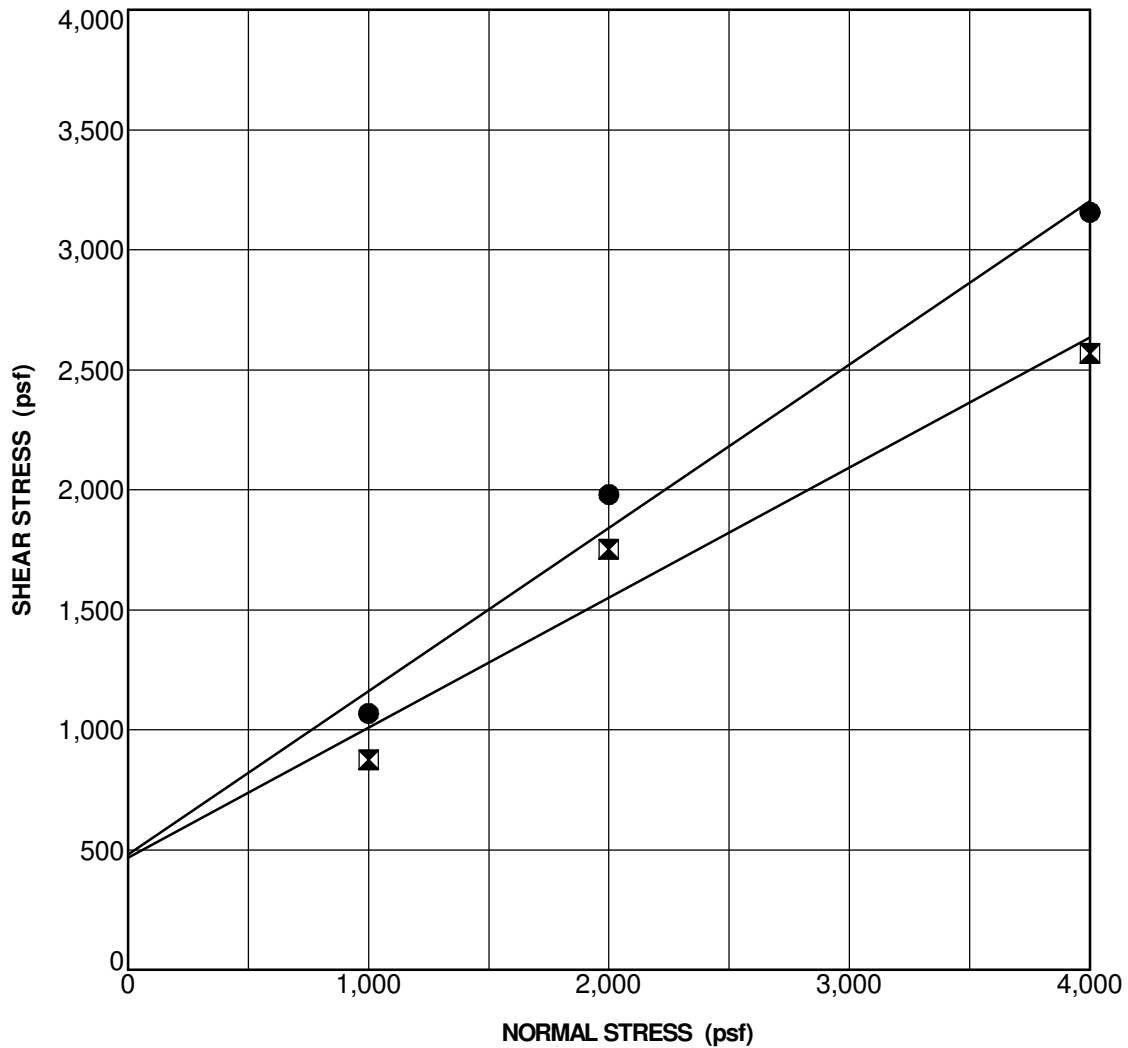
SAMPLE AND TEST DESCRIPTION		
<b>Sample Location:</b> DH-45 @ 5.0 ft	<b>Geologic Unit:</b> Qaf	<b>Classification:</b> CLAYEY SAND (SC)
<b>Strain Rate (in/min):</b> 0.005	<b>Sample Preparation:</b> Undisturbed	
<b>Notes:</b> Sample saturated prior and during shearing

STRENGTH PARAMETERS		
STRENGTH TYPE	COHESION (psf)	FRICTION ANGLE (degrees)
● Peak Strength	480	34.0
⊠ Ultimate Strength	468	28.0

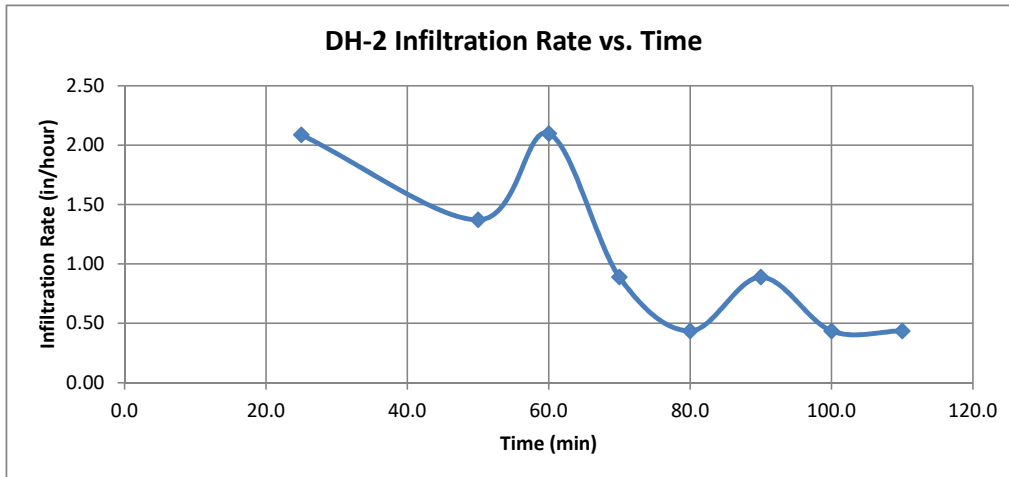
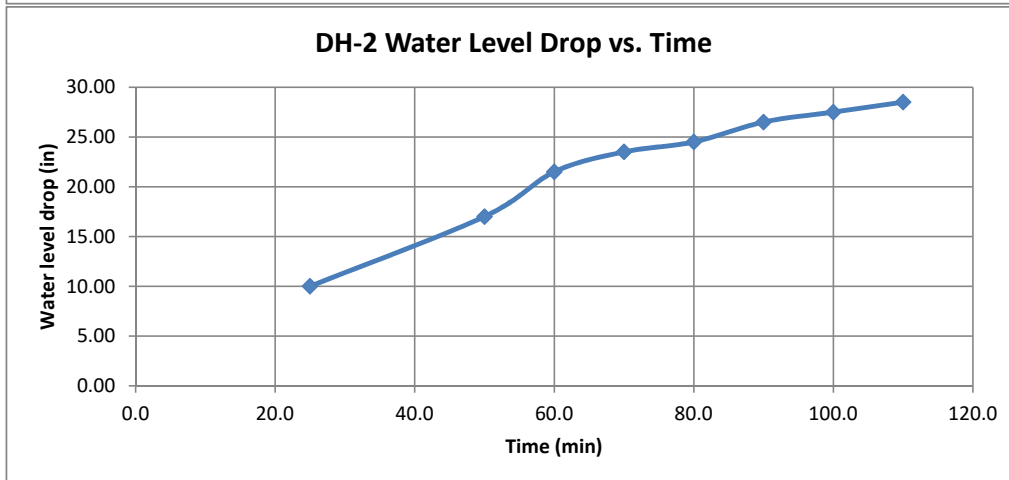
Trial	Start Time	End Time	$\Delta T$	Total Time	Initial Depth of Water	Final Depth of Water	$\Delta D$	$\Sigma \Delta D$	$\Delta H_{avg}$	Infiltration Rate
			(min)							
1	8:40	9:05	25.0	25.0	0.83	1.67	10.00	10.00	21.00	2.09
2	9:05	9:30	25.0	50.0	0.83	1.42	7.00	17.00	22.50	1.37
3	9:32	9:42	10.0	60.0	0.83	1.21	4.50	21.50	23.75	2.10
4	9:42	9:52	10.0	70.0	0.83	1.00	2.00	23.50	25.00	0.89
5	9:52	10:02	10.0	80.0	0.83	0.92	1.00	24.50	25.50	0.44
6	10:02	10:12	10.0	90.0	0.83	1.00	2.00	26.50	25.00	0.89
7	10:12	10:22	10.0	100.0	0.83	0.92	1.00	27.50	25.50	0.44
8	10:22	10:32	10.0	110.0	0.83	0.92	1.00	28.50	25.50	0.44

Average Infiltration Rate (in/hour) **0.59**  
 ADJUSTED INFILTRATION RATE (IN/HOUR) **0.29**

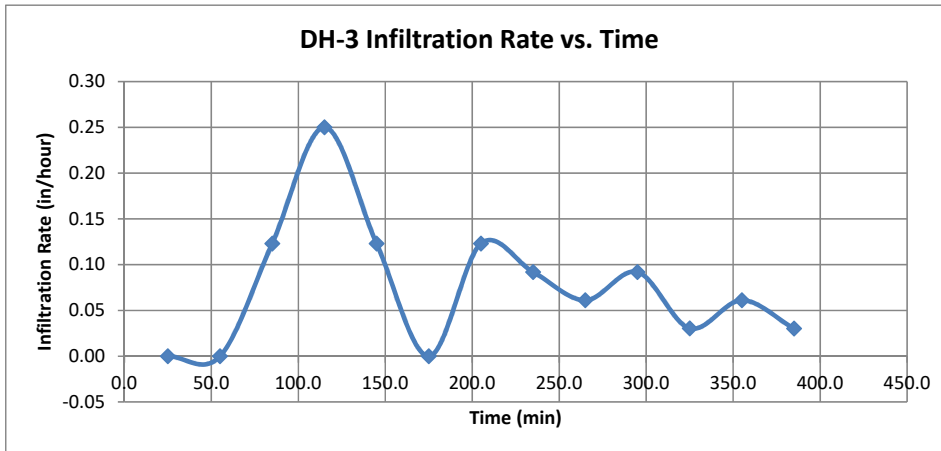
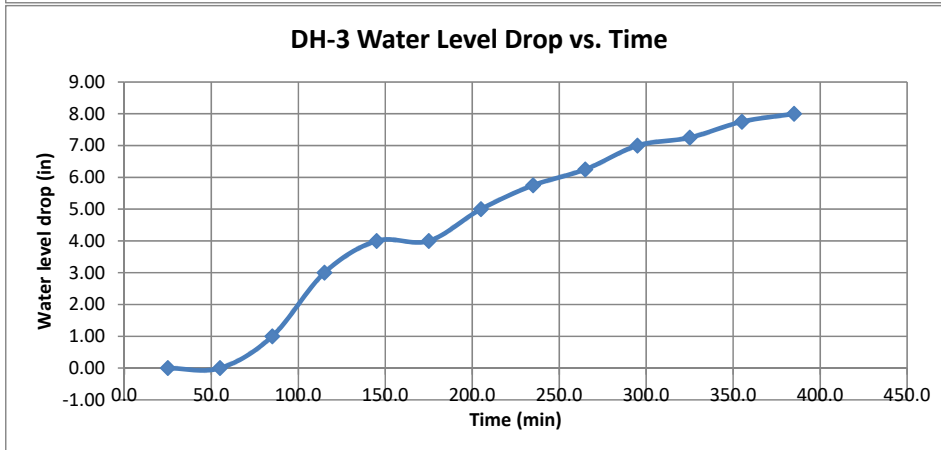
**Riverside/Orange County - Infiltration Test in a Boring**

Trial	Start Time	End Time	$\Delta T$	Total Time	Initial Depth of Water	Final Depth of Water	$\Delta D$	$\Sigma \Delta D$	$\Delta H_{avg}$	Infiltration Rate
			(min)		(ft)	(ft)				
1	9:01	9:26	25.0	25.0	0.42	0.42	0.00	0.00	31.00	0.00
2	9:26	9:56	30.0	55.0	0.42	0.42	0.00	0.00	31.00	0.00
3	9:56	10:26	30.0	85.0	0.42	0.50	1.00	1.00	30.50	0.12
4	10:26	10:56	30.0	115.0	0.42	0.58	2.00	3.00	30.00	0.25
5	10:56	11:26	30.0	145.0	0.42	0.50	1.00	4.00	30.50	0.12
6	11:26	11:56	30.0	175.0	0.42	0.42	0.00	4.00	31.00	0.00
7	11:56	12:26	30.0	205.0	0.42	0.50	1.00	5.00	30.50	0.12
8	12:26	12:56	30.0	235.0	0.42	0.48	0.75	5.75	30.63	0.09
9	12:56	1:26	30.0	265.0	0.42	0.46	0.50	6.25	30.75	0.06
10	1:26	1:56	30.0	295.0	0.42	0.48	0.75	7.00	30.63	0.09
11	1:56	2:26	30.0	325.0	0.42	0.44	0.25	7.25	30.88	0.03
12	2:26	2:56	30.0	355.0	0.42	0.46	0.50	7.75	30.75	0.06
13	2:56	3:26	30.0	385.0	0.40	0.42	0.25	8.00	31.13	0.03

Average Infiltration Rate (in/hour) **0.04**

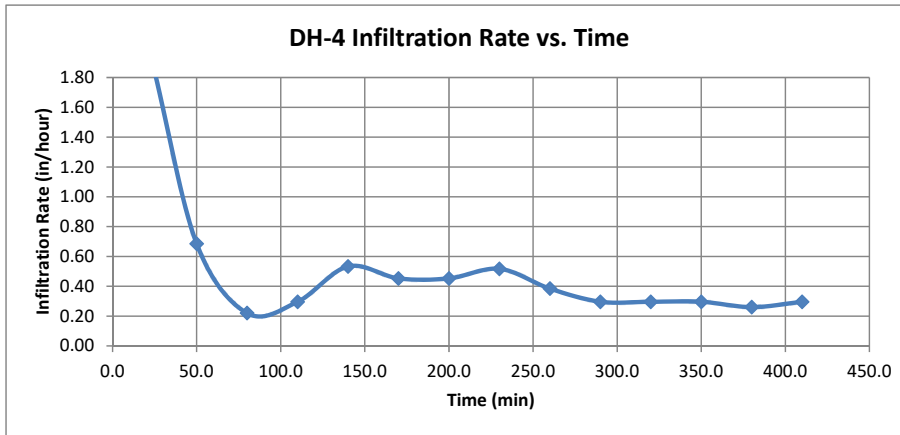
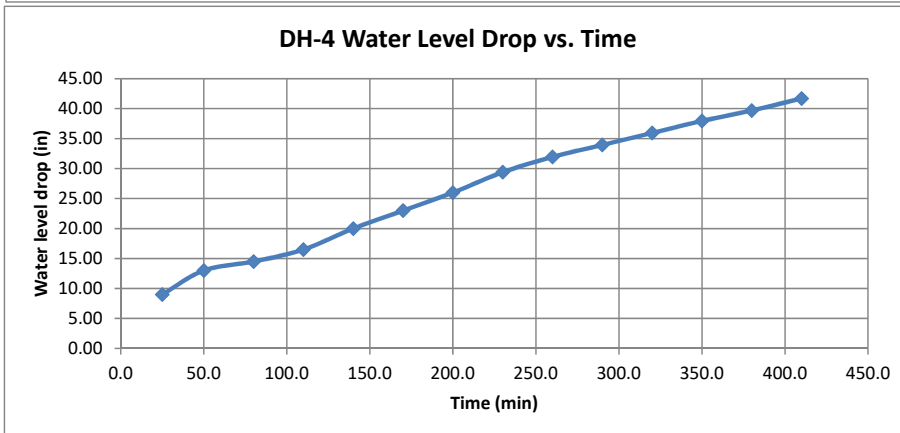
**Riverside/Orange County - Infiltration Test in a Boring**

Trial	Start Time	End Time	$\Delta T$	Total Time	Initial Depth of Water	Final Depth of Water	$\Delta D$	$\Sigma \Delta D$	$\Delta H_{avg}$	Infiltration Rate
			(min)							
1	9:15	9:40	25.0	25.0	0.83	1.58	9.00	9.00	21.50	1.84
2	9:40	10:05	25.0	50.0	0.67	1.00	4.00	13.00	26.00	0.69
3	10:05	10:35	30.0	80.0	0.83	0.96	1.50	14.50	25.25	0.22
4	10:35	11:05	30.0	110.0	0.83	1.00	2.00	16.50	25.00	0.30
5	11:05	11:35	30.0	140.0	0.83	1.13	3.50	20.00	24.25	0.53
6	11:35	12:05	30.0	170.0	0.83	1.08	3.00	23.00	24.50	0.45
7	12:05	12:35	30.0	200.0	0.83	1.08	3.00	26.00	24.50	0.45
8	12:35	1:05	30.0	230.0	0.83	1.12	3.40	29.40	24.30	0.52
9	1:05	1:35	30.0	260.0	0.85	1.06	2.55	31.95	24.53	0.38
10	1:35	2:05	30.0	290.0	0.83	1.00	2.00	33.95	25.00	0.30
11	2:05	2:35	30.0	320.0	0.83	1.00	2.00	35.95	25.00	0.30
12	2:35	3:05	30.0	350.0	0.83	1.00	2.00	37.95	25.00	0.30
13	3:05	3:35	30.0	380.0	0.85	1.00	1.75	39.70	24.88	0.26
14	3:35	4:05	30.0	410.0	0.83	1.00	2.00	41.70	25.00	0.30

Average Infiltration Rate (in/hour) **0.28**

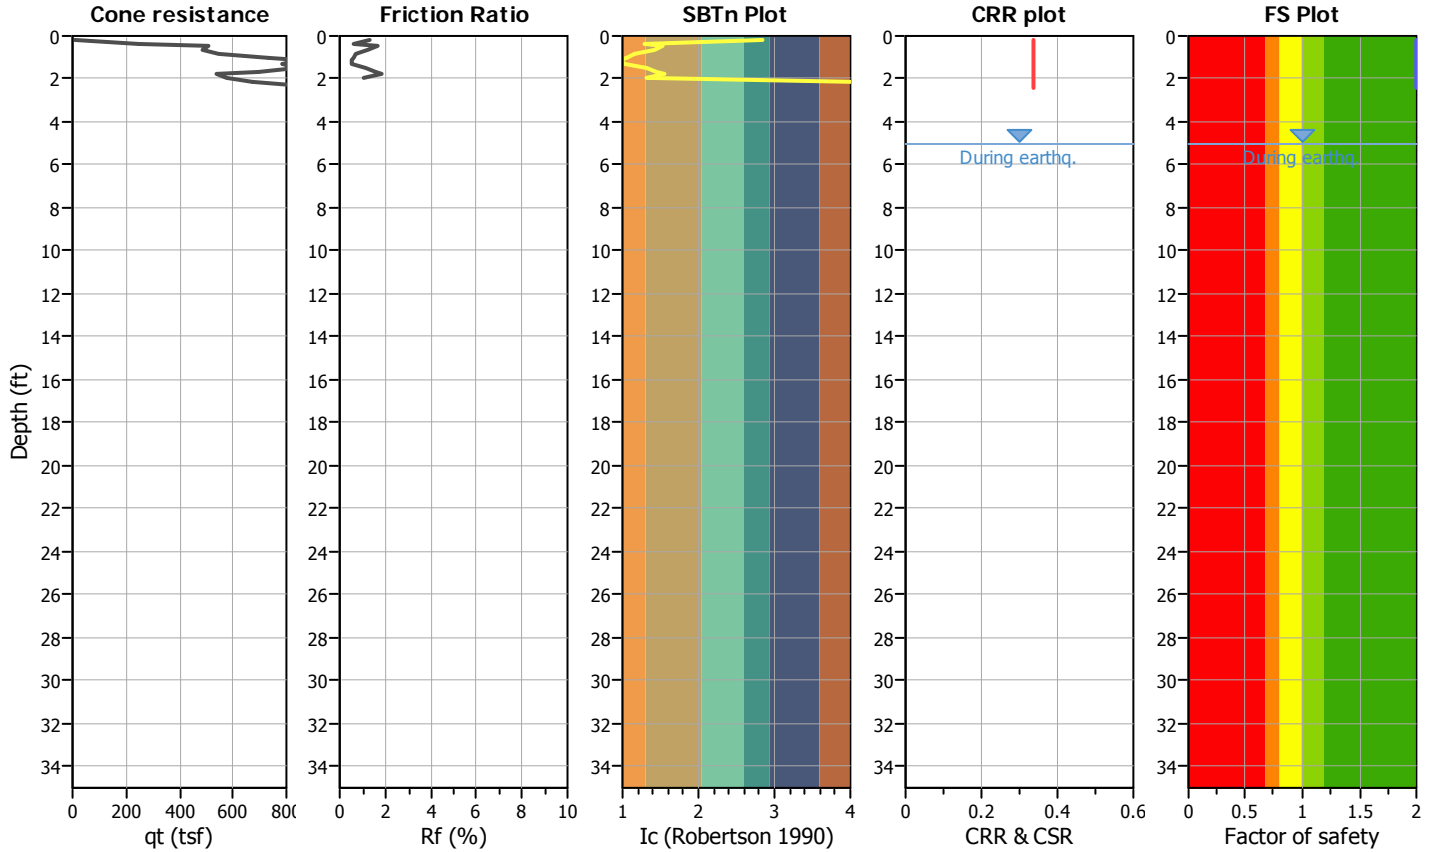
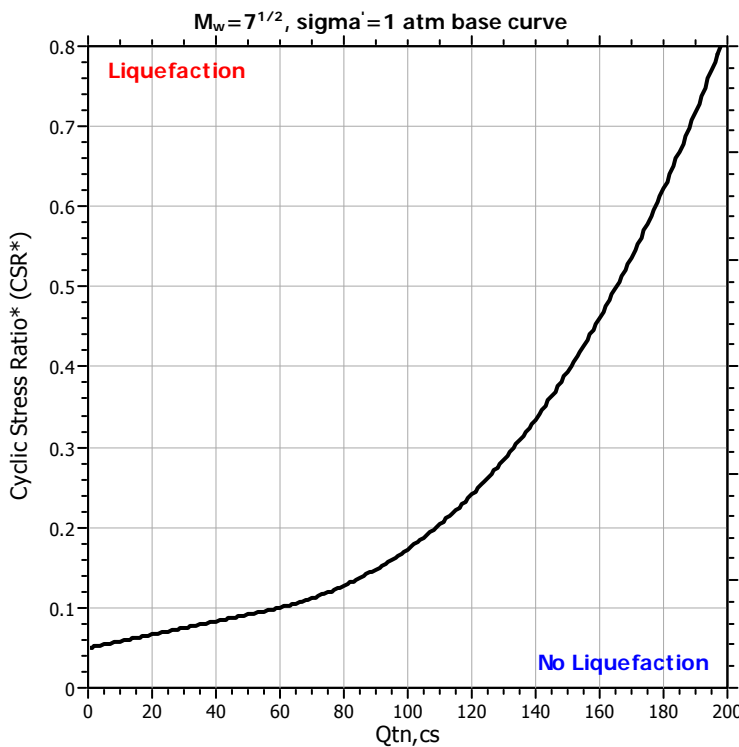
Input parameters and analysis data

Analysis method:	Robertson (2009)	G.W.T. (in-situ):	26.00 ft	Use fill:	No	Clay like behavior applied:	All soils
Fines correction method:	Robertson (2009)	G.W.T. (earthq.):	5.00 ft	Fill height:	N/A	Limit depth applied:	No
Points to test:	Based on Ic value	Average results interval:	1	Fill weight:	N/A	Limit depth:	N/A
Earthquake magnitude $M_w$ :	6.80	Ic cut-off value:	2.60	Trans. detect. applied:	Yes	MSF method:	Method based
Peak ground acceleration:	0.67	Unit weight calculation:	Based on SBT	$K_0$ applied:	Yes

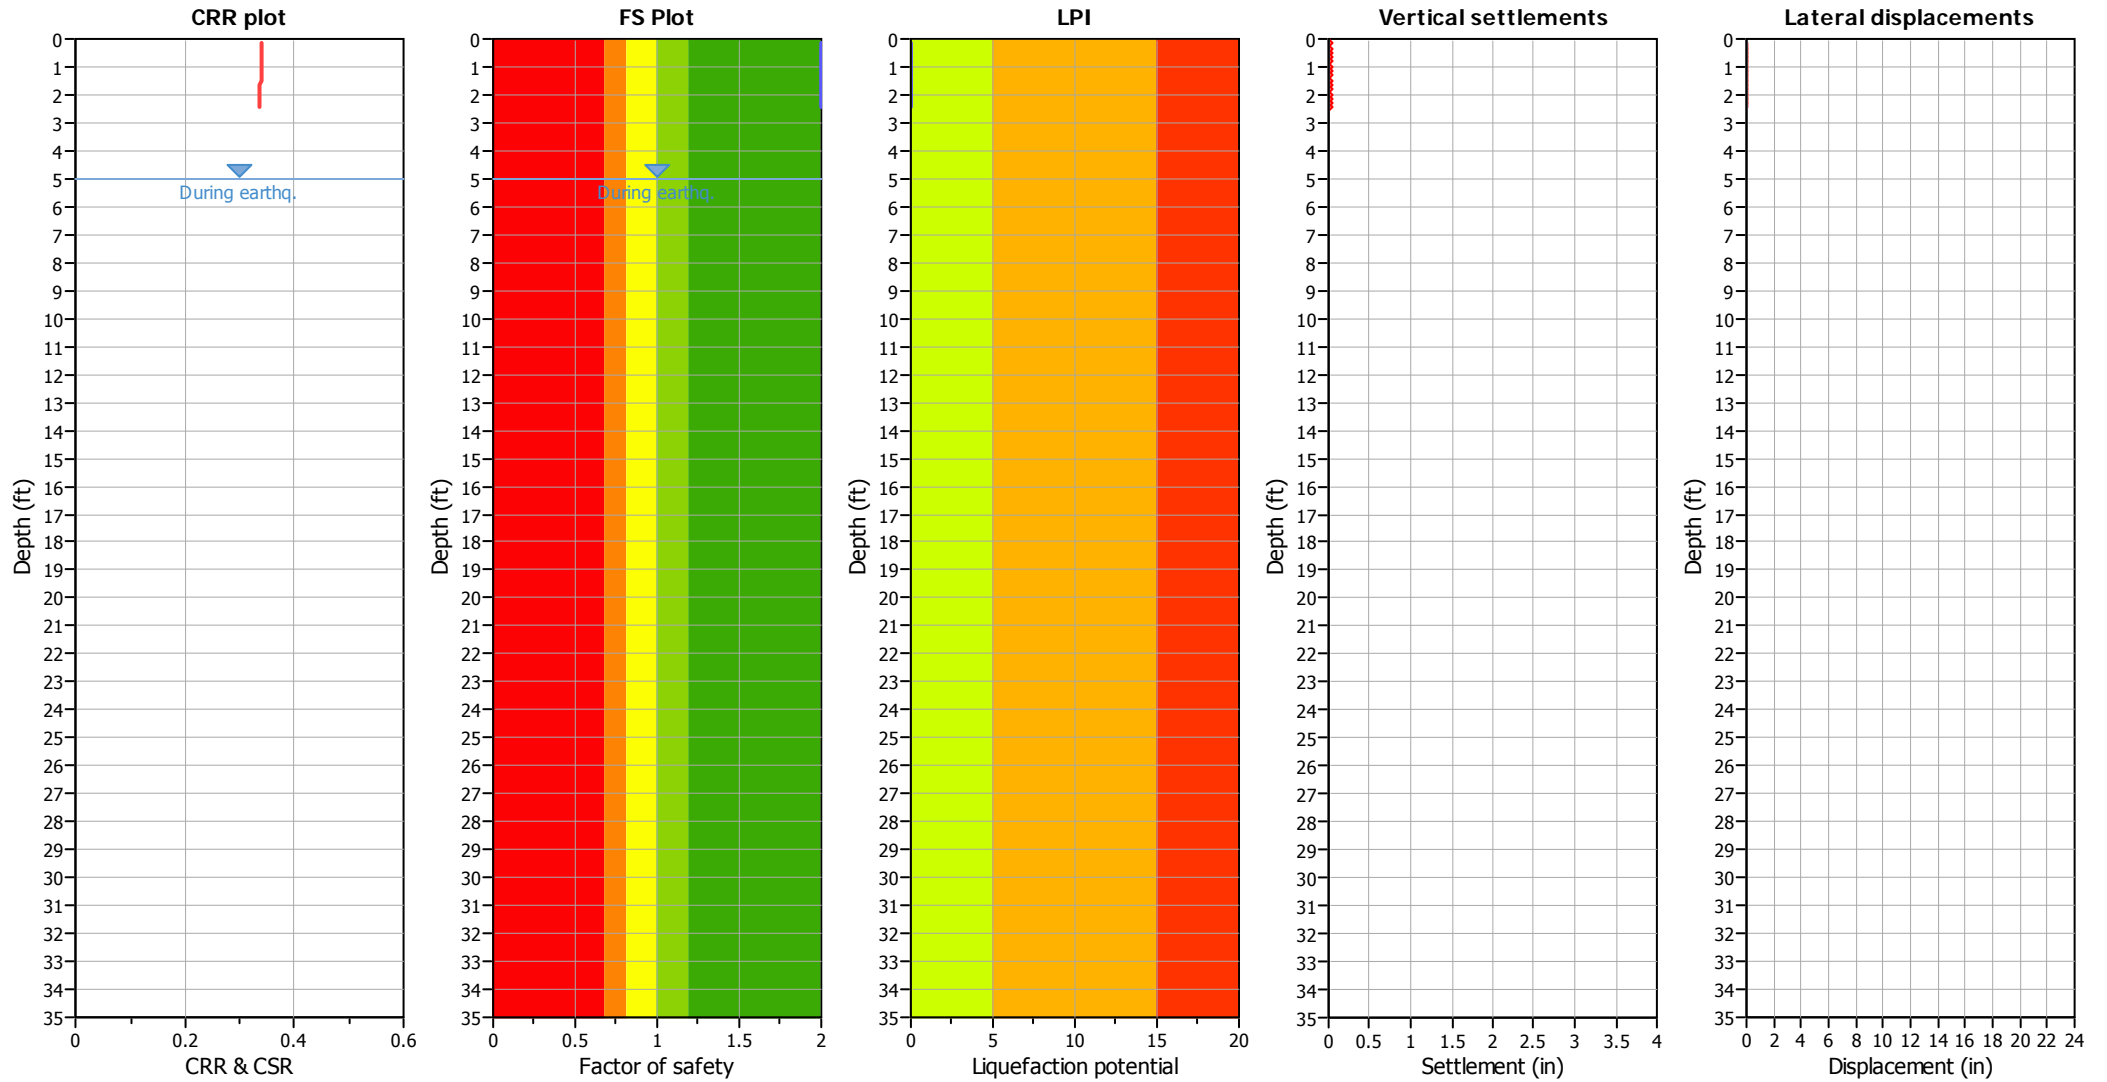
### Liquefaction analysis overall plots

**Input parameters and analysis data**

Analysis method:	Robertson (2009)	Depth to water table (earthq.):	5.00 ft	Fill weight:	N/A
Fines correction method:	Robertson (2009)	Average results interval:	1	Transition detect. applied:	Yes
Points to test:	Based on Ic value	Ic cut-off value:	2.60	$K_{\sigma}$ applied:	Yes
Earthquake magnitude $M_w$ :	6.80	Unit weight calculation:	Based on SBT	Clay like behavior applied:	All soils
Peak ground acceleration:	0.67	Use fill:	No	Limit depth applied:	No
Depth to water table (insitu):	26.00 ft	Fill height:	N/A	Limit depth:	N/A

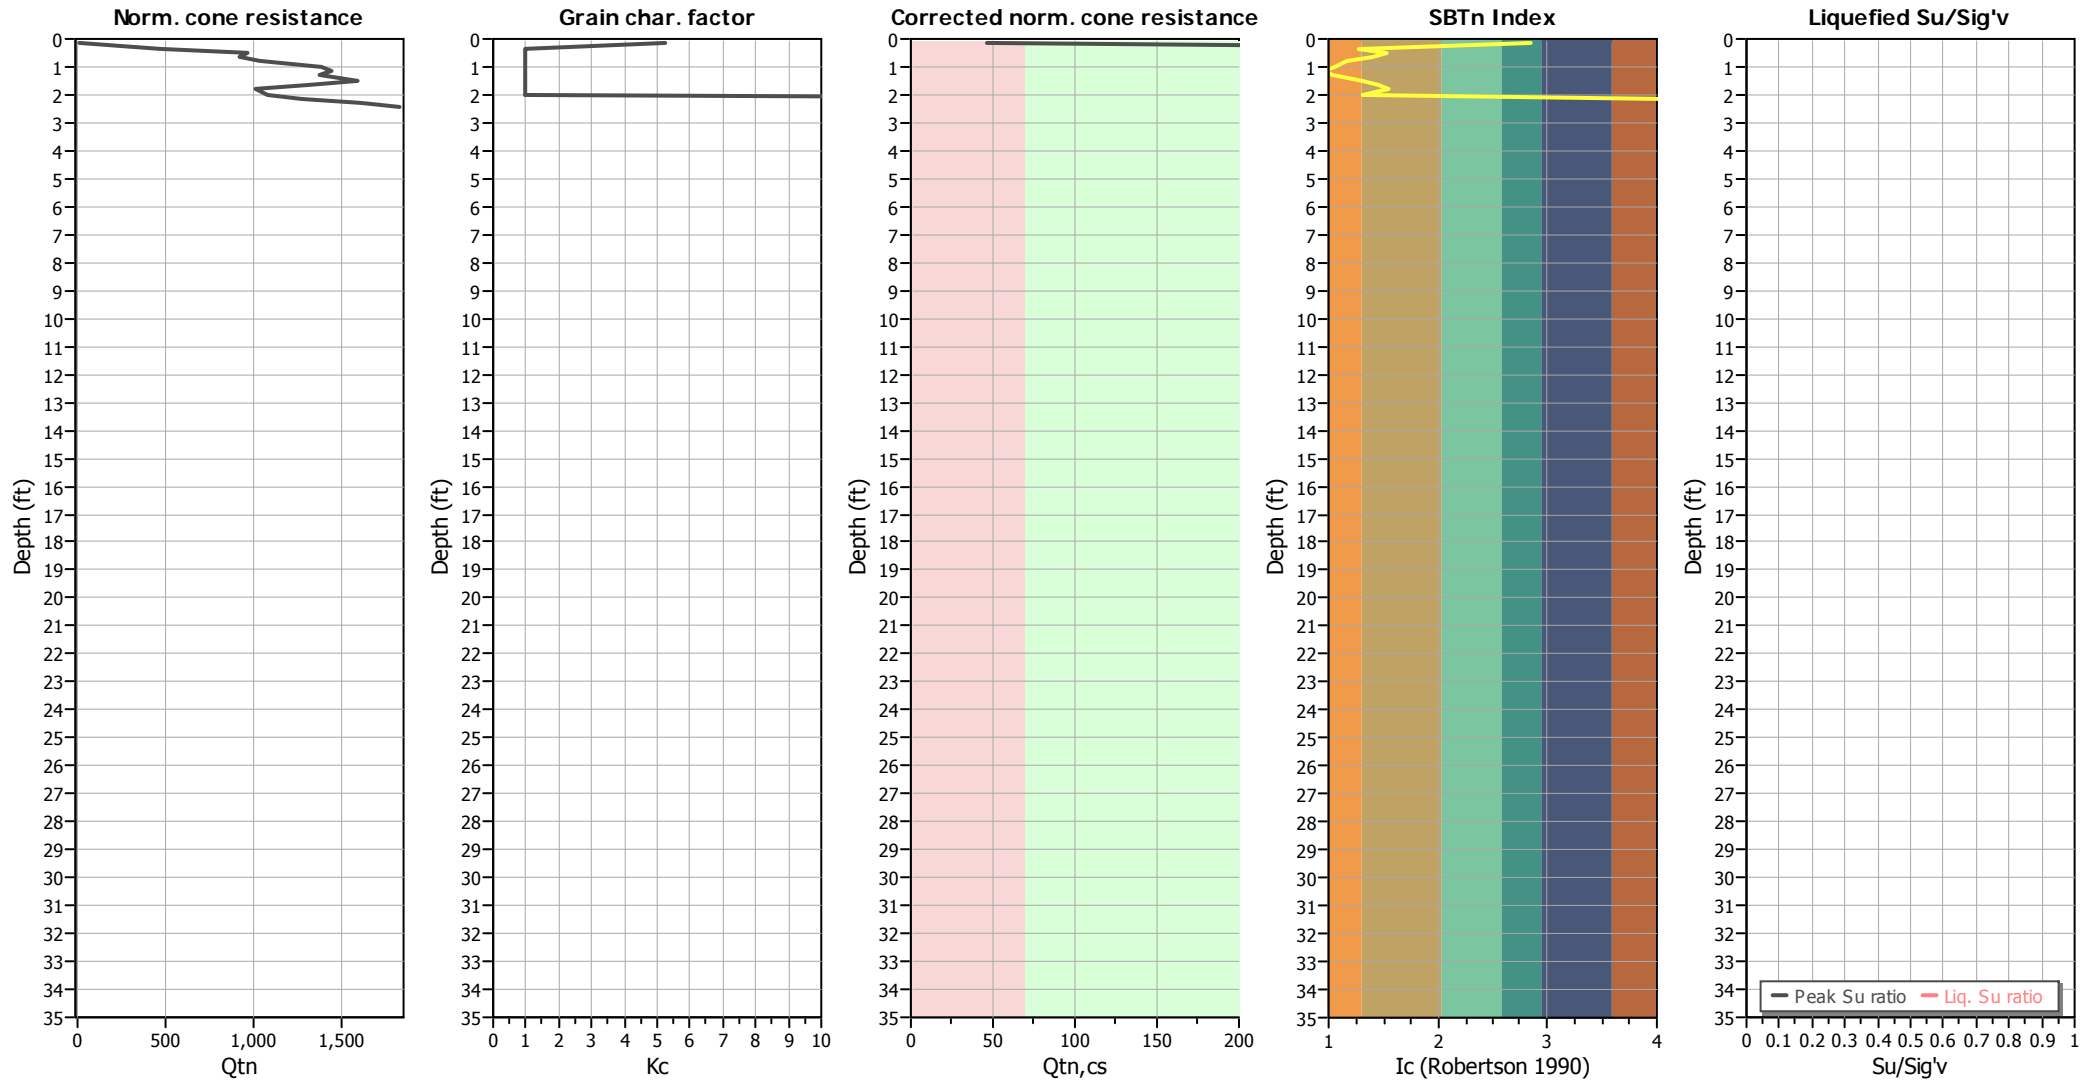
### Check for strength loss plots (Robertson (2010))

#### Input parameters and analysis data

Analysis method:	Robertson (2009)	Depth to water table (erthq.):	5.00 ft	Fill weight:	N/A
Fines correction method:	Robertson (2009)	Average results interval:	1	Transition detect. applied:	Yes
Points to test:	Based on Ic value	Ic cut-off value:	2.60	K <sub>cs</sub> applied:	Yes
Earthquake magnitude M <sub>w</sub> :	6.80	Unit weight calculation:	Based on SBT	Clay like behavior applied:	All soils
Peak ground acceleration:	0.67	Use fill:	No	Limit depth applied:	No
Depth to water table (insitu):	26.00 ft	Fill height:	N/A	Limit depth:	N/A

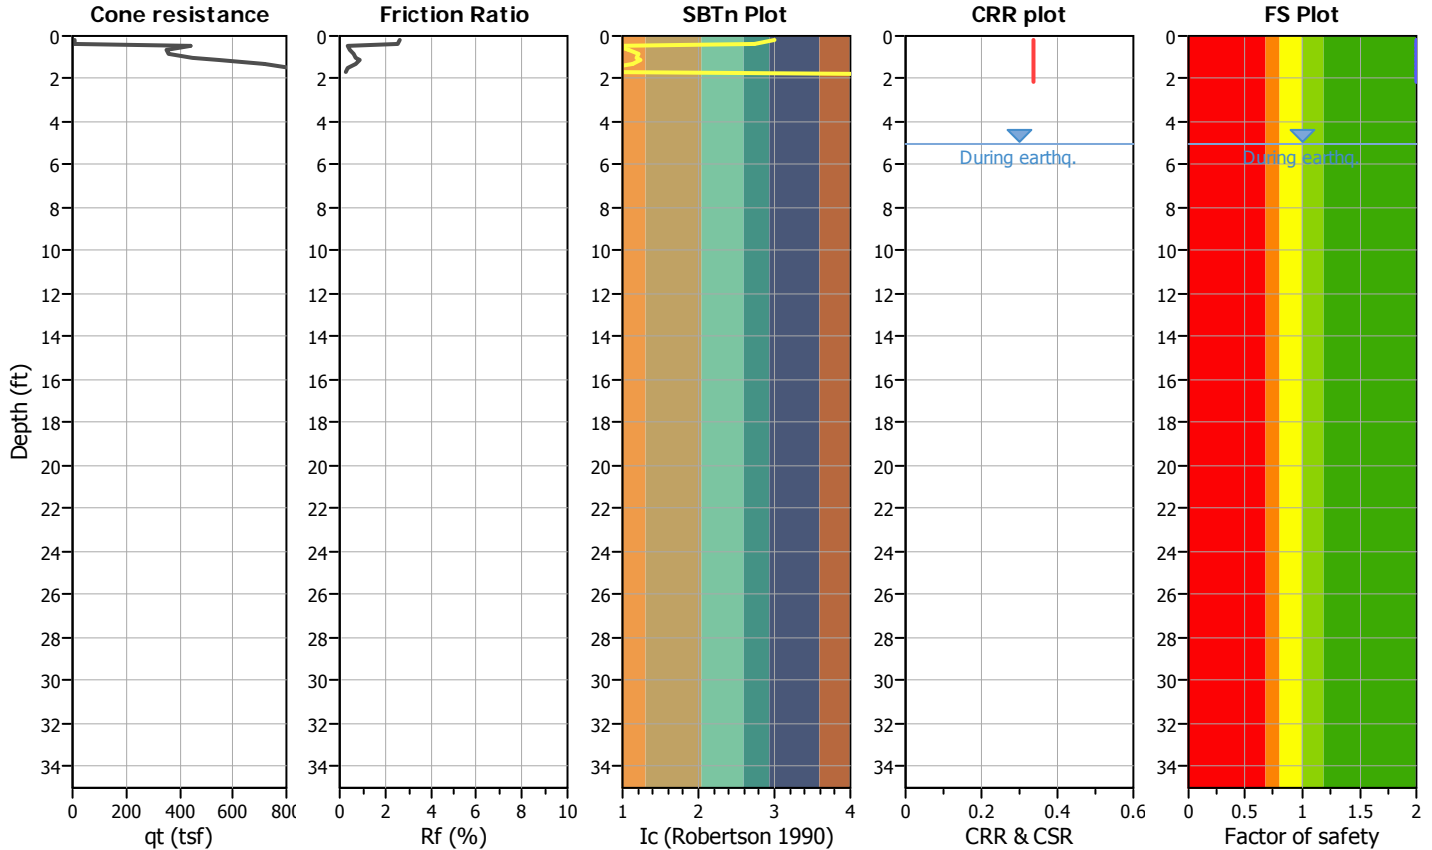
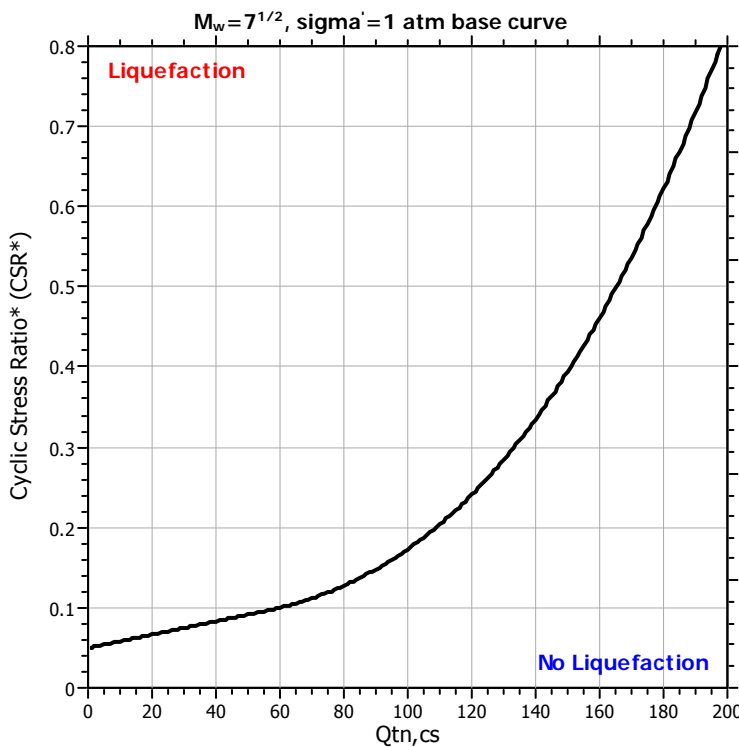
Analysis method:	Robertson (2009)	G.W.T. (in-situ):	26.00 ft	Use fill:	No	Clay like behavior applied:	All soils
Fines correction method:	Robertson (2009)	G.W.T. (earthq.):	5.00 ft	Fill height:	N/A	Limit depth applied:	No
Points to test:	Based on Ic value	Average results interval:	1	Fill weight:	N/A	Limit depth:	N/A
Earthquake magnitude $M_w$ :	6.80	Ic cut-off value:	2.60	Trans. detect. applied:	Yes	MSF method:	Method based
Peak ground acceleration:	0.67	Unit weight calculation:	Based on SBT	$K_0$ applied:	Yes

Zone A<sub>1</sub>: Cyclic liquefaction likely depending on size and duration of cyclic loading  
 Zone A<sub>2</sub>: Cyclic liquefaction and strength loss likely depending on loading and ground geometry  
 Zone B: Liquefaction and post-earthquake strength loss unlikely, check cyclic softening  
 Zone C: Cyclic liquefaction and strength loss possible depending on soil plasticity, brittleness/sensitivity, strain to peak undrained strength and ground geometry

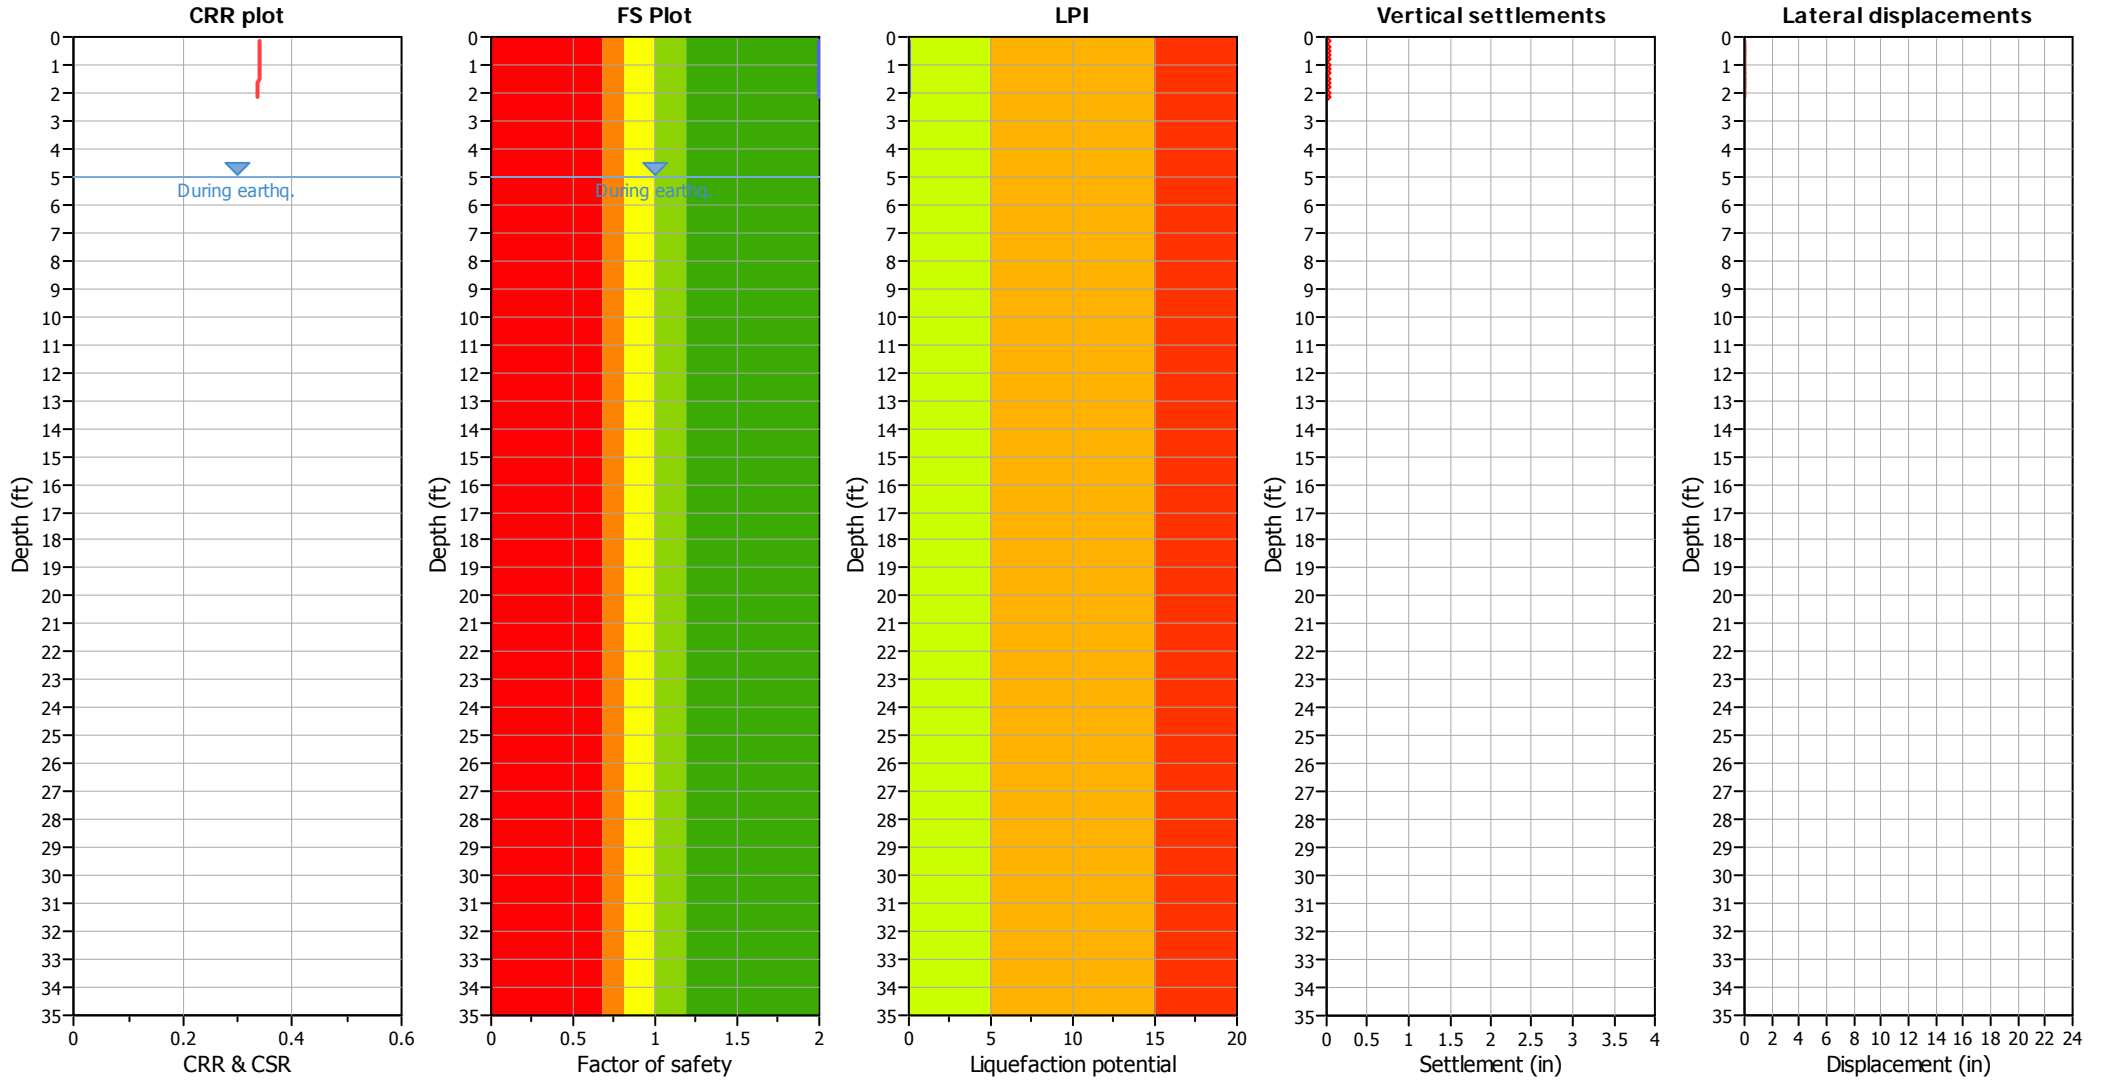
### Liquefaction analysis overall plots

**Input parameters and analysis data**

Analysis method:	Robertson (2009)	Depth to water table (earthq.):	5.00 ft	Fill weight:	N/A
Fines correction method:	Robertson (2009)	Average results interval:	1	Transition detect. applied:	Yes
Points to test:	Based on Ic value	Ic cut-off value:	2.60	$K_{\sigma}$ applied:	Yes
Earthquake magnitude $M_w$ :	6.80	Unit weight calculation:	Based on SBT	Clay like behavior applied:	All soils
Peak ground acceleration:	0.67	Use fill:	No	Limit depth applied:	No
Depth to water table (insitu):	26.00 ft	Fill height:	N/A	Limit depth:	N/A

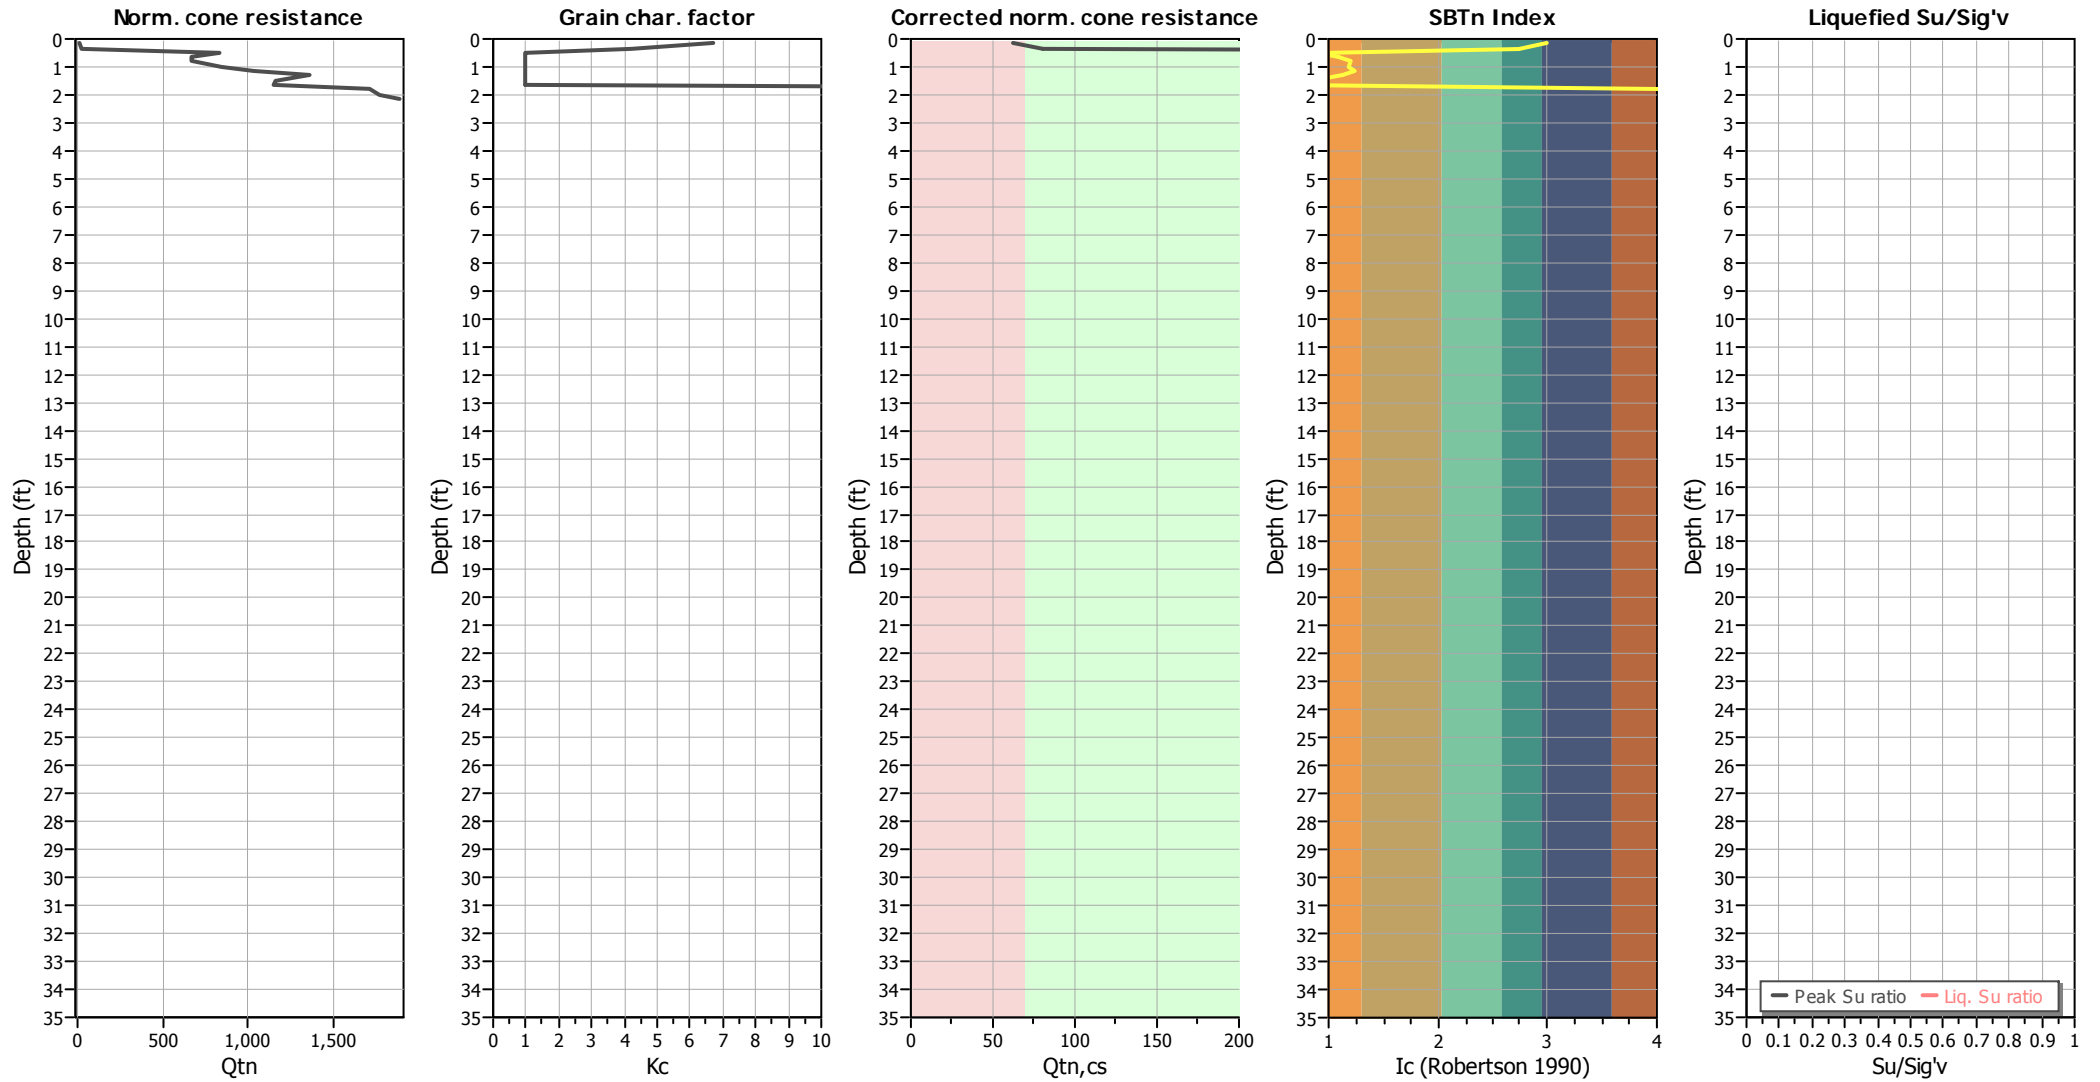
### Check for strength loss plots (Robertson (2010))

#### Input parameters and analysis data

Analysis method:	Robertson (2009)	Depth to water table (erthq.):	5.00 ft	Fill weight:	N/A
Fines correction method:	Robertson (2009)	Average results interval:	1	Transition detect. applied:	Yes
Points to test:	Based on Ic value	Ic cut-off value:	2.60	K <sub>cs</sub> applied:	Yes
Earthquake magnitude M <sub>w</sub> :	6.80	Unit weight calculation:	Based on SBT	Clay like behavior applied:	All soils
Peak ground acceleration:	0.67	Use fill:	No	Limit depth applied:	No
Depth to water table (insitu):	26.00 ft	Fill height:	N/A	Limit depth:	N/A

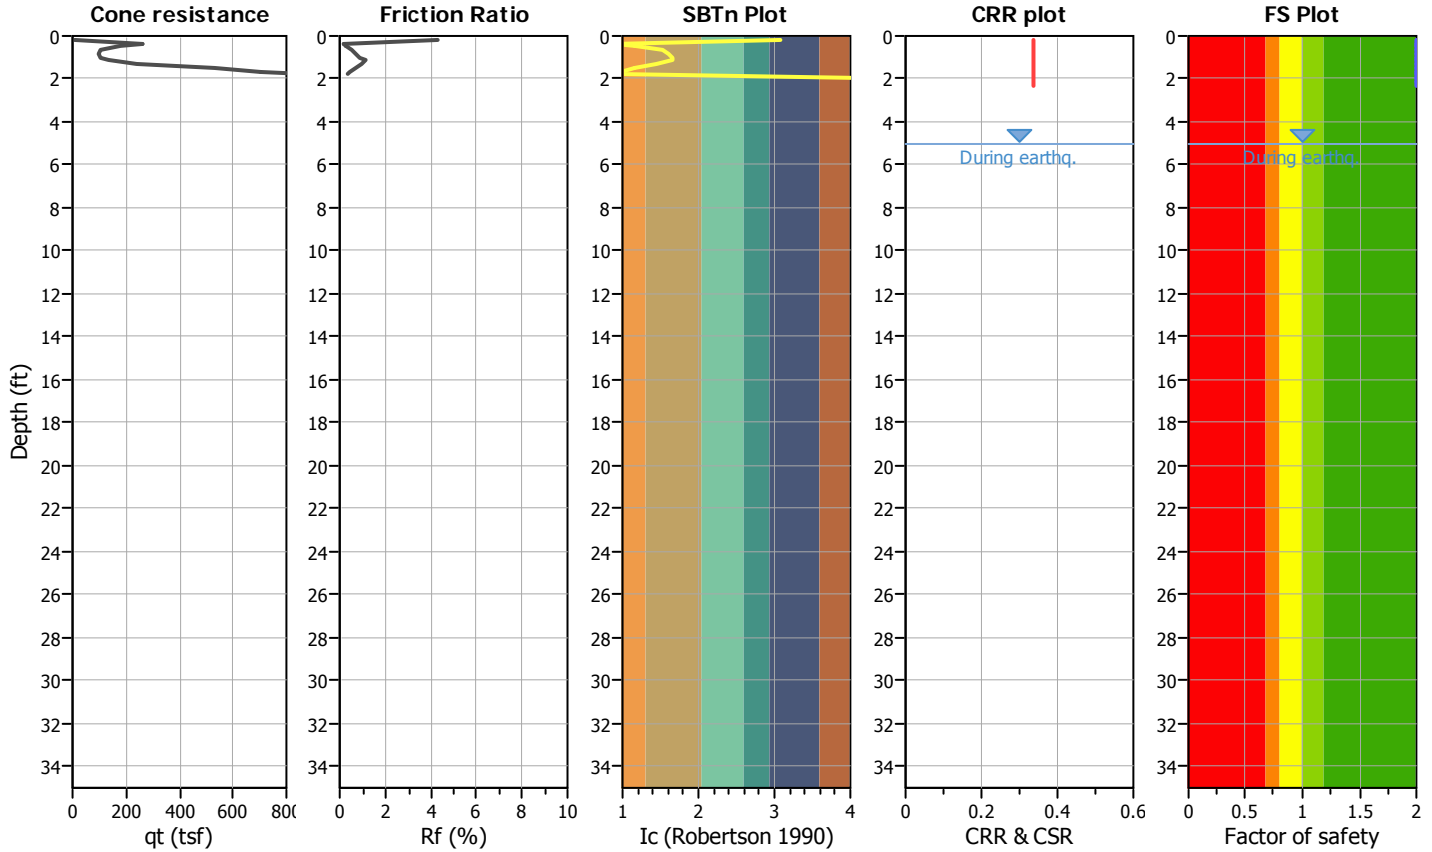
Input parameters and analysis data

Analysis method:	Robertson (2009)	G.W.T. (in-situ):	15.00 ft	Use fill:	No	Clay like behavior applied:	All soils
Fines correction method:	Robertson (2009)	G.W.T. (earthq.):	5.00 ft	Fill height:	N/A	Limit depth applied:	No
Points to test:	Based on Ic value	Average results interval:	1	Fill weight:	N/A	Limit depth:	N/A
Earthquake magnitude $M_w$ :	6.80	Ic cut-off value:	2.60	Trans. detect. applied:	Yes	MSF method:	Method based
Peak ground acceleration:	0.67	Unit weight calculation:	Based on SBT	$K_0$ applied:	Yes
