## PRELIMINARY GEOTECHNICAL INVESTIGATION

**Preliminary Geotechnical Investigation,  
Dana Point Harbor Revitalization,  
Hotel Component,  
City of Dana Point, California**

September 10, 2019

GMU Project No. 17-206-01

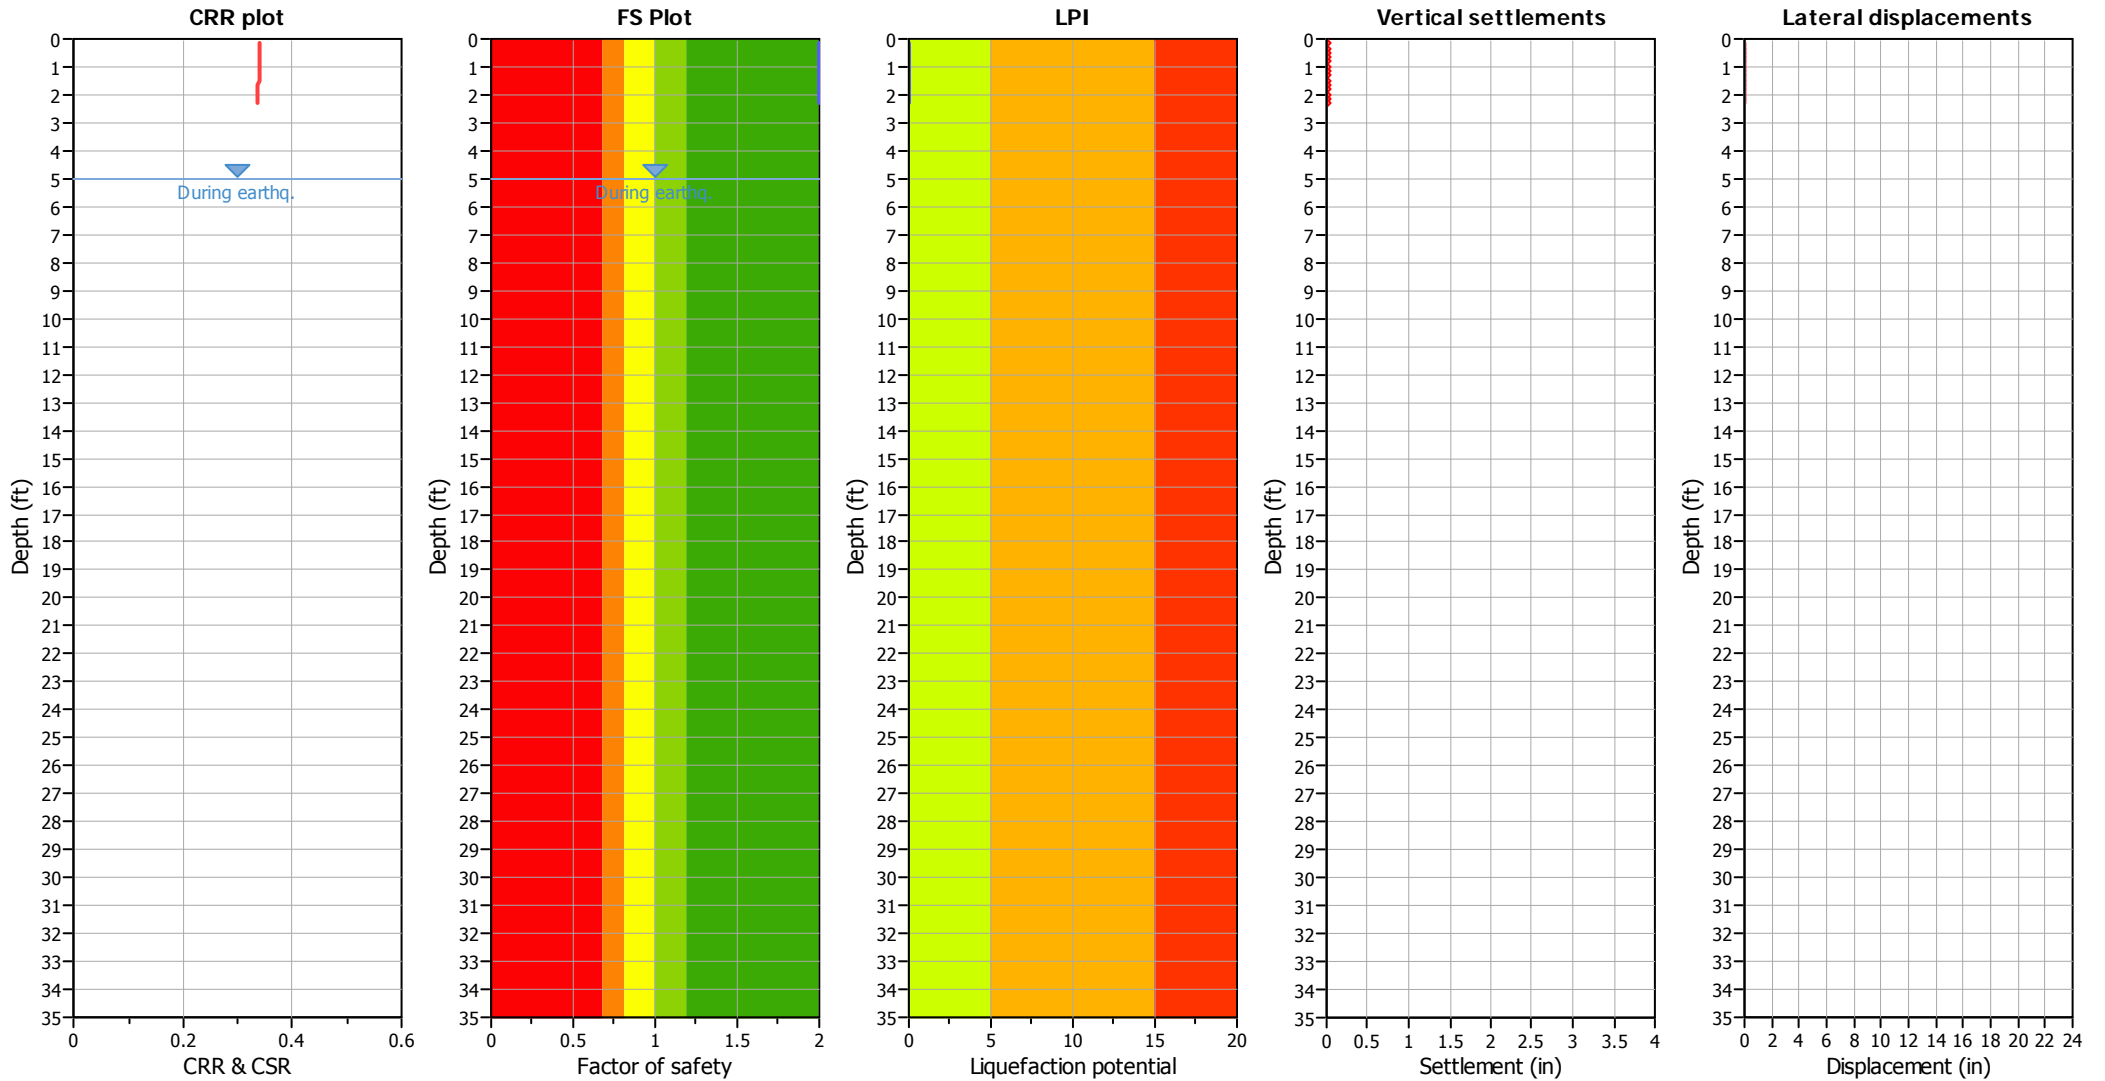
### Liquefaction analysis overall plots

**Input parameters and analysis data**

Analysis method:	Robertson (2009)	Depth to water table (earthq.):	5.00 ft	Fill weight:	N/A
Fines correction method:	Robertson (2009)	Average results interval:	1	Transition detect. applied:	Yes
Points to test:	Based on Ic value	Ic cut-off value:	2.60	$K_{\sigma}$ applied:	Yes
Earthquake magnitude $M_w$ :	6.80	Unit weight calculation:	Based on SBT	Clay like behavior applied:	All soils
Peak ground acceleration:	0.67	Use fill:	No	Limit depth applied:	No
Depth to water table (insitu):	15.00 ft	Fill height:	N/A	Limit depth:	N/A

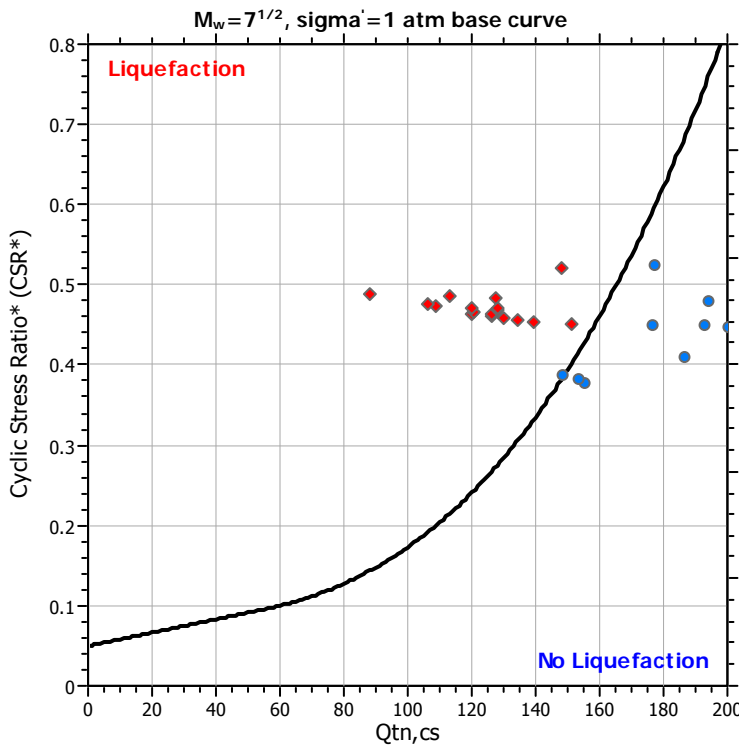
Input parameters and analysis data

Analysis method:	Robertson (2009)	G.W.T. (in-situ):	11.00 ft	Use fill:	No	Clay like behavior applied:	All soils
Fines correction method:	Robertson (2009)	G.W.T. (earthq.):	5.00 ft	Fill height:	N/A	Limit depth applied:	No
Points to test:	Based on Ic value	Average results interval:	1	Fill weight:	N/A	Limit depth:	N/A
Earthquake magnitude $M_w$ :	6.80	Ic cut-off value:	2.60	Trans. detect. applied:	Yes	MSF method:	Method based
Peak ground acceleration:	0.67	Unit weight calculation:	Based on SBT	$K_0$ applied:	Yes

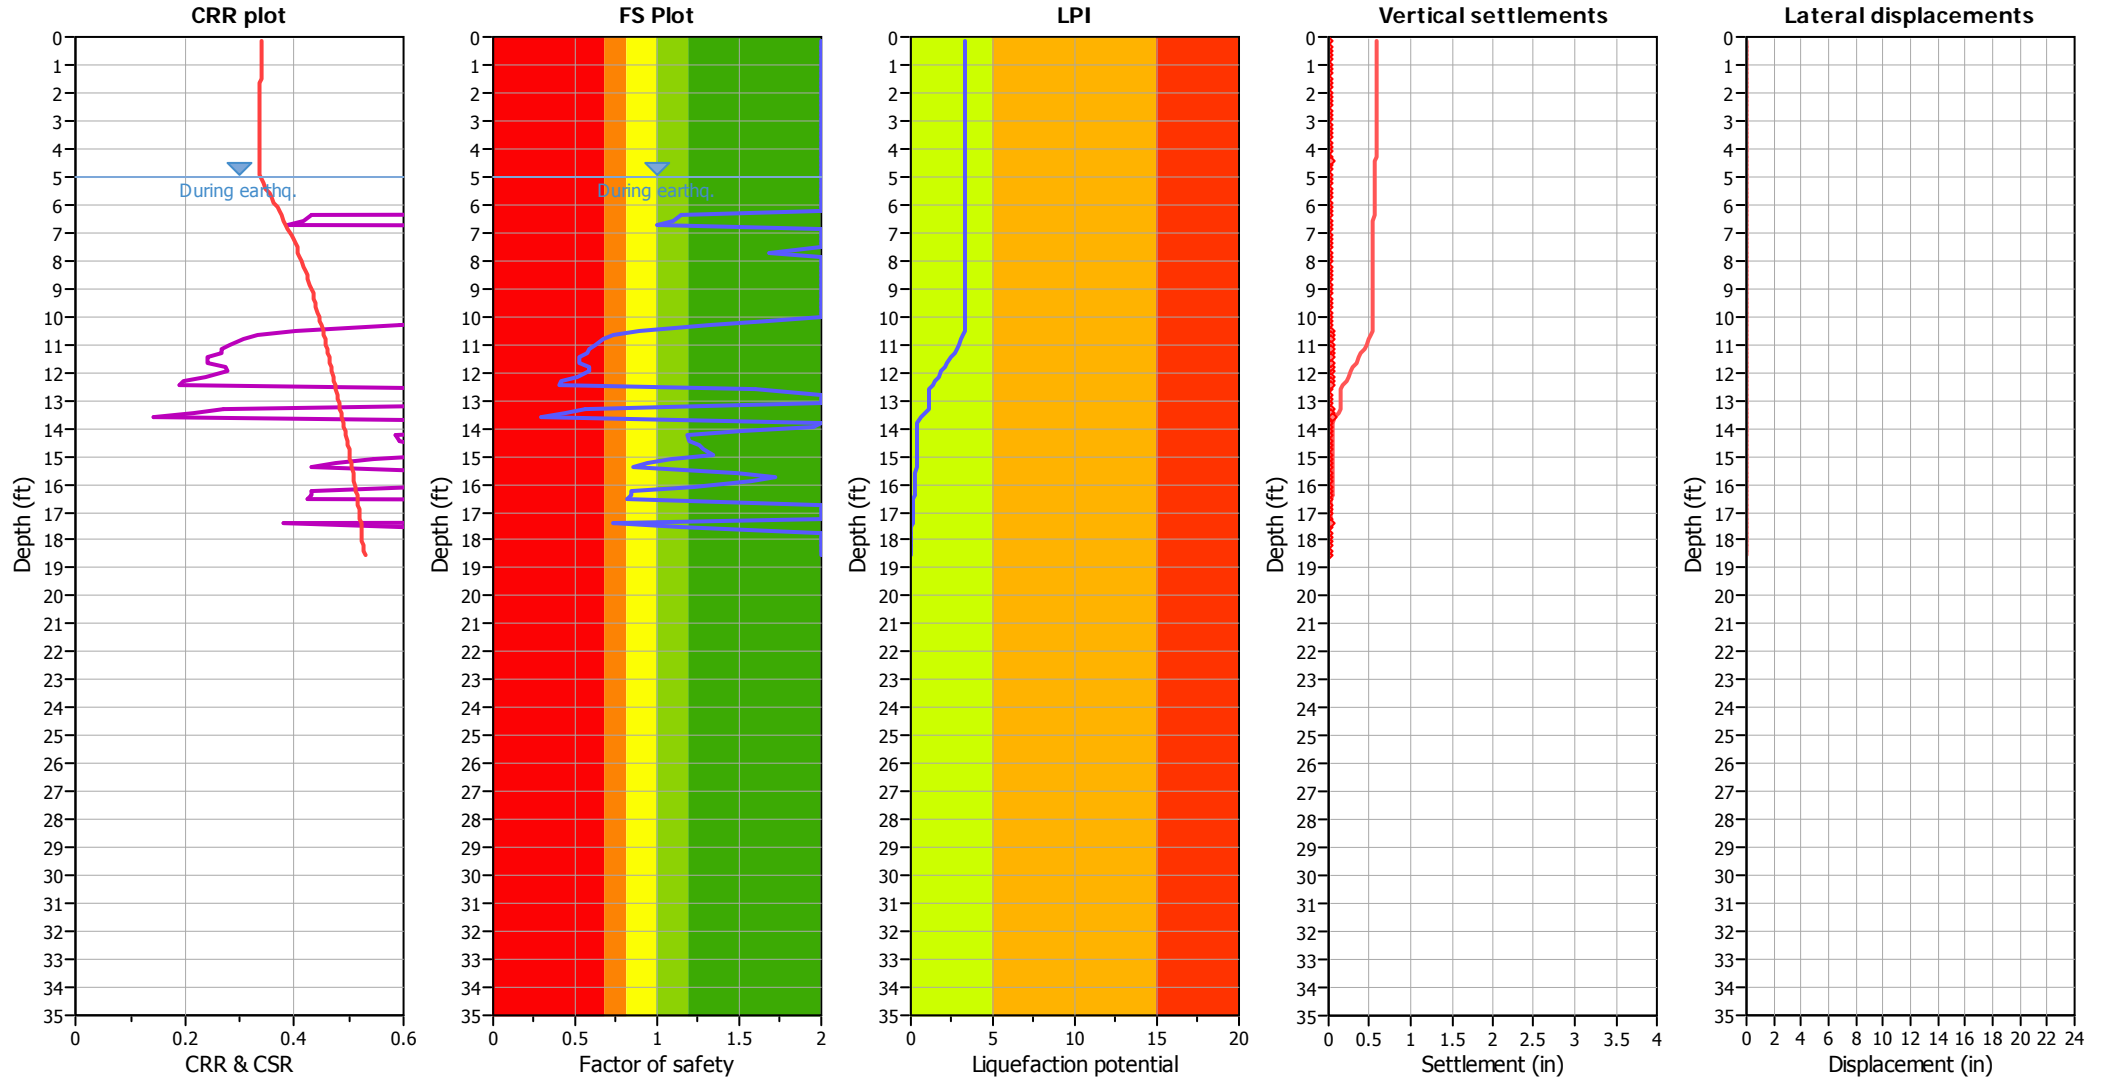
### Liquefaction analysis overall plots

**Input parameters and analysis data**

Analysis method:	Robertson (2009)	Depth to water table (earthq.):	5.00 ft	Fill weight:	N/A
Fines correction method:	Robertson (2009)	Average results interval:	1	Transition detect. applied:	Yes
Points to test:	Based on Ic value	Ic cut-off value:	2.60	$K_{\sigma}$ applied:	Yes
Earthquake magnitude $M_w$ :	6.80	Unit weight calculation:	Based on SBT	Clay like behavior applied:	All soils
Peak ground acceleration:	0.67	Use fill:	No	Limit depth applied:	No
Depth to water table (insitu):	11.00 ft	Fill height:	N/A	Limit depth:	N/A

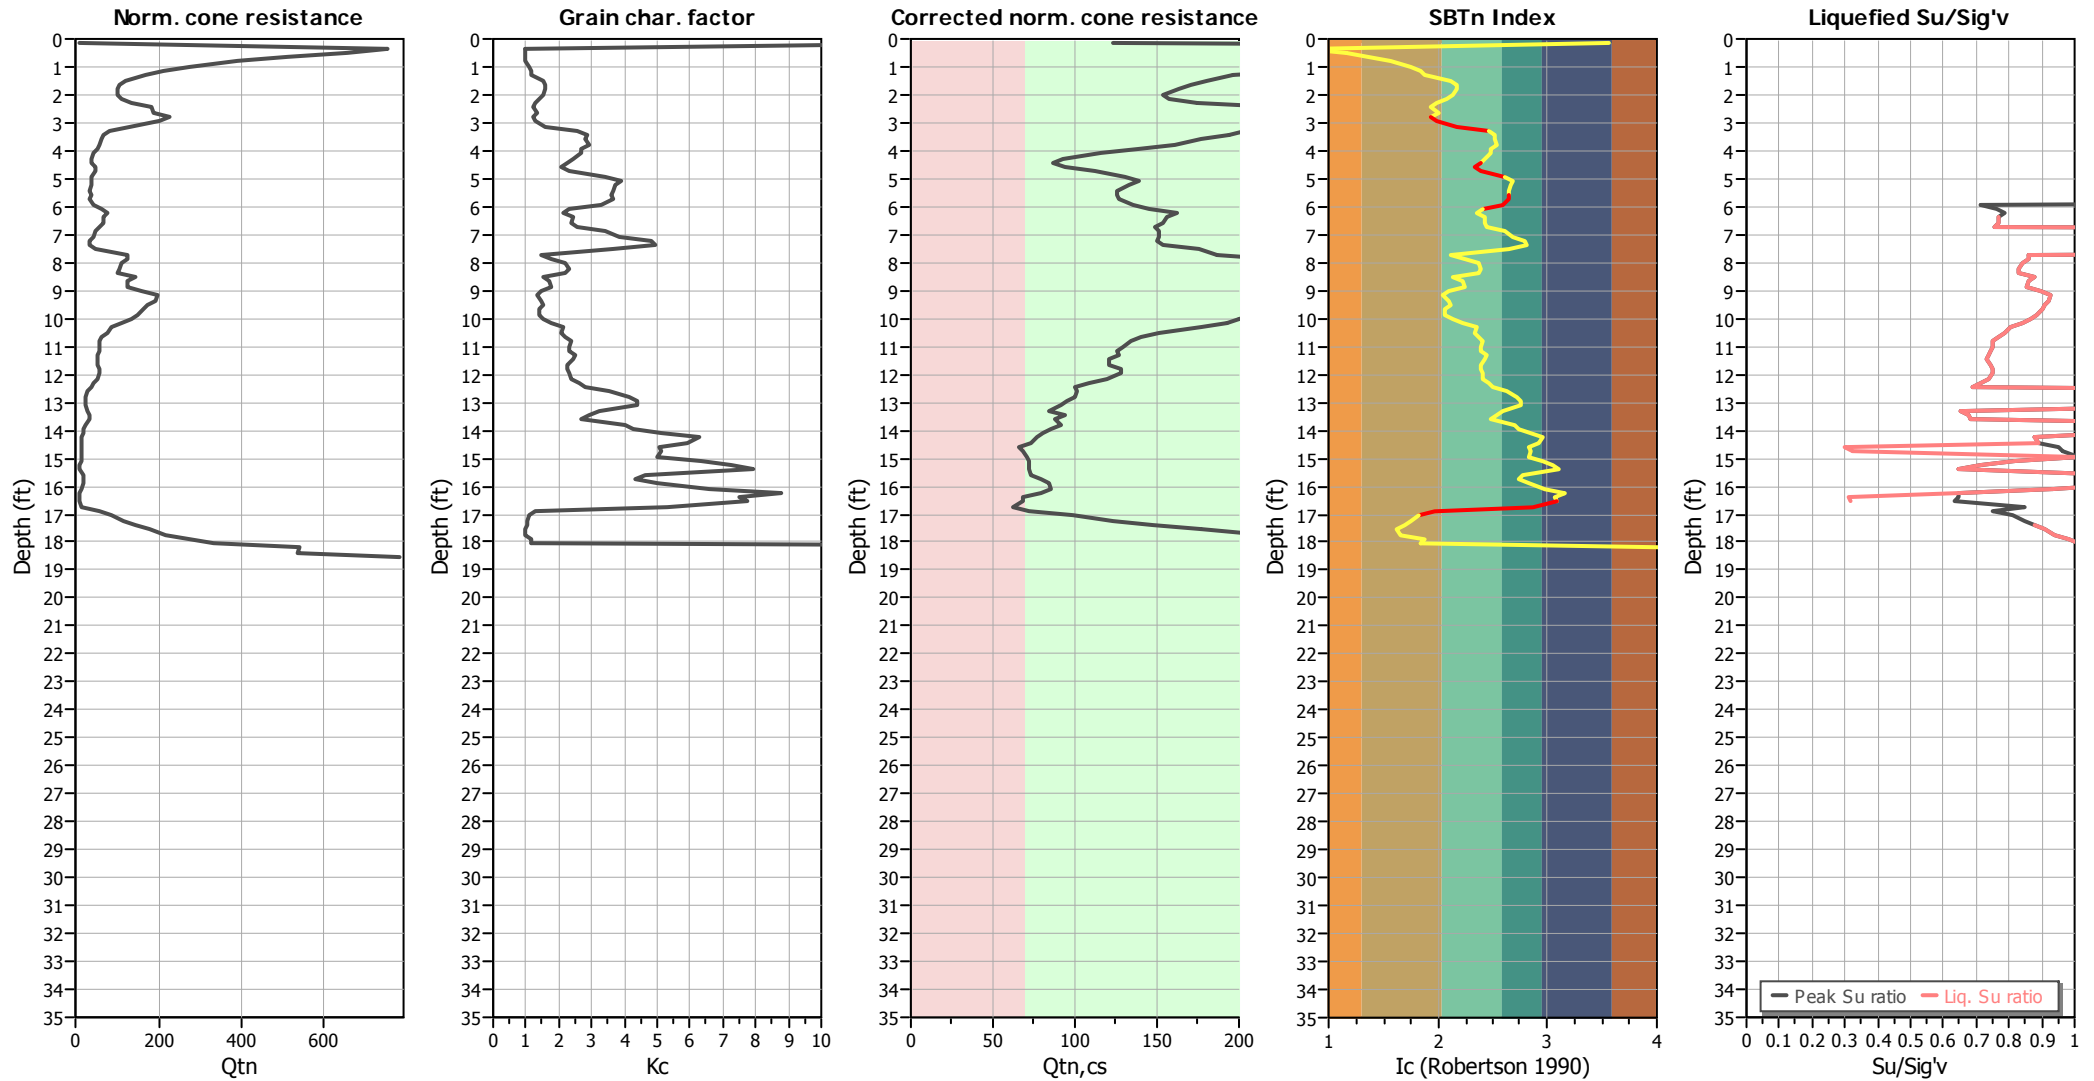
### Check for strength loss plots (Robertson (2010))

#### Input parameters and analysis data

Analysis method:	Robertson (2009)	Depth to water table (erthq.):	5.00 ft	Fill weight:	N/A
Fines correction method:	Robertson (2009)	Average results interval:	1	Transition detect. applied:	Yes
Points to test:	Based on Ic value	Ic cut-off value:	2.60	K <sub>cs</sub> applied:	Yes
Earthquake magnitude M <sub>w</sub> :	6.80	Unit weight calculation:	Based on SBT	Clay like behavior applied:	All soils
Peak ground acceleration:	0.67	Use fill:	No	Limit depth applied:	No
Depth to water table (insitu):	11.00 ft	Fill height:	N/A	Limit depth:	N/A

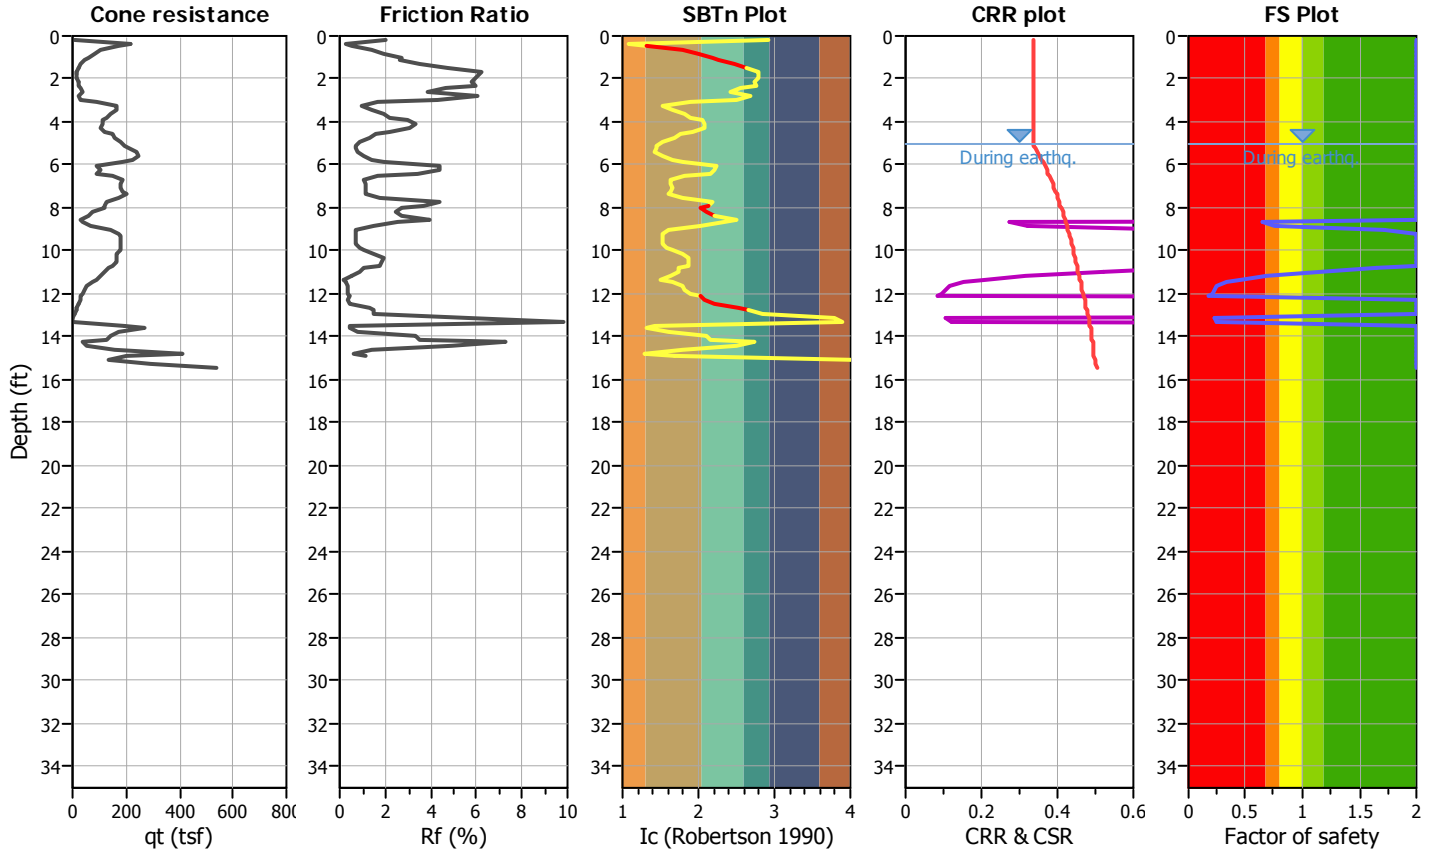
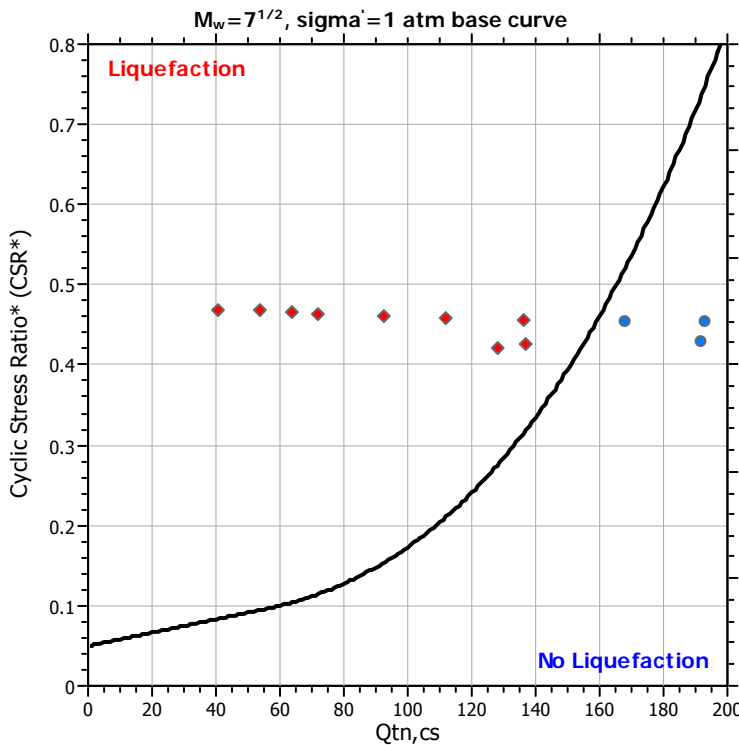
Input parameters and analysis data

Analysis method:	Robertson (2009)	G.W.T. (in-situ):	6.50 ft	Use fill:	No	Clay like behavior applied:	All soils
Fines correction method:	Robertson (2009)	G.W.T. (earthq.):	5.00 ft	Fill height:	N/A	Limit depth applied:	No
Points to test:	Based on Ic value	Average results interval:	1	Fill weight:	N/A	Limit depth:	N/A
Earthquake magnitude $M_w$ :	6.80	Ic cut-off value:	2.60	Trans. detect. applied:	Yes	MSF method:	Method based
Peak ground acceleration:	0.67	Unit weight calculation:	Based on SBT	$K_0$ applied:	Yes

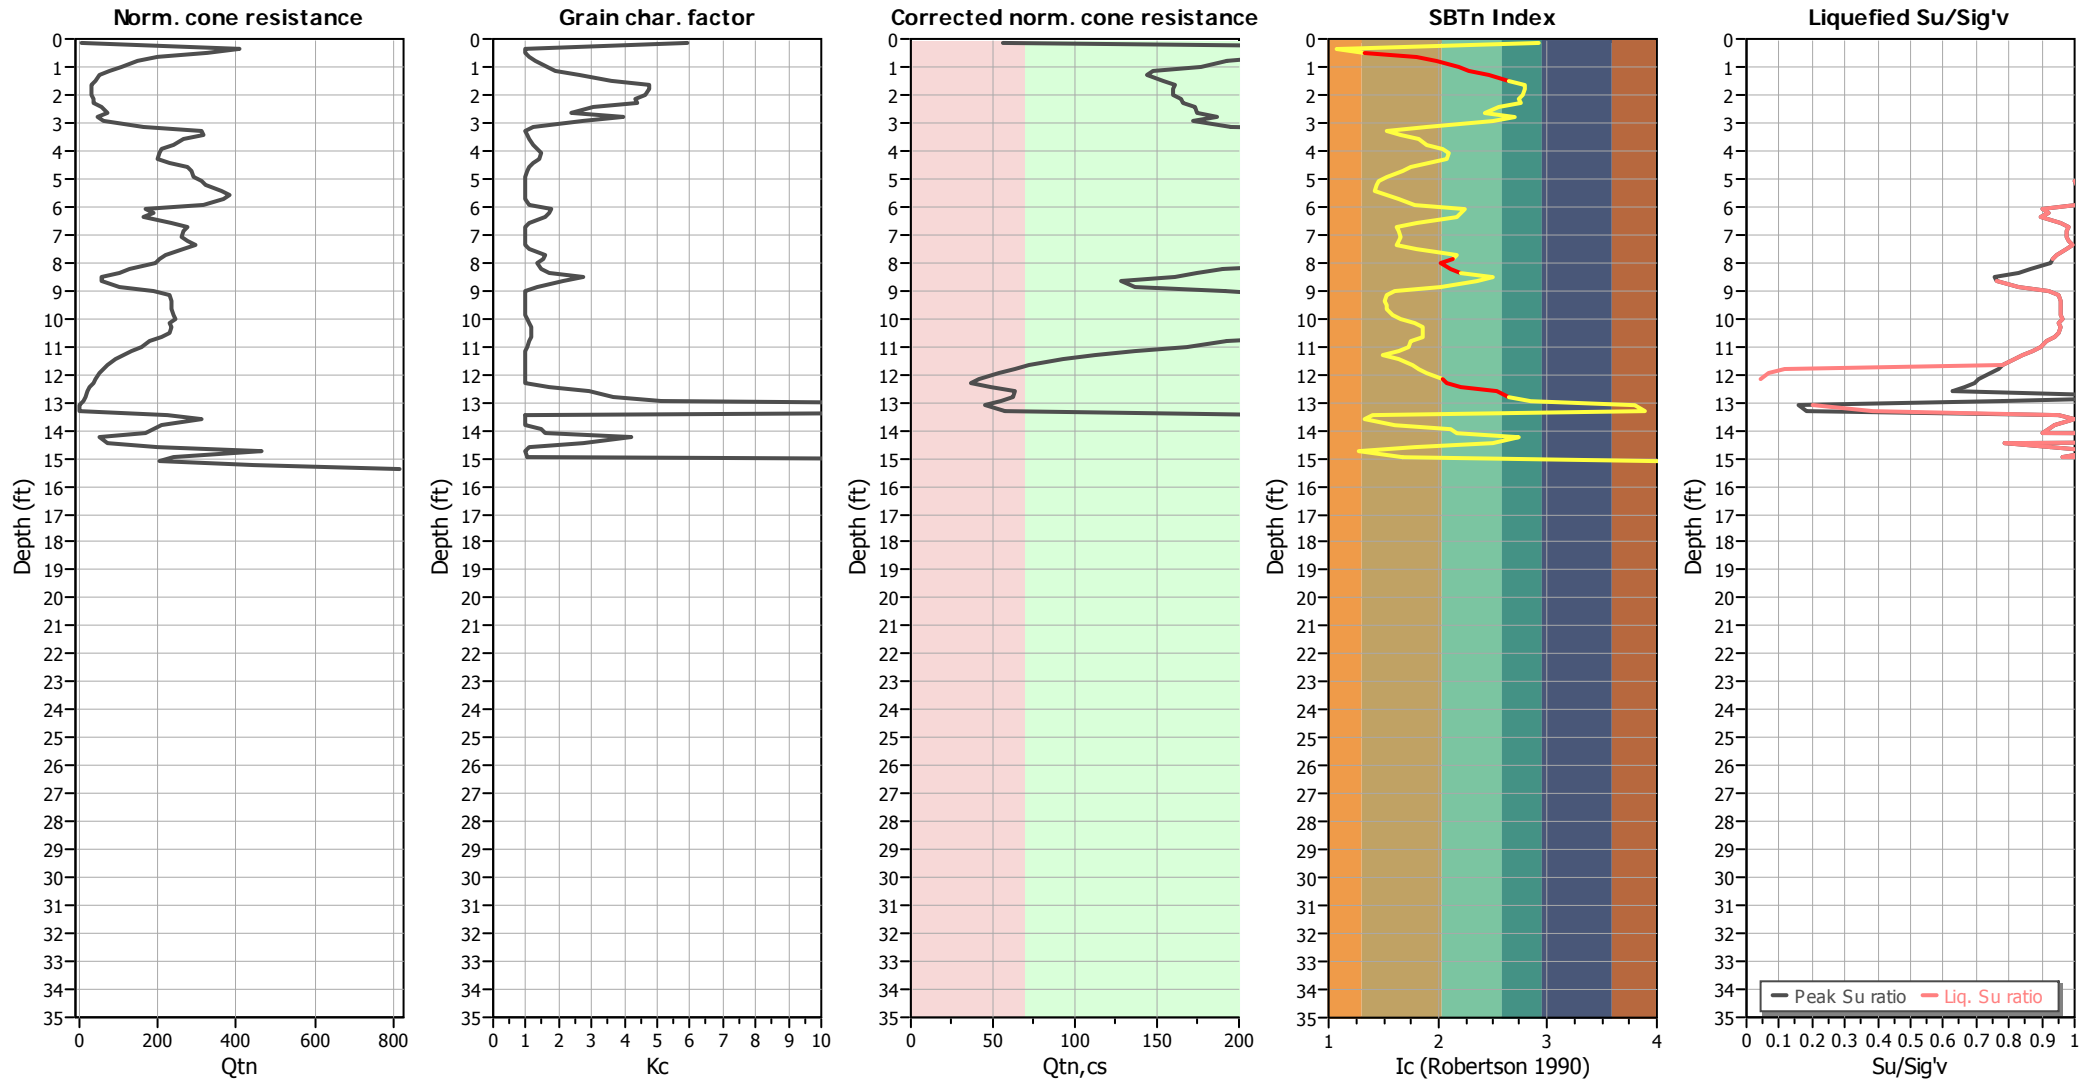
### Check for strength loss plots (Robertson (2010))

#### Input parameters and analysis data

Analysis method:	Robertson (2009)	Depth to water table (erthq.):	5.00 ft	Fill weight:	N/A
Fines correction method:	Robertson (2009)	Average results interval:	1	Transition detect. applied:	Yes
Points to test:	Based on Ic value	Ic cut-off value:	2.60	$K_{\sigma}$ applied:	Yes
Earthquake magnitude $M_w$ :	6.80	Unit weight calculation:	Based on SBT	Clay like behavior applied:	All soils
Peak ground acceleration:	0.67	Use fill:	No	Limit depth applied:	No
Depth to water table (insitu):	6.50 ft	Fill height:	N/A	Limit depth:	N/A

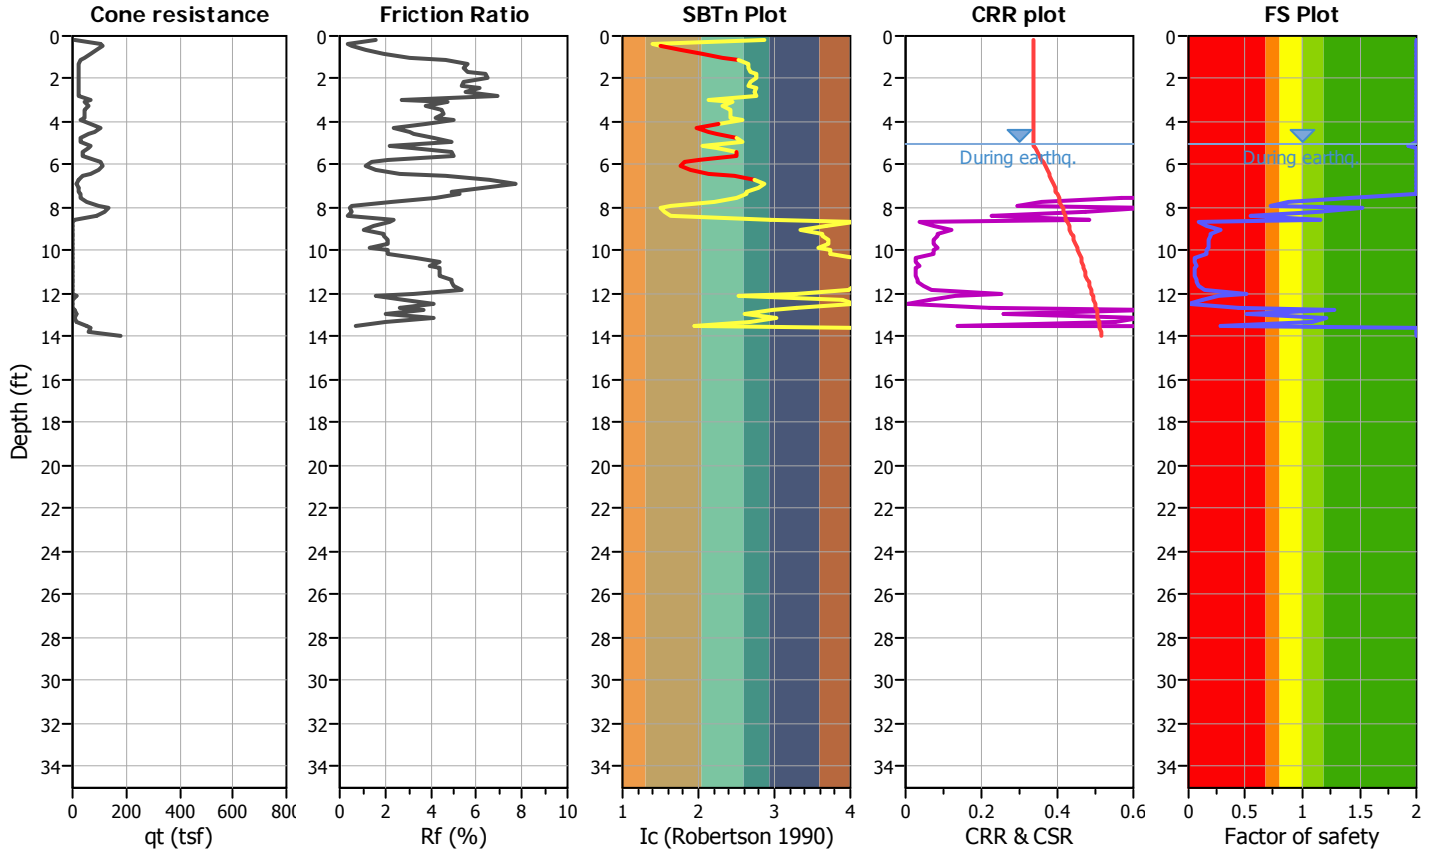
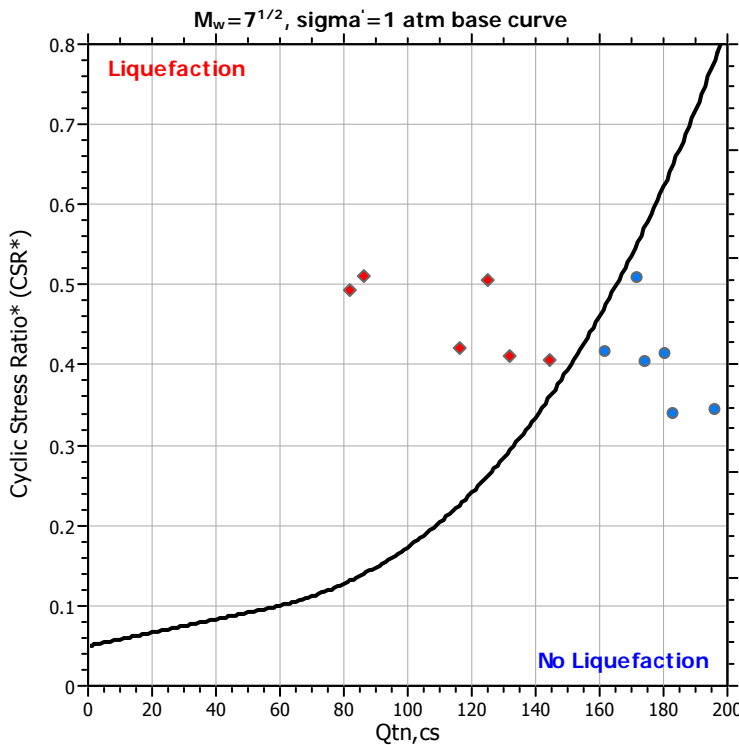
Input parameters and analysis data

Analysis method:	Robertson (2009)	G.W.T. (in-situ):	9.00 ft	Use fill:	No	Clay like behavior applied:	All soils
Fines correction method:	Robertson (2009)	G.W.T. (earthq.):	5.00 ft	Fill height:	N/A	Limit depth applied:	No
Points to test:	Based on Ic value	Average results interval:	1	Fill weight:	N/A	Limit depth:	N/A
Earthquake magnitude $M_w$ :	6.80	Ic cut-off value:	2.60	Trans. detect. applied:	Yes	MSF method:	Method based
Peak ground acceleration:	0.67	Unit weight calculation:	Based on SBT	$K_0$ applied:	Yes

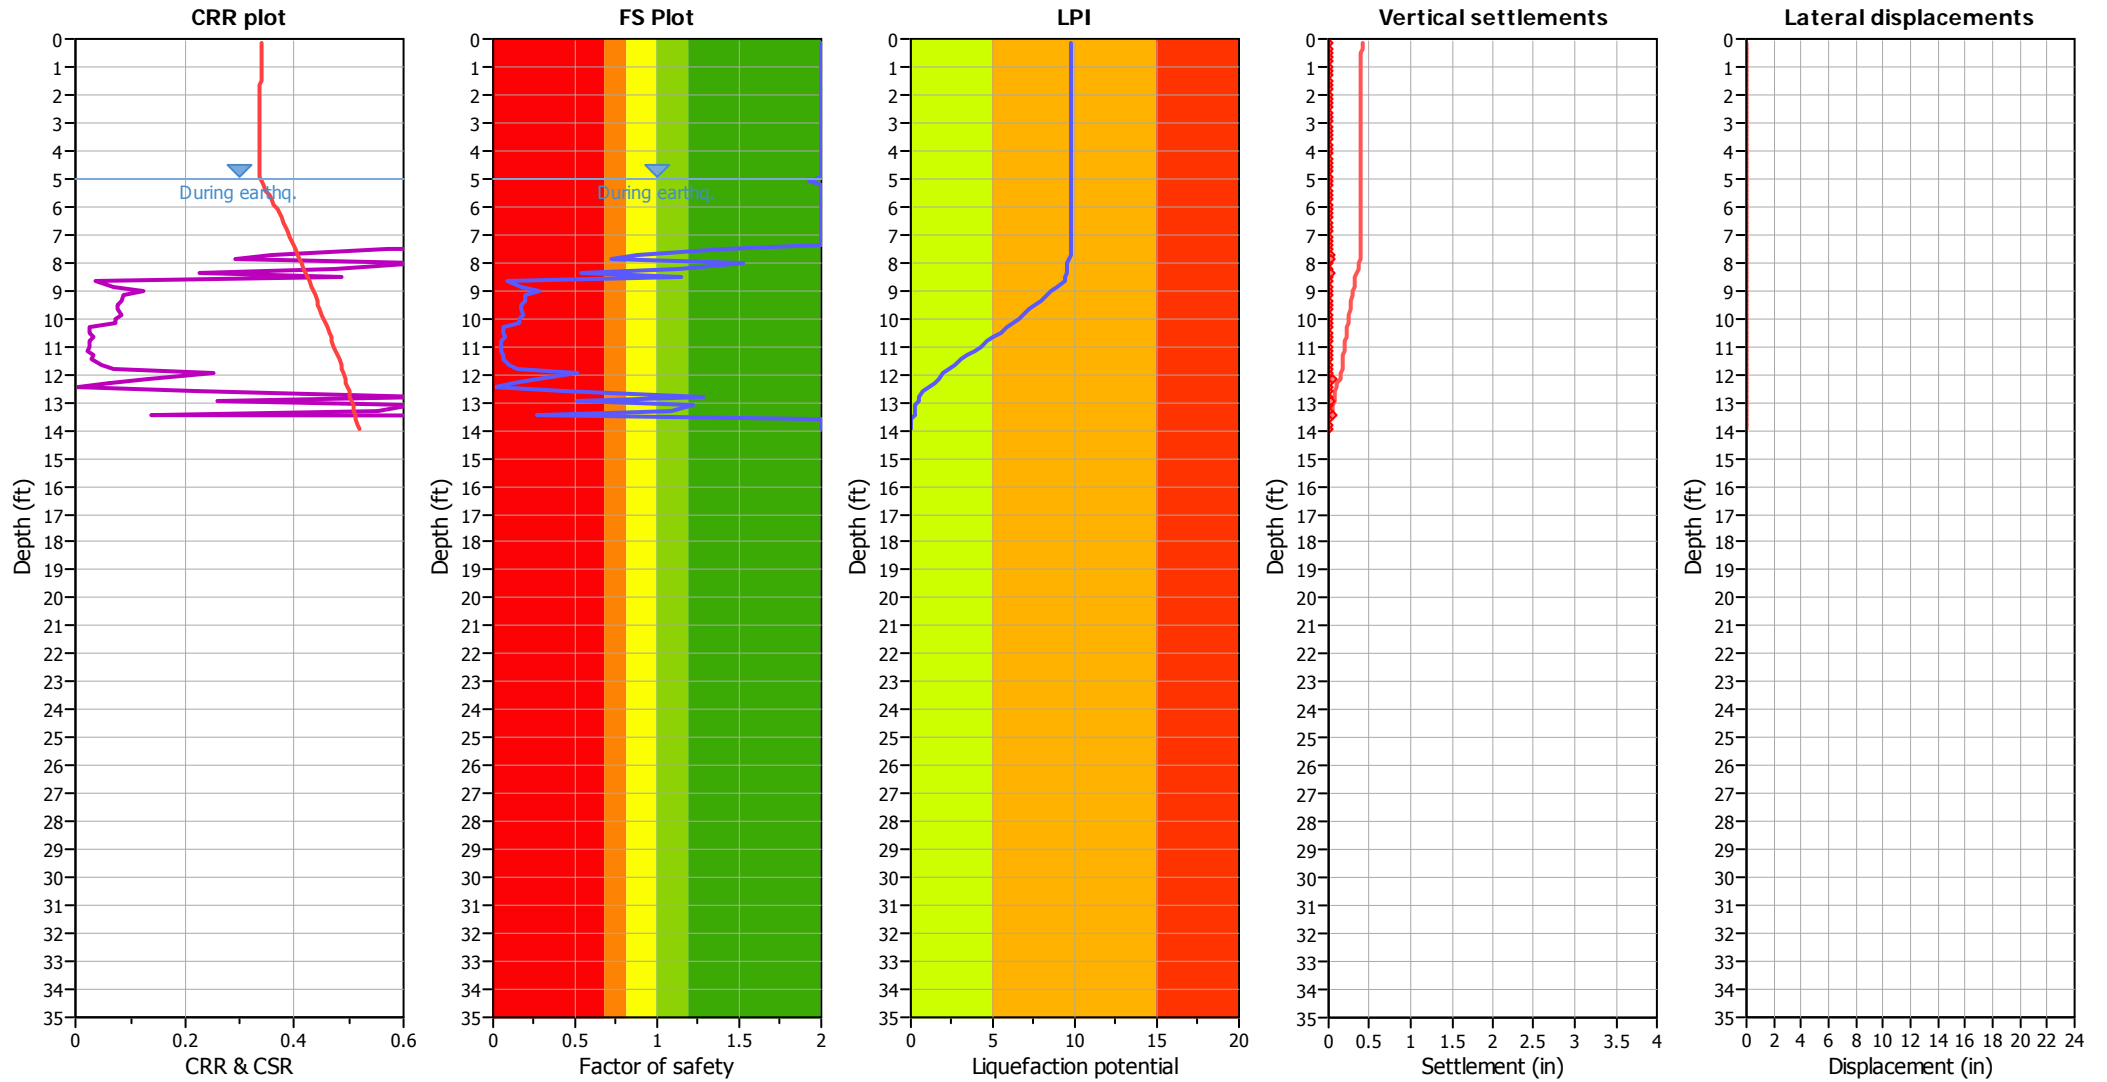
### Liquefaction analysis overall plots

**Input parameters and analysis data**

Analysis method:	Robertson (2009)	Depth to water table (earthq.):	5.00 ft	Fill weight:	N/A
Fines correction method:	Robertson (2009)	Average results interval:	1	Transition detect. applied:	Yes
Points to test:	Based on I <sub>c</sub> value	I <sub>c</sub> cut-off value:	2.60	K <sub>σ</sub> applied:	Yes
Earthquake magnitude M <sub>w</sub> :	6.80	Unit weight calculation:	Based on SBT	Clay like behavior applied:	All soils
Peak ground acceleration:	0.67	Use fill:	No	Limit depth applied:	No
Depth to water table (insitu):	9.00 ft	Fill height:	N/A	Limit depth:	N/A

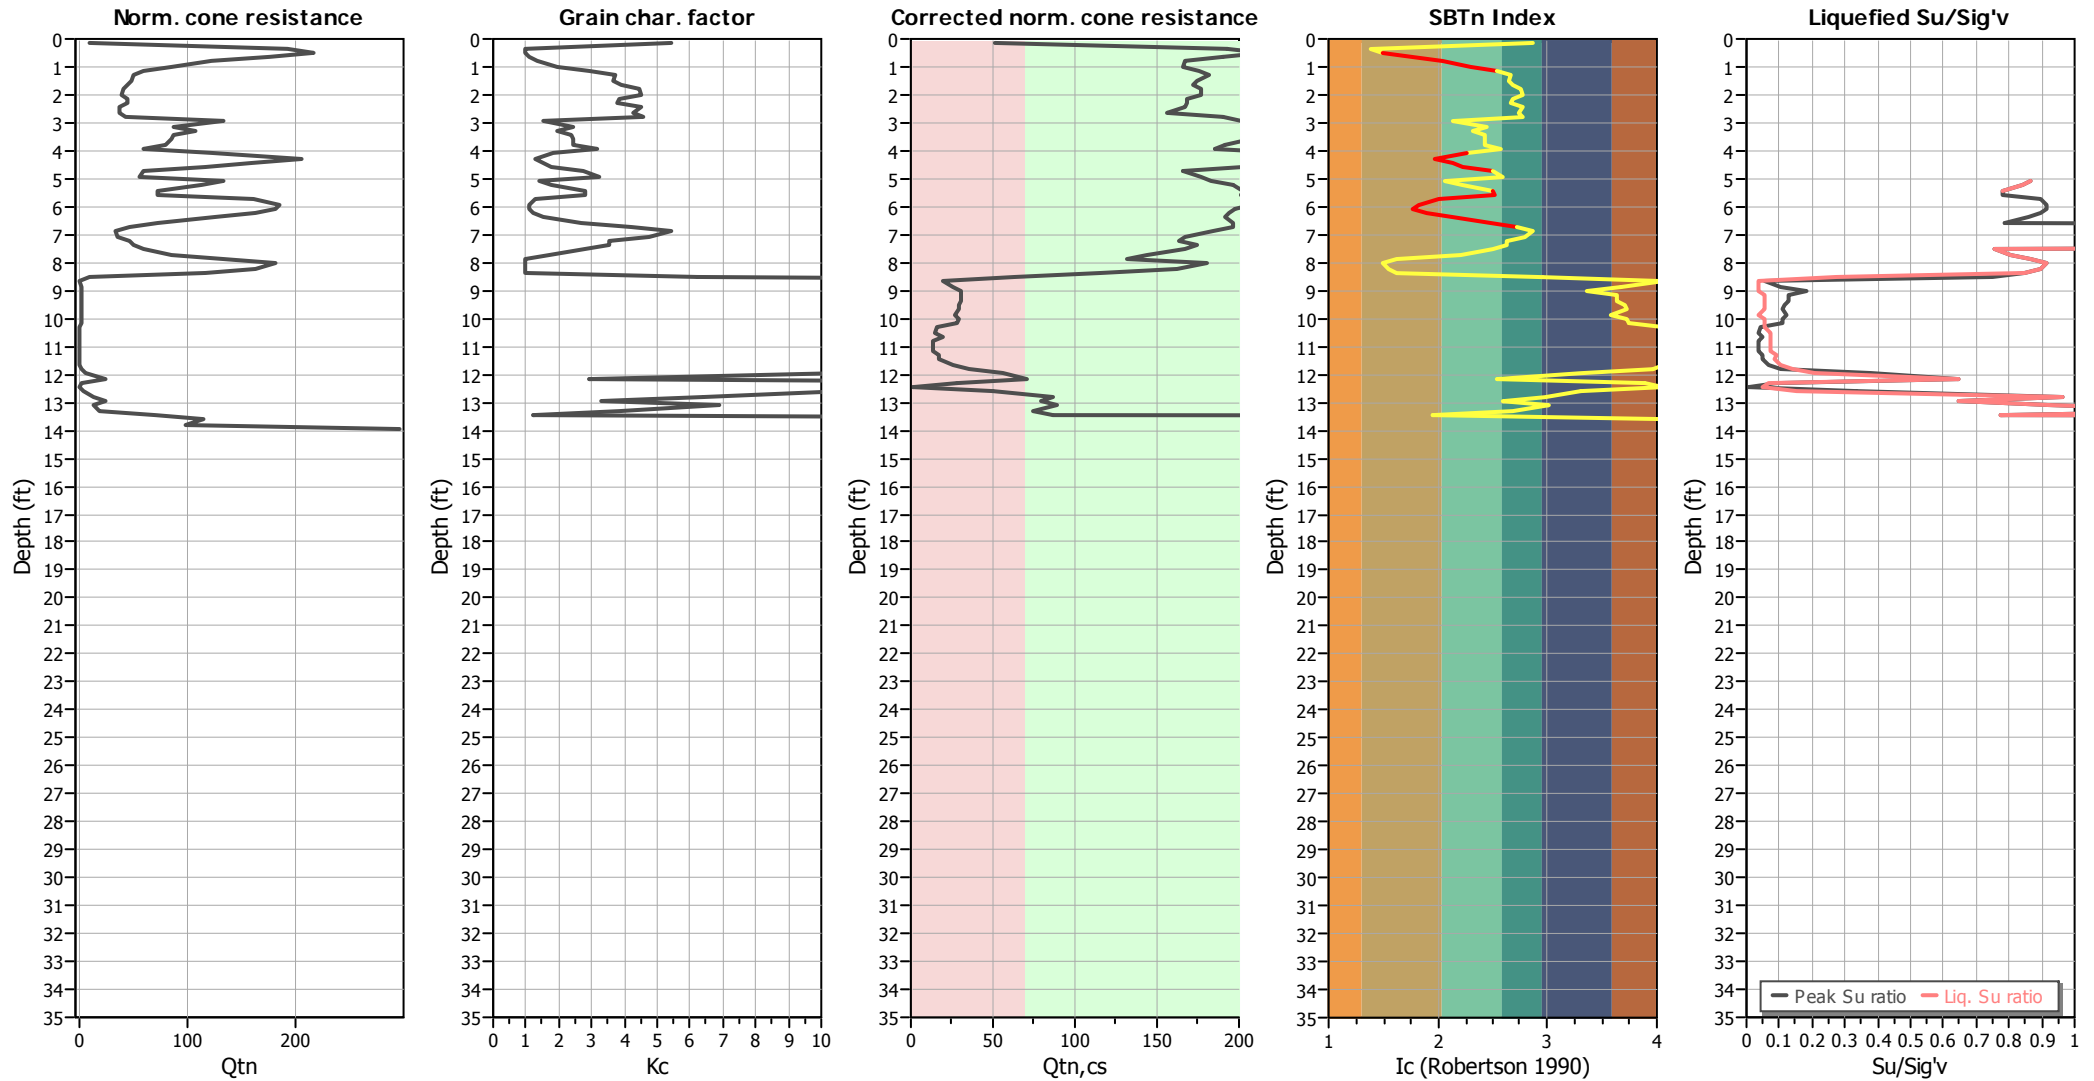
### Check for strength loss plots (Robertson (2010))

#### Input parameters and analysis data

Analysis method:	Robertson (2009)	Depth to water table (erthq.):	5.00 ft	Fill weight:	N/A
Fines correction method:	Robertson (2009)	Average results interval:	1	Transition detect. applied:	Yes
Points to test:	Based on Ic value	Ic cut-off value:	2.60	$K_{cs}$ applied:	Yes
Earthquake magnitude $M_w$ :	6.80	Unit weight calculation:	Based on SBT	Clay like behavior applied:	All soils
Peak ground acceleration:	0.67	Use fill:	No	Limit depth applied:	No
Depth to water table (insitu):	9.00 ft	Fill height:	N/A	Limit depth:	N/A

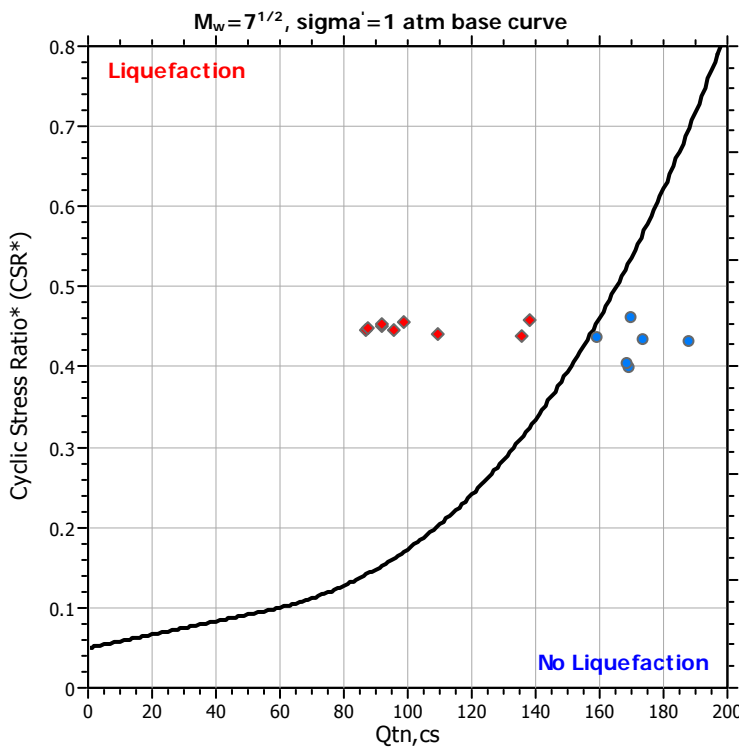
Input parameters and analysis data

Analysis method:	Robertson (2009)	G.W.T. (in-situ):	9.00 ft	Use fill:	No	Clay like behavior applied:	All soils
Fines correction method:	Robertson (2009)	G.W.T. (earthq.):	5.00 ft	Fill height:	N/A	Limit depth applied:	No
Points to test:	Based on Ic value	Average results interval:	1	Fill weight:	N/A	Limit depth:	N/A
Earthquake magnitude $M_w$ :	6.80	Ic cut-off value:	2.60	Trans. detect. applied:	Yes	MSF method:	Method based
Peak ground acceleration:	0.67	Unit weight calculation:	Based on SBT	$K_0$ applied:	Yes

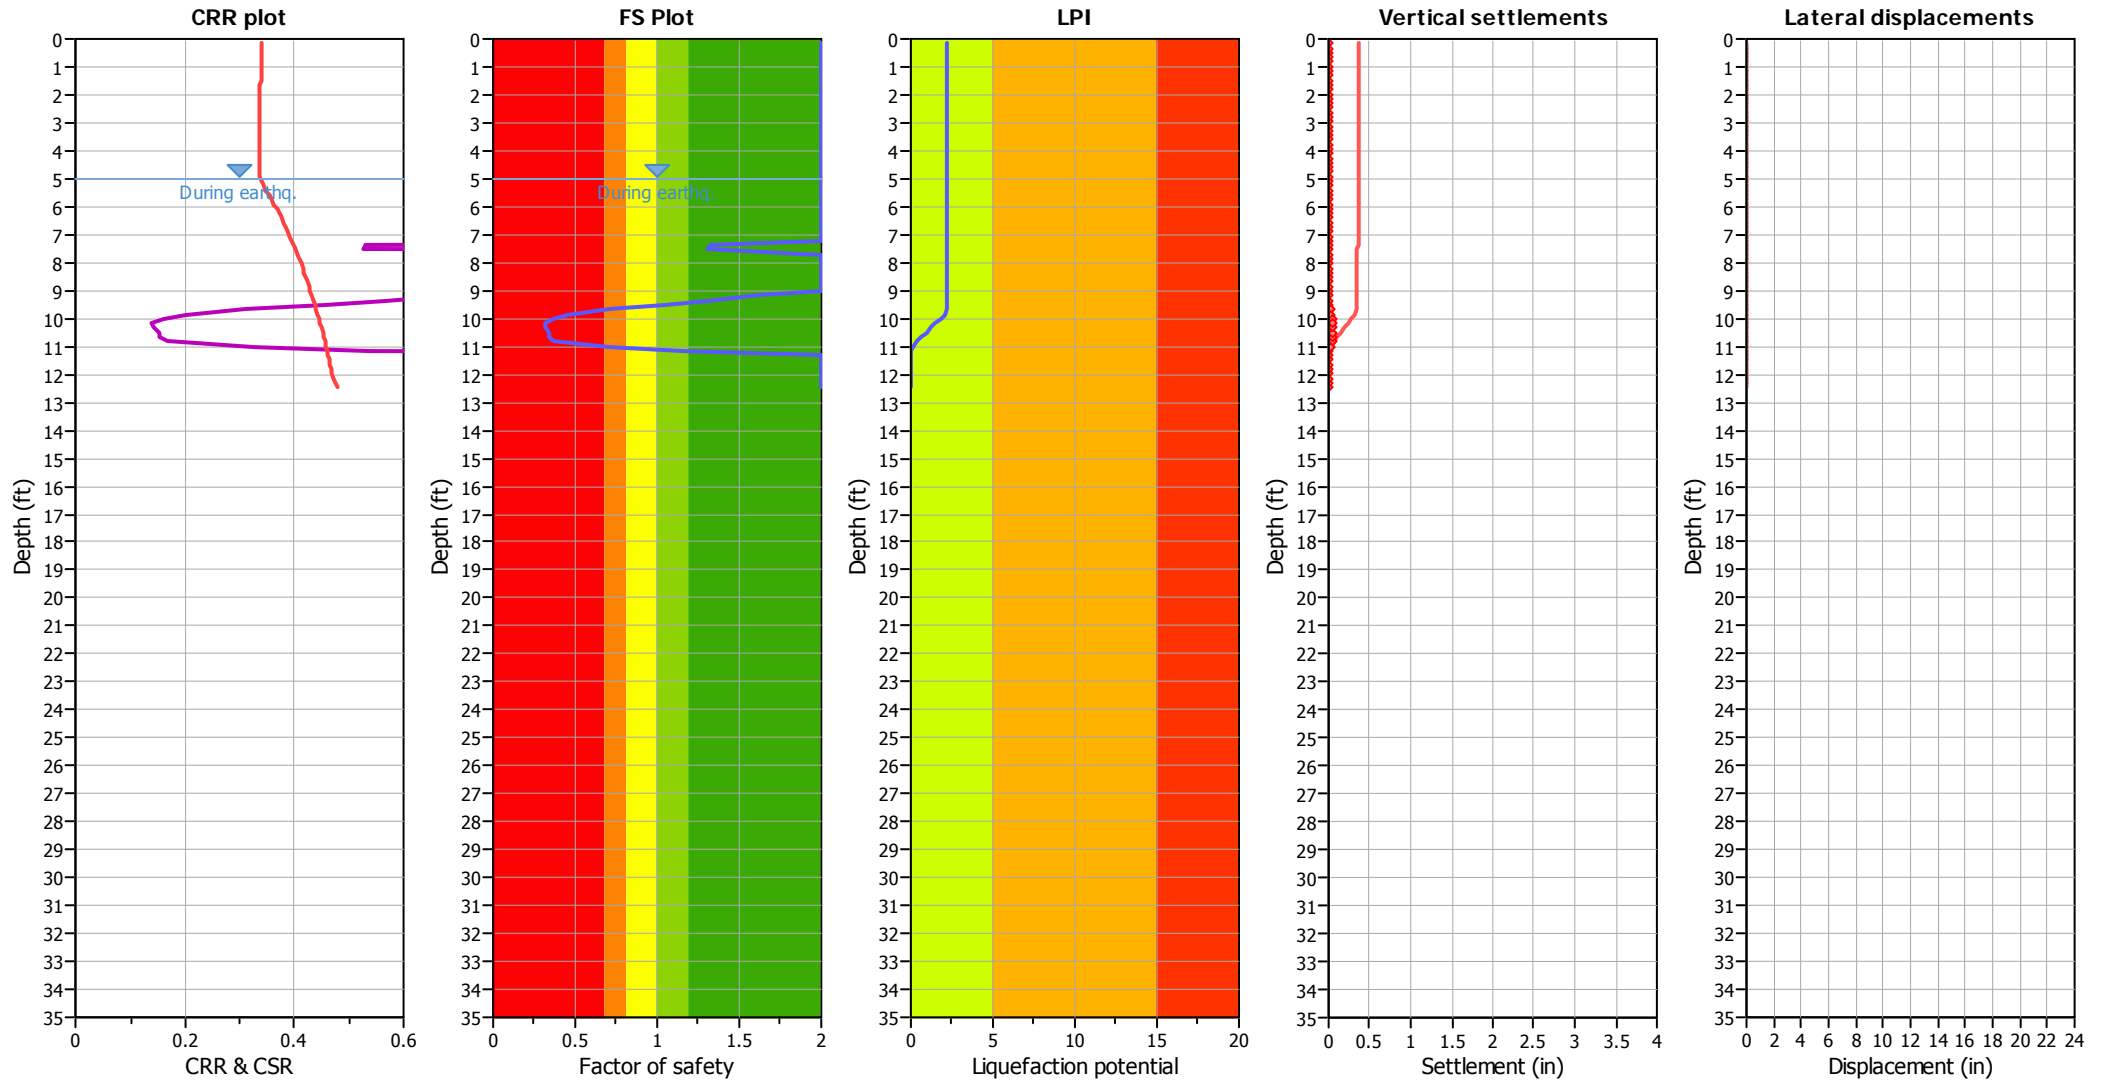
### Liquefaction analysis overall plots

**Input parameters and analysis data**

Analysis method:	Robertson (2009)	Depth to water table (earthq.):	5.00 ft	Fill weight:	N/A
Fines correction method:	Robertson (2009)	Average results interval:	1	Transition detect. applied:	Yes
Points to test:	Based on Ic value	Ic cut-off value:	2.60	$K_{\sigma}$ applied:	Yes
Earthquake magnitude $M_w$ :	6.80	Unit weight calculation:	Based on SBT	Clay like behavior applied:	All soils
Peak ground acceleration:	0.67	Use fill:	No	Limit depth applied:	No
Depth to water table (insitu):	9.00 ft	Fill height:	N/A	Limit depth:	N/A
