## PRELIMINARY GEOTECHNICAL INVESTIGATION

**Preliminary Geotechnical Investigation,  
Dana Point Harbor Revitalization,  
Hotel Component,  
City of Dana Point, California**

September 10, 2019

GMU Project No. 17-206-01

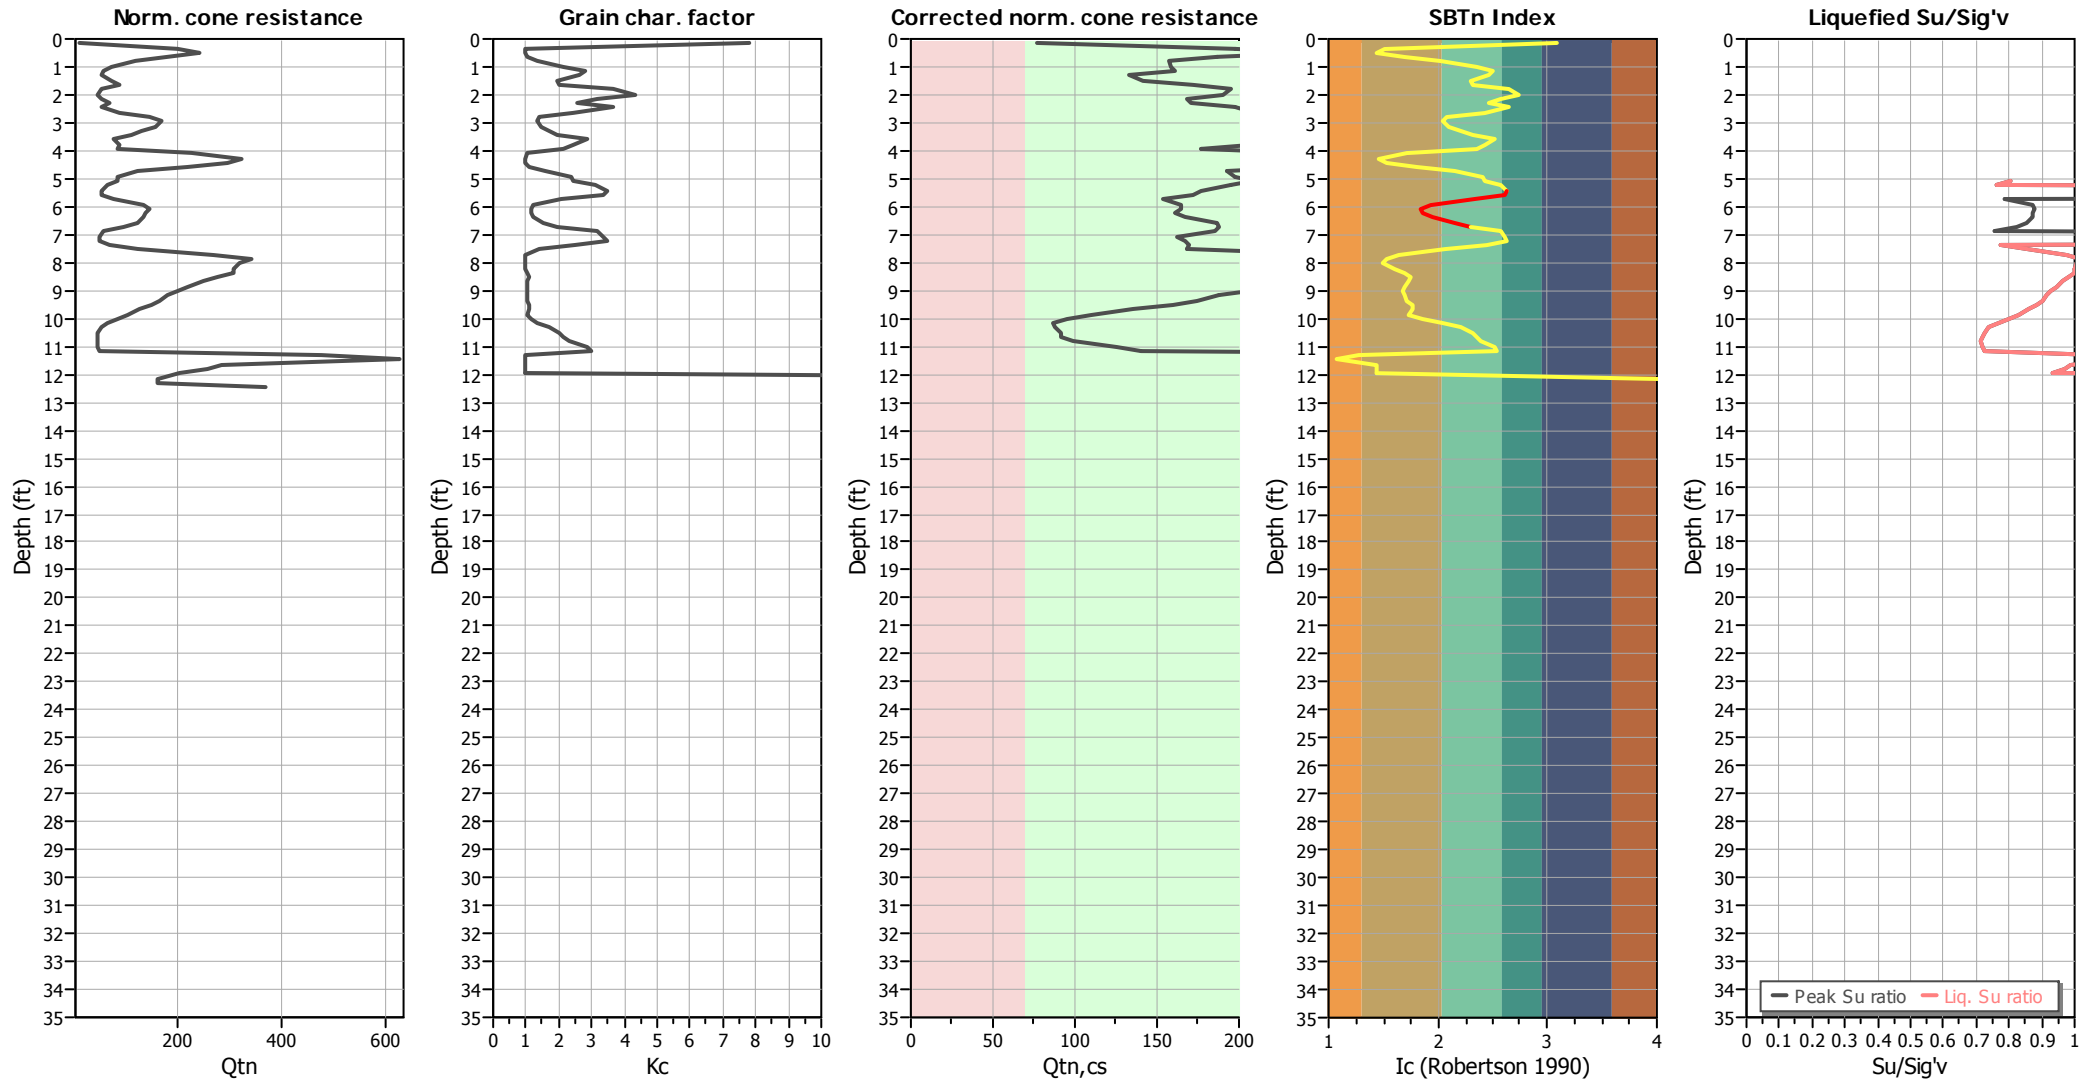
### Check for strength loss plots (Robertson (2010))

#### Input parameters and analysis data

Analysis method:	Robertson (2009)	Depth to water table (erthq.):	5.00 ft	Fill weight:	N/A
Fines correction method:	Robertson (2009)	Average results interval:	1	Transition detect. applied:	Yes
Points to test:	Based on Ic value	Ic cut-off value:	2.60	$K_{cs}$ applied:	Yes
Earthquake magnitude $M_w$ :	6.80	Unit weight calculation:	Based on SBT	Clay like behavior applied:	All soils
Peak ground acceleration:	0.67	Use fill:	No	Limit depth applied:	No
Depth to water table (insitu):	9.00 ft	Fill height:	N/A	Limit depth:	N/A

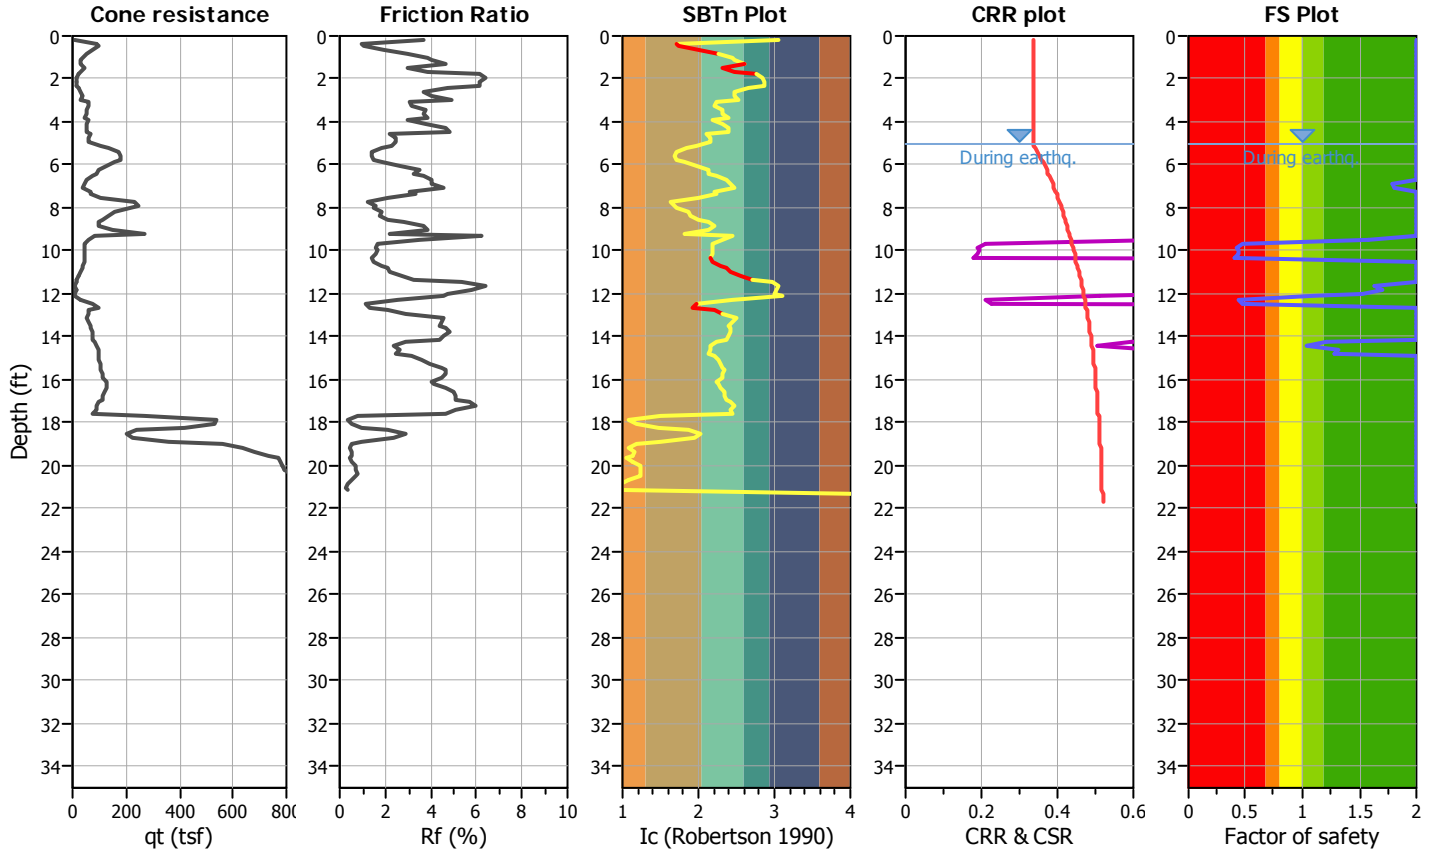
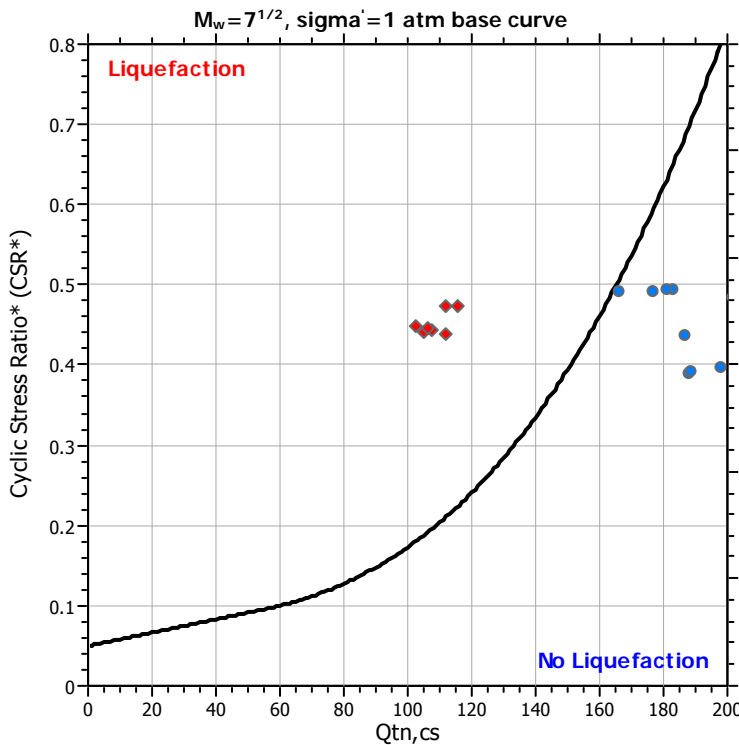
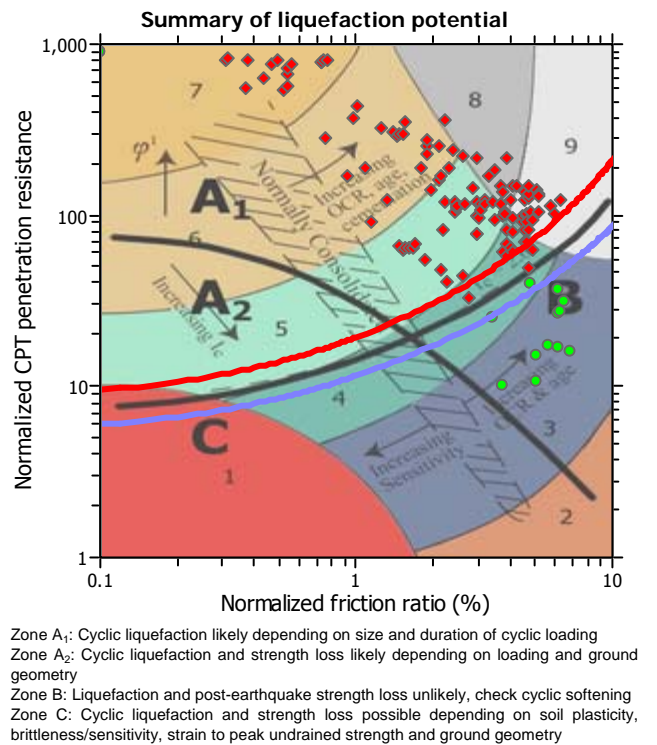
Input parameters and analysis data

Analysis method:	Robertson (2009)	G.W.T. (in-situ):	9.00 ft	Use fill:	No	Clay like behavior applied:	All soils
Fines correction method:	Robertson (2009)	G.W.T. (earthq.):	5.00 ft	Fill height:	N/A	Limit depth applied:	No
Points to test:	Based on Ic value	Average results interval:	1	Fill weight:	N/A	Limit depth:	N/A
Earthquake magnitude $M_w$ :	6.80	Ic cut-off value:	2.60	Trans. detect. applied:	Yes	MSF method:	Method based
Peak ground acceleration:	0.67	Unit weight calculation:	Based on SBT	$K_0$ applied:	Yes

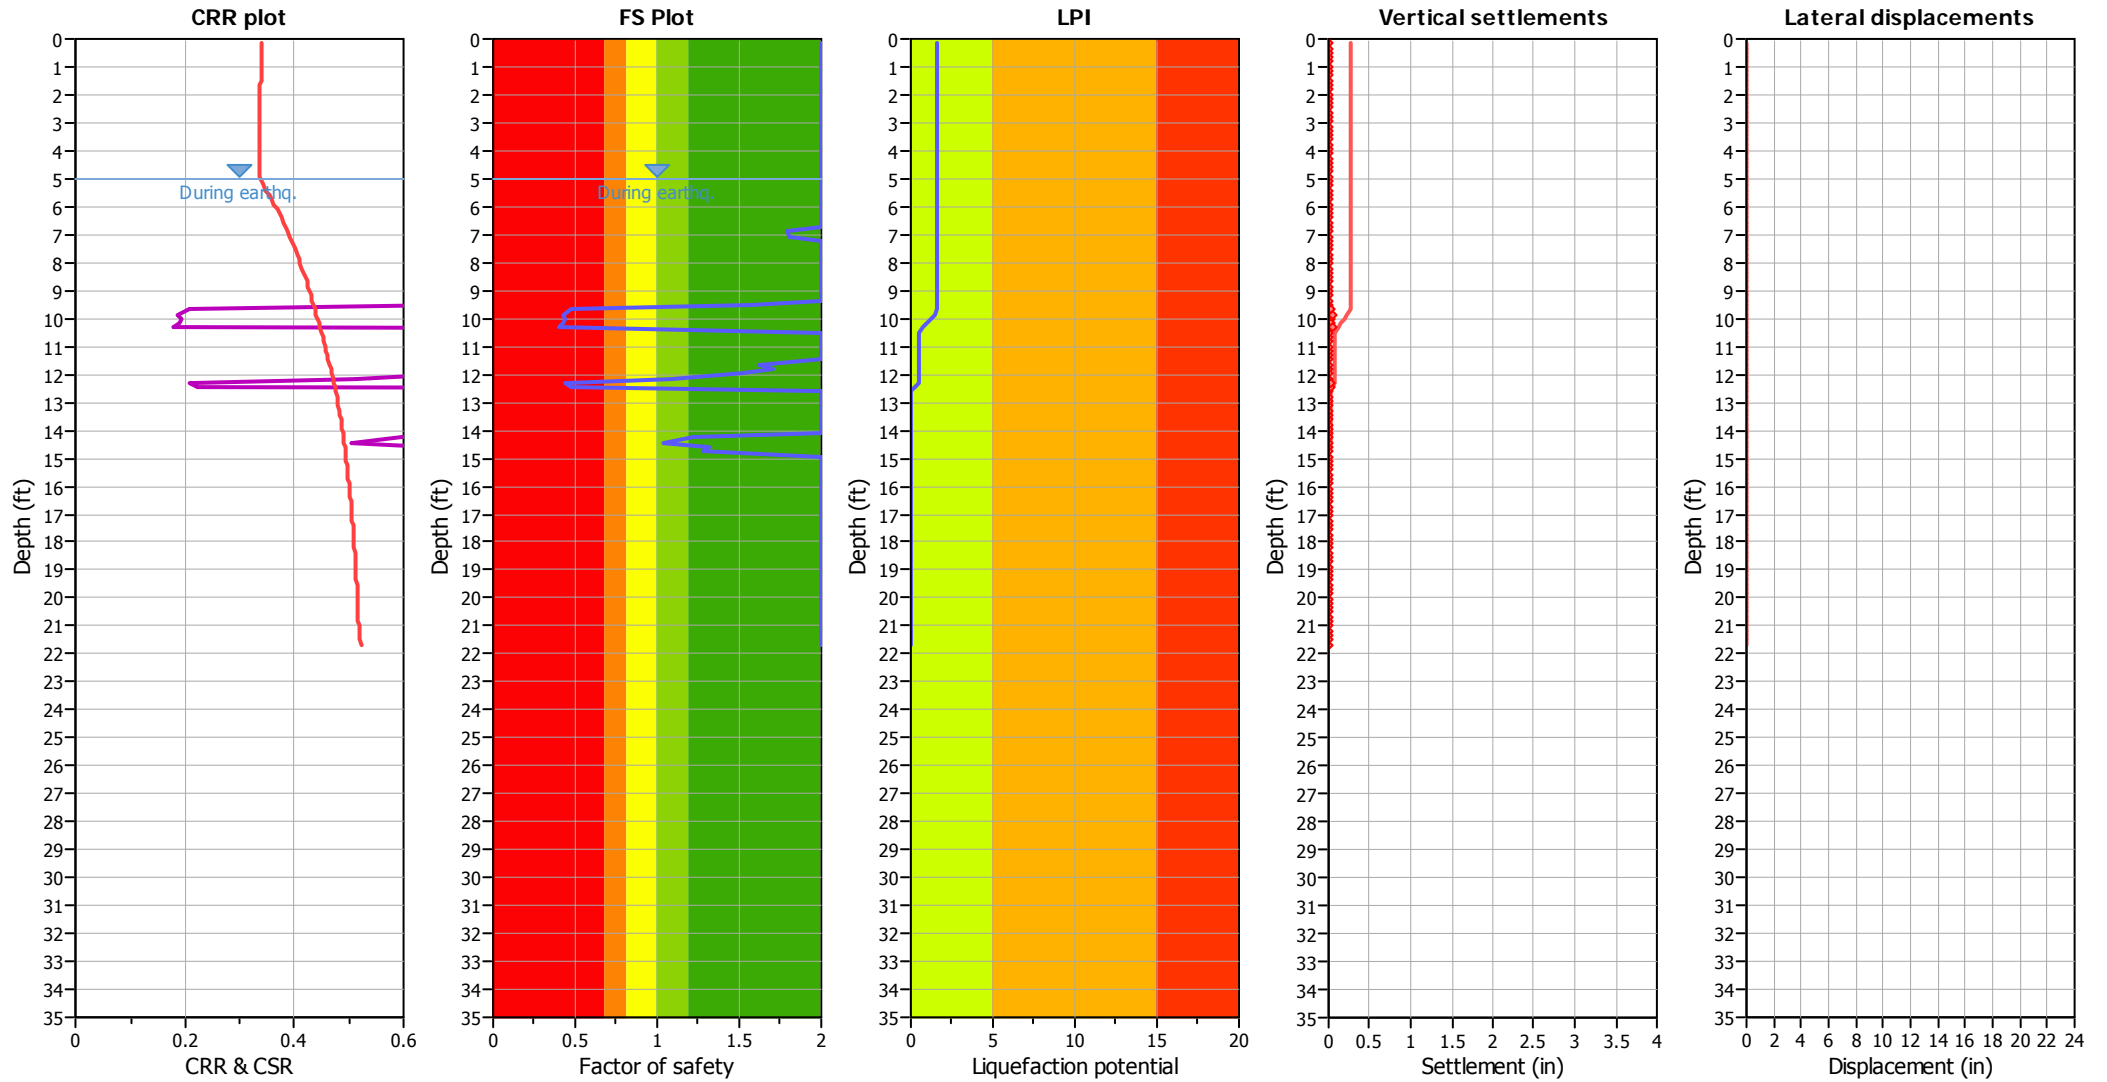
### Liquefaction analysis overall plots

#### Input parameters and analysis data

Analysis method:	Robertson (2009)	Depth to water table (earthq.):	5.00 ft	Fill weight:	N/A
Fines correction method:	Robertson (2009)	Average results interval:	1	Transition detect. applied:	Yes
Points to test:	Based on Ic value	Ic cut-off value:	2.60	$K_{\sigma}$ applied:	Yes
Earthquake magnitude $M_w$ :	6.80	Unit weight calculation:	Based on SBT	Clay like behavior applied:	All soils
Peak ground acceleration:	0.67	Use fill:	No	Limit depth applied:	No
Depth to water table (insitu):	9.00 ft	Fill height:	N/A	Limit depth:	N/A

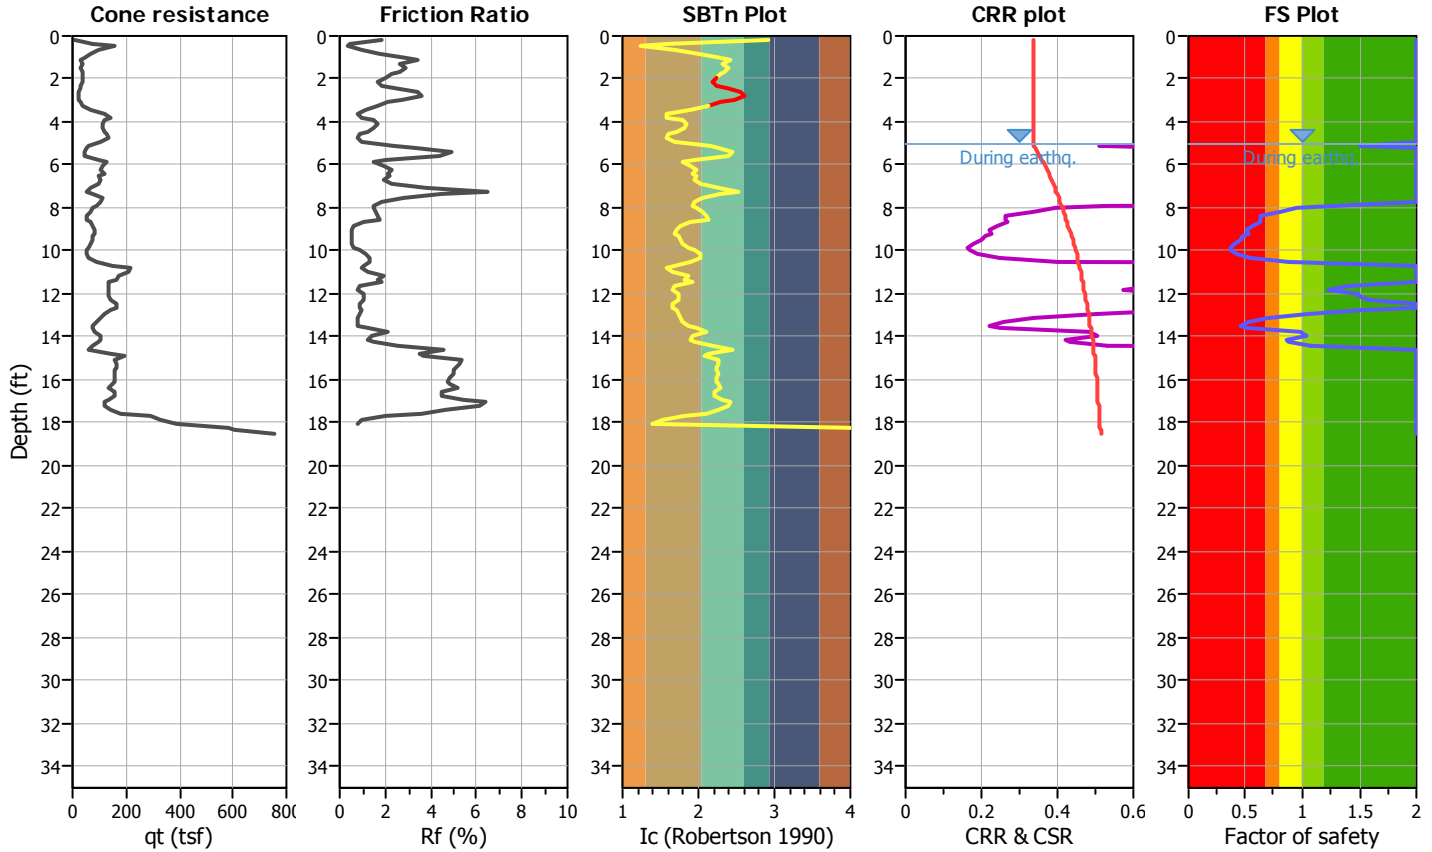
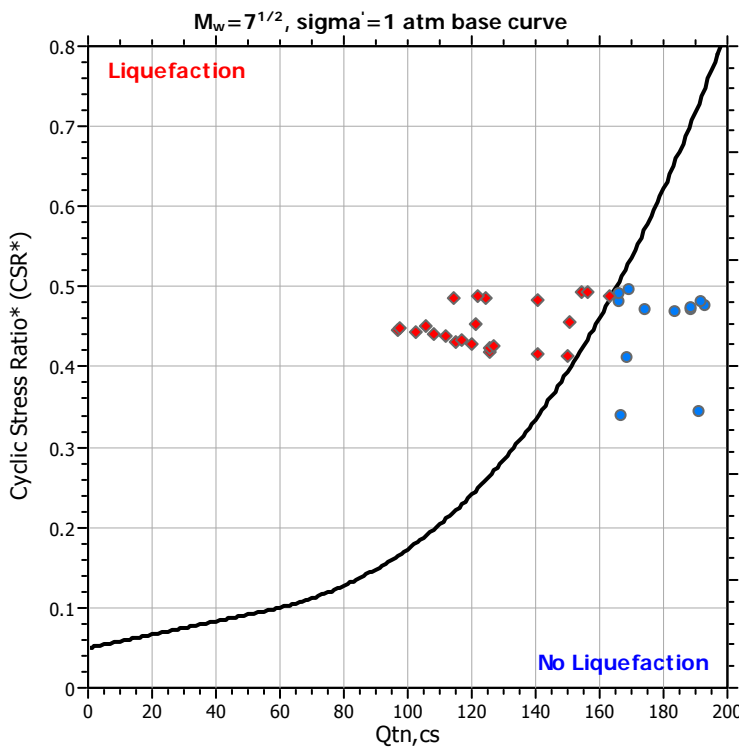
Input parameters and analysis data

Analysis method:	Robertson (2009)	G.W.T. (in-situ):	7.00 ft	Use fill:	No	Clay like behavior applied:	All soils
Fines correction method:	Robertson (2009)	G.W.T. (earthq.):	5.00 ft	Fill height:	N/A	Limit depth applied:	No
Points to test:	Based on Ic value	Average results interval:	1	Fill weight:	N/A	Limit depth:	N/A
Earthquake magnitude $M_w$ :	6.80	Ic cut-off value:	2.60	Trans. detect. applied:	Yes	MSF method:	Method based
Peak ground acceleration:	0.67	Unit weight calculation:	Based on SBT	$K_0$ applied:	Yes

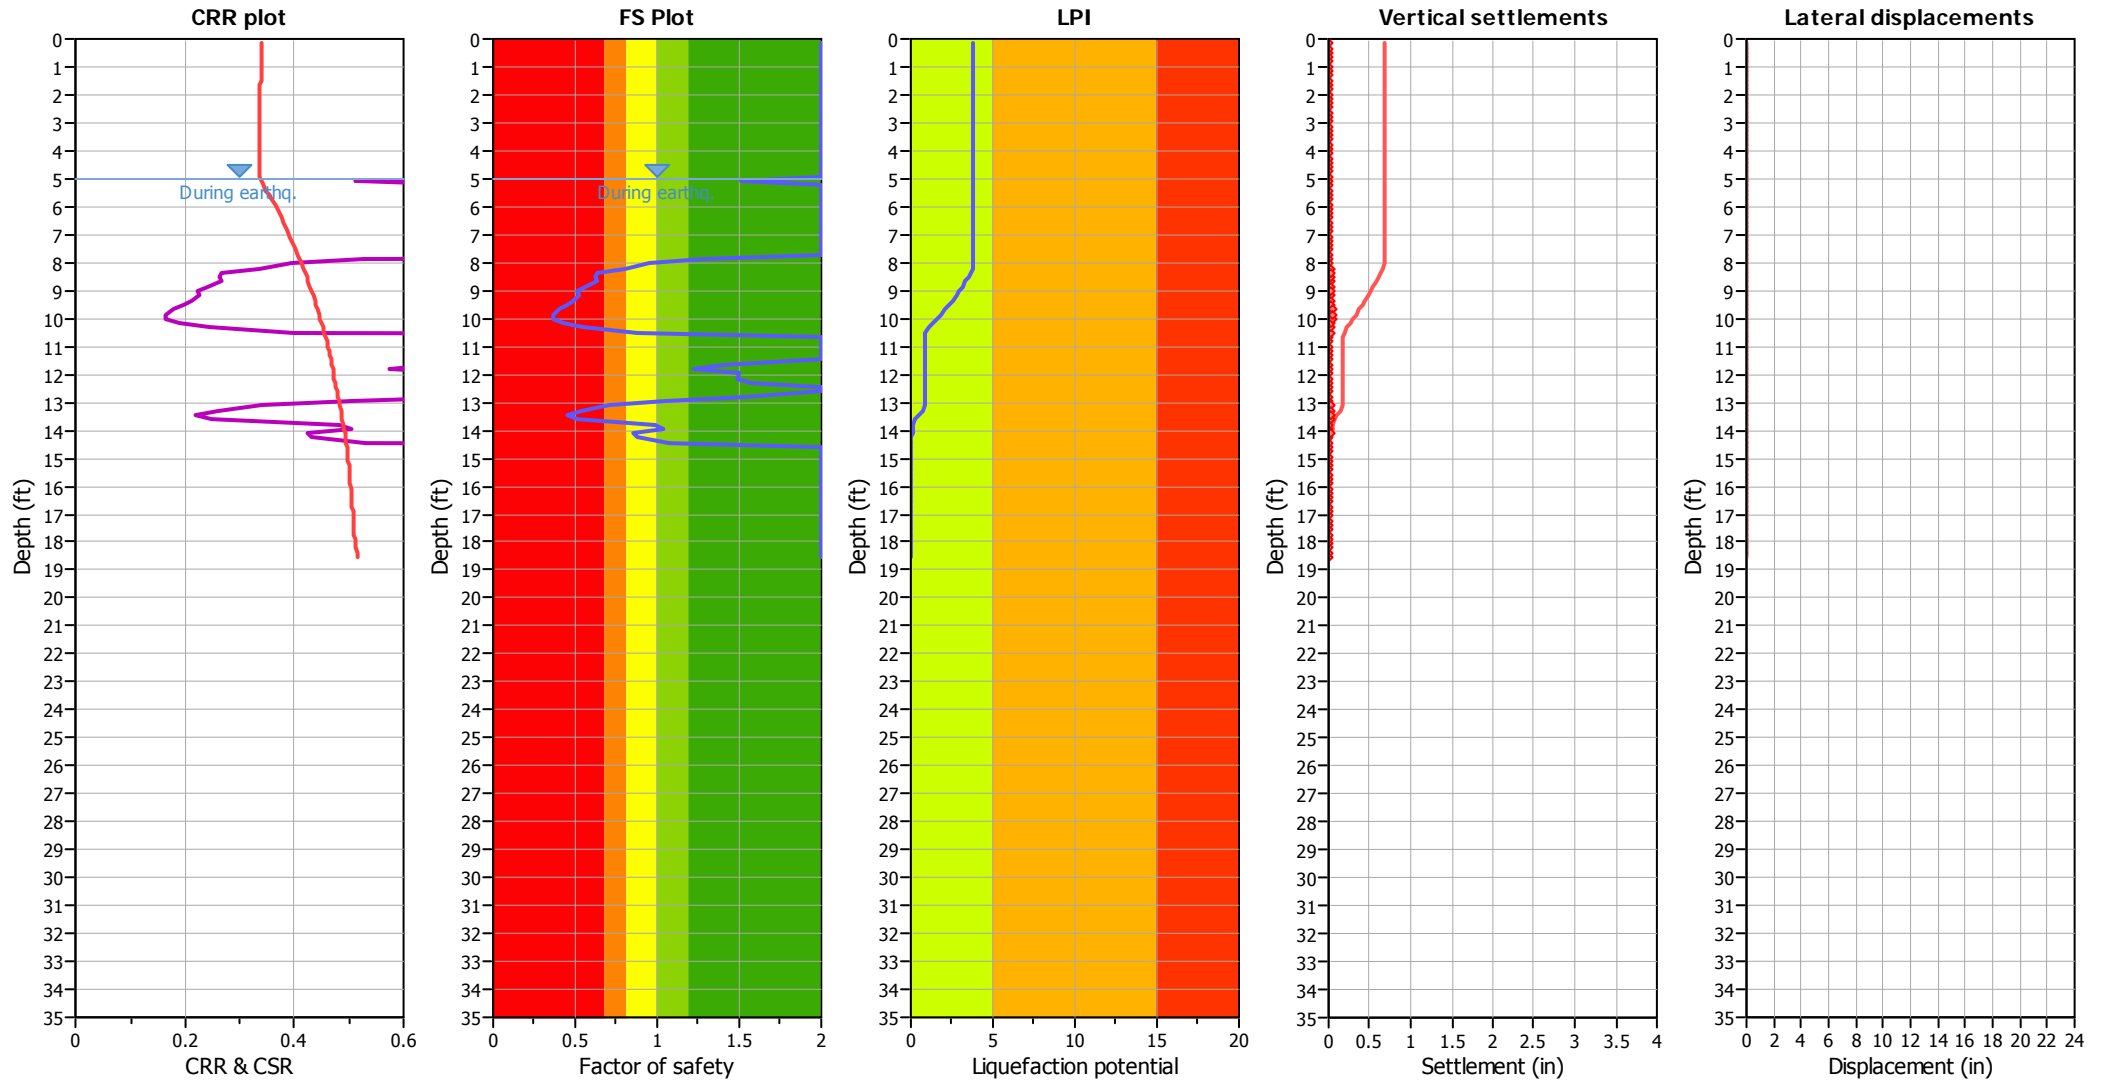
### Liquefaction analysis overall plots

**Input parameters and analysis data**

Analysis method:	Robertson (2009)	Depth to water table (earthq.):	5.00 ft	Fill weight:	N/A
Fines correction method:	Robertson (2009)	Average results interval:	1	Transition detect. applied:	Yes
Points to test:	Based on Ic value	Ic cut-off value:	2.60	$K_{\sigma}$ applied:	Yes
Earthquake magnitude $M_w$ :	6.80	Unit weight calculation:	Based on SBT	Clay like behavior applied:	All soils
Peak ground acceleration:	0.67	Use fill:	No	Limit depth applied:	No
Depth to water table (insitu):	7.00 ft	Fill height:	N/A	Limit depth:	N/A

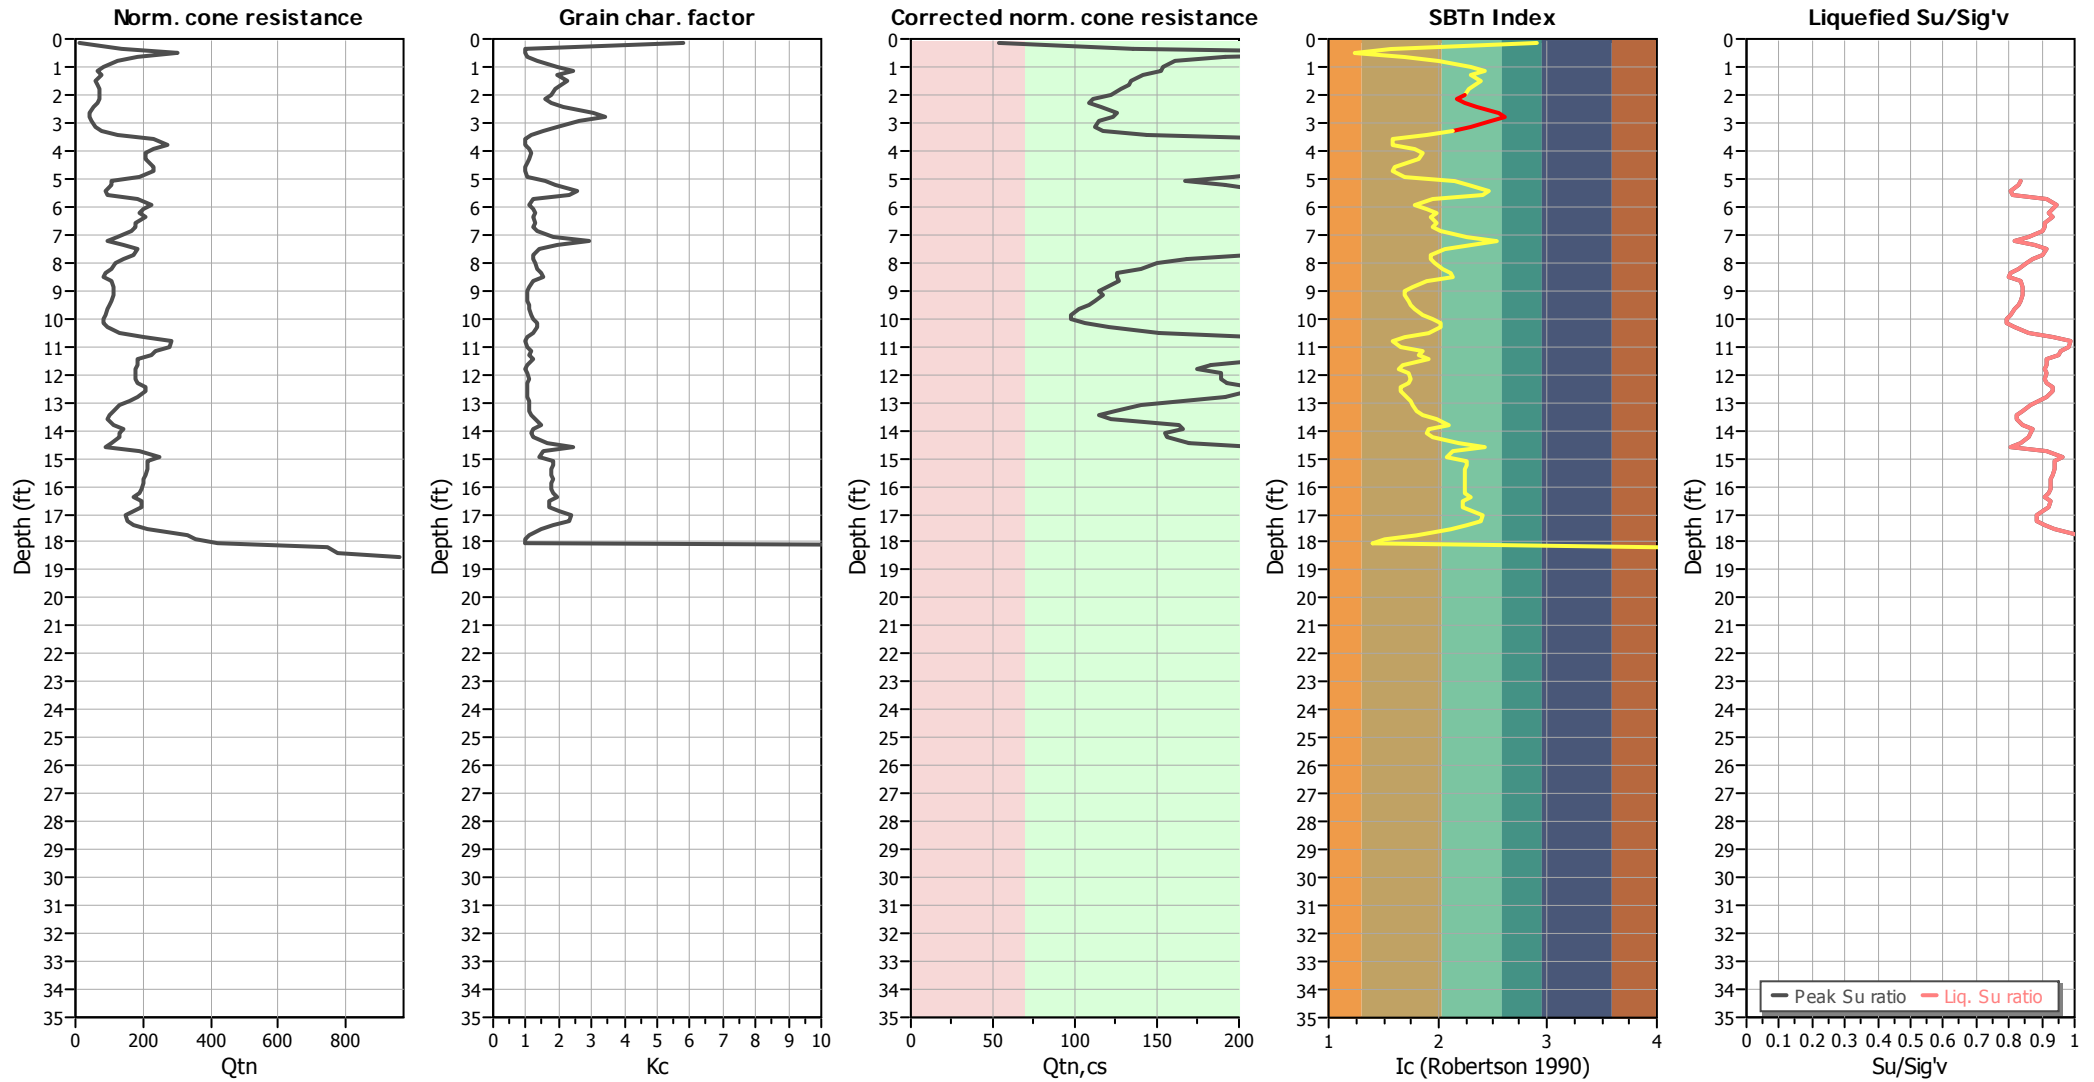
### Check for strength loss plots (Robertson (2010))

#### Input parameters and analysis data

Analysis method:	Robertson (2009)	Depth to water table (erthq.):	5.00 ft	Fill weight:	N/A
Fines correction method:	Robertson (2009)	Average results interval:	1	Transition detect. applied:	Yes
Points to test:	Based on Ic value	Ic cut-off value:	2.60	$K_{cs}$ applied:	Yes
Earthquake magnitude $M_w$ :	6.80	Unit weight calculation:	Based on SBT	Clay like behavior applied:	All soils
Peak ground acceleration:	0.67	Use fill:	No	Limit depth applied:	No
Depth to water table (insitu):	7.00 ft	Fill height:	N/A	Limit depth:	N/A

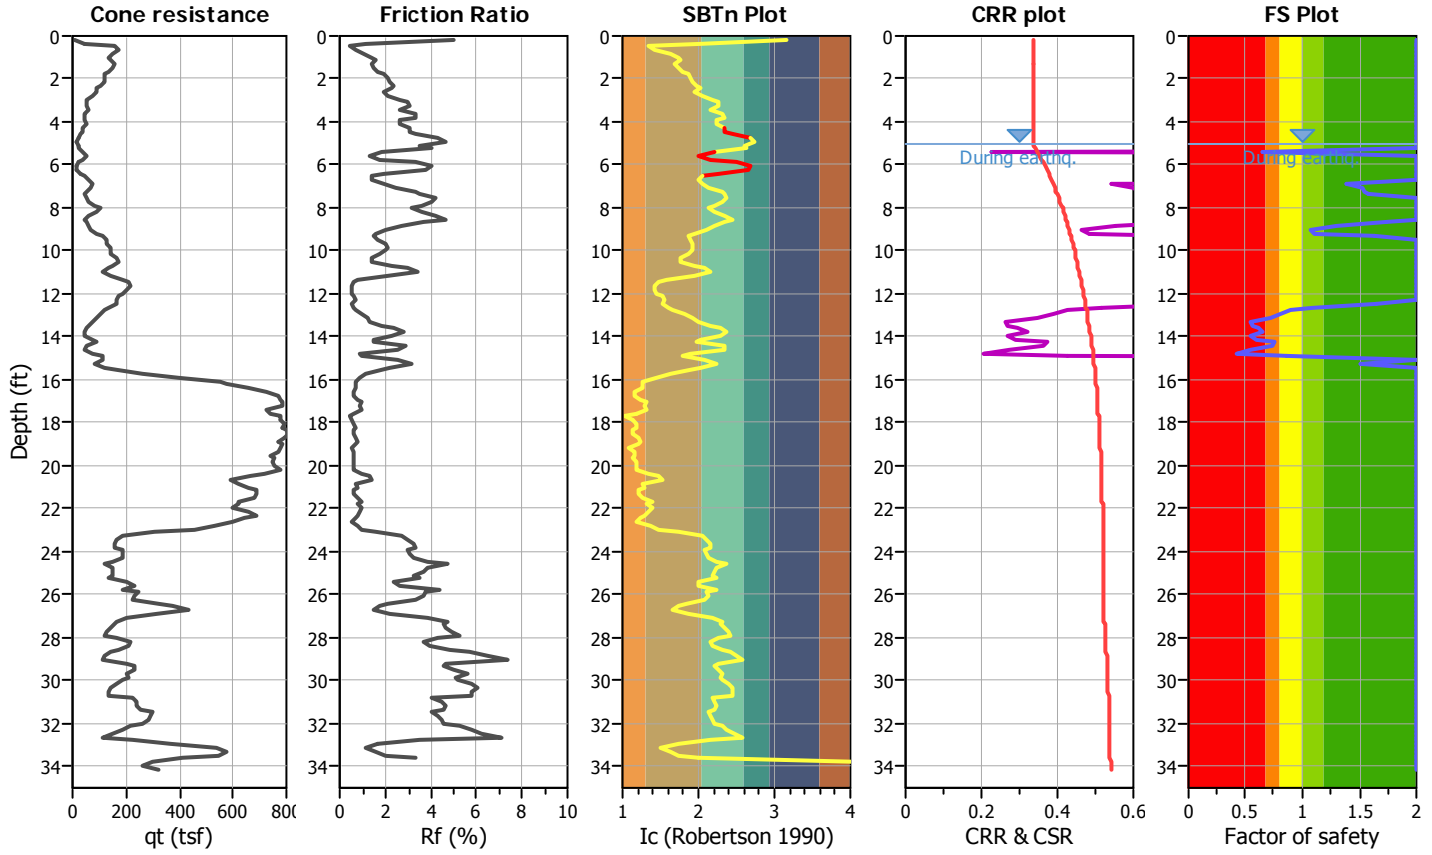
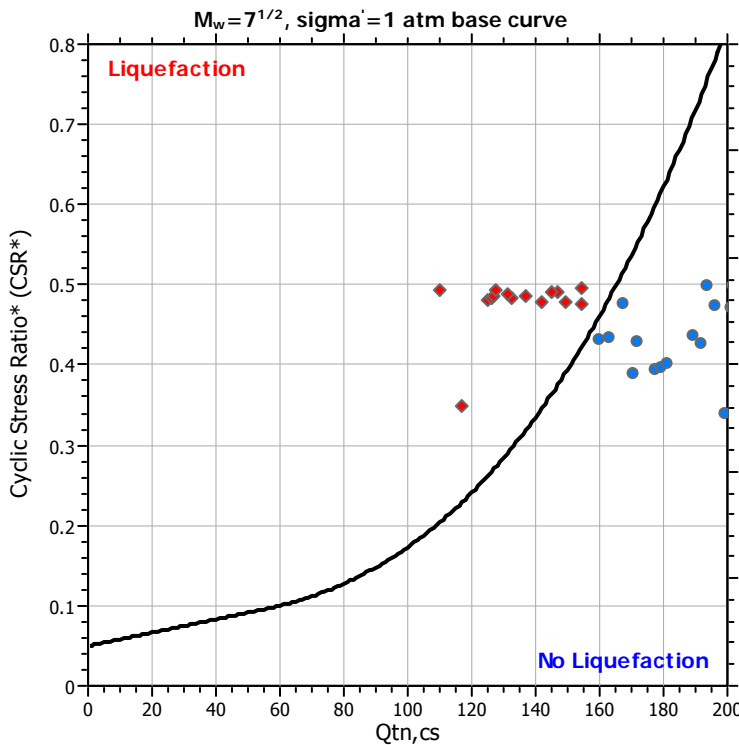
Input parameters and analysis data

Analysis method:	Robertson (2009)	G.W.T. (in-situ):	7.00 ft	Use fill:	No	Clay like behavior applied:	All soils
Fines correction method:	Robertson (2009)	G.W.T. (earthq.):	5.00 ft	Fill height:	N/A	Limit depth applied:	No
Points to test:	Based on Ic value	Average results interval:	1	Fill weight:	N/A	Limit depth:	N/A
Earthquake magnitude $M_w$ :	6.80	Ic cut-off value:	2.60	Trans. detect. applied:	Yes	MSF method:	Method based
Peak ground acceleration:	0.67	Unit weight calculation:	Based on SBT	$K_0$ applied:	Yes

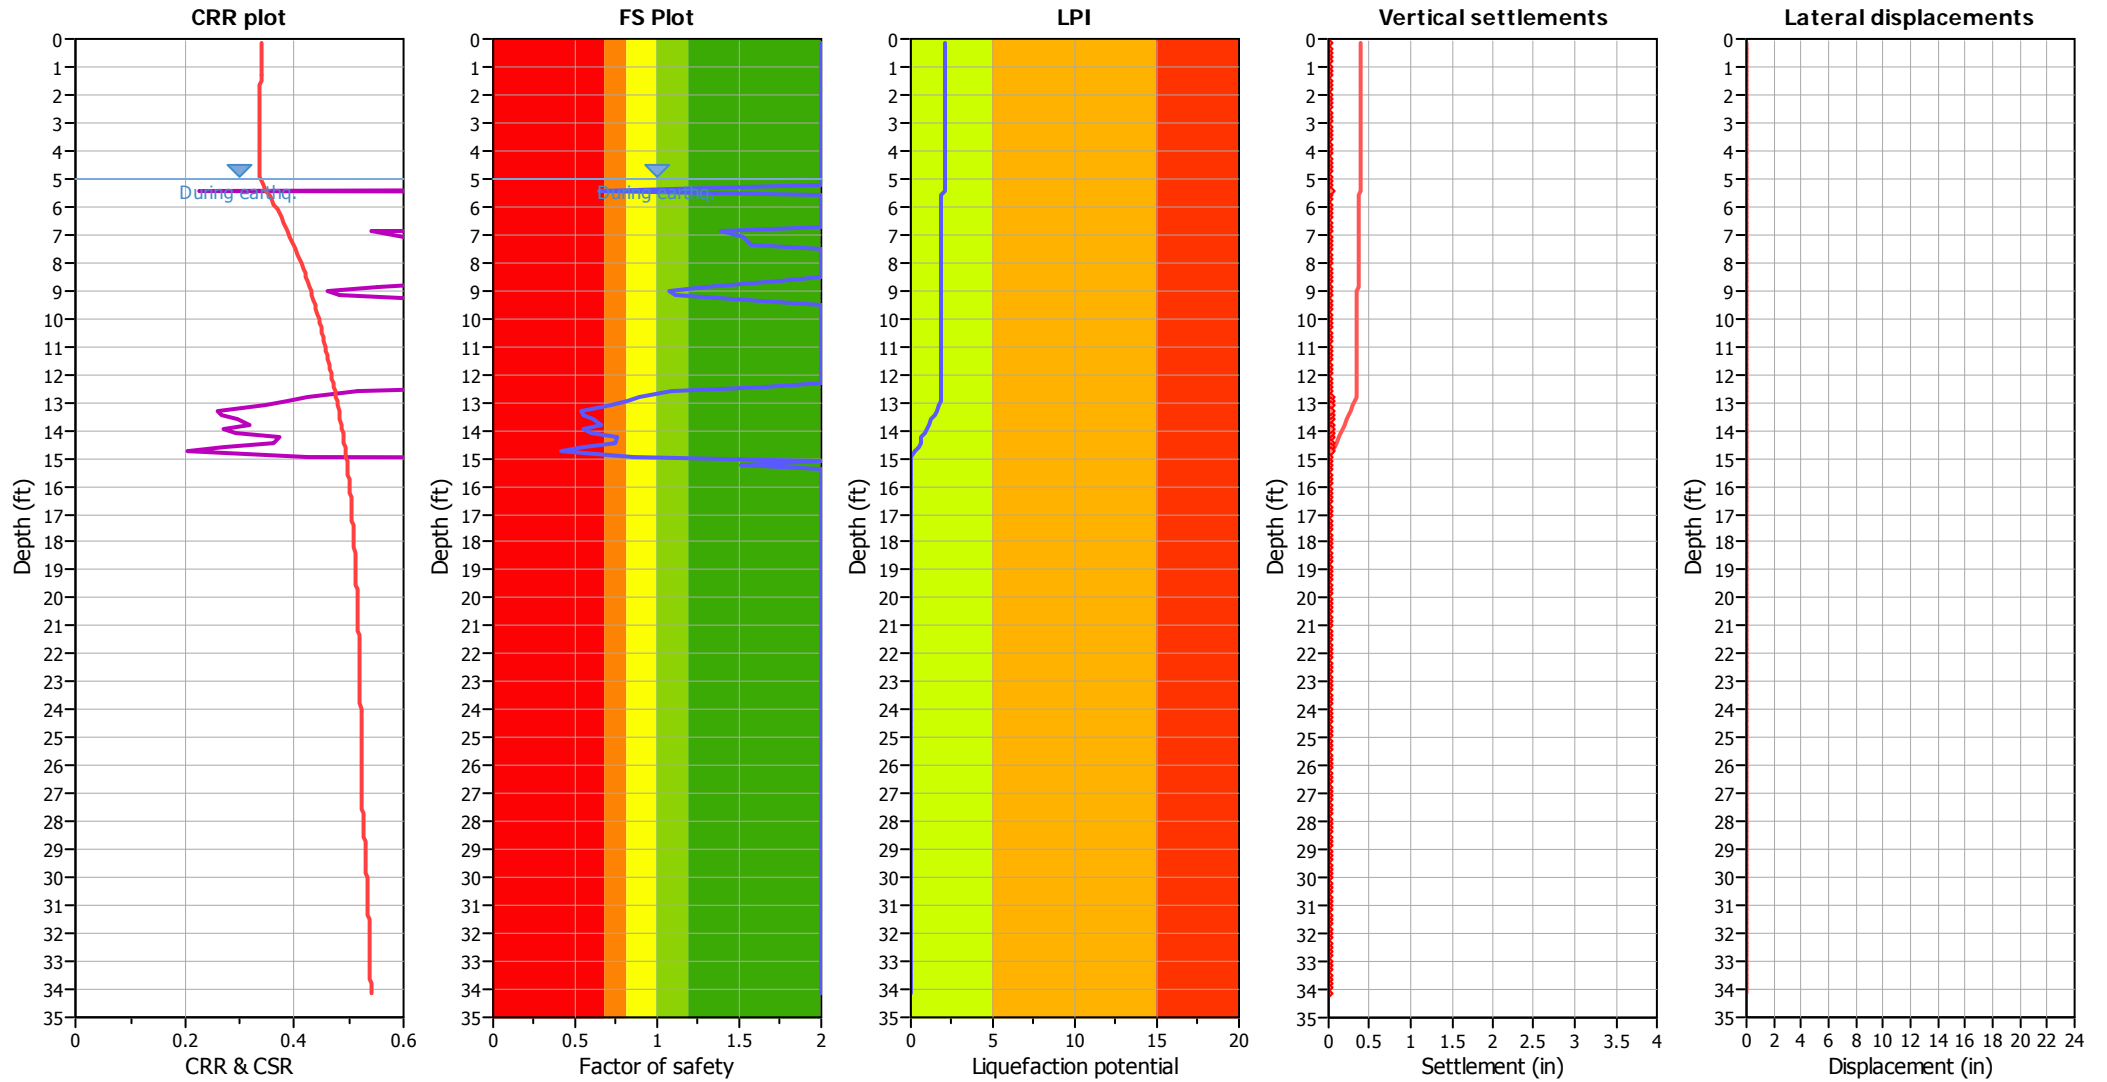
### Liquefaction analysis overall plots

#### Input parameters and analysis data

Analysis method:	Robertson (2009)	Depth to water table (earthq.):	5.00 ft	Fill weight:	N/A
Fines correction method:	Robertson (2009)	Average results interval:	1	Transition detect. applied:	Yes
Points to test:	Based on Ic value	Ic cut-off value:	2.60	$K_{\sigma}$ applied:	Yes
Earthquake magnitude $M_w$ :	6.80	Unit weight calculation:	Based on SBT	Clay like behavior applied:	All soils
Peak ground acceleration:	0.67	Use fill:	No	Limit depth applied:	No
Depth to water table (insitu):	7.00 ft	Fill height:	N/A	Limit depth:	N/A

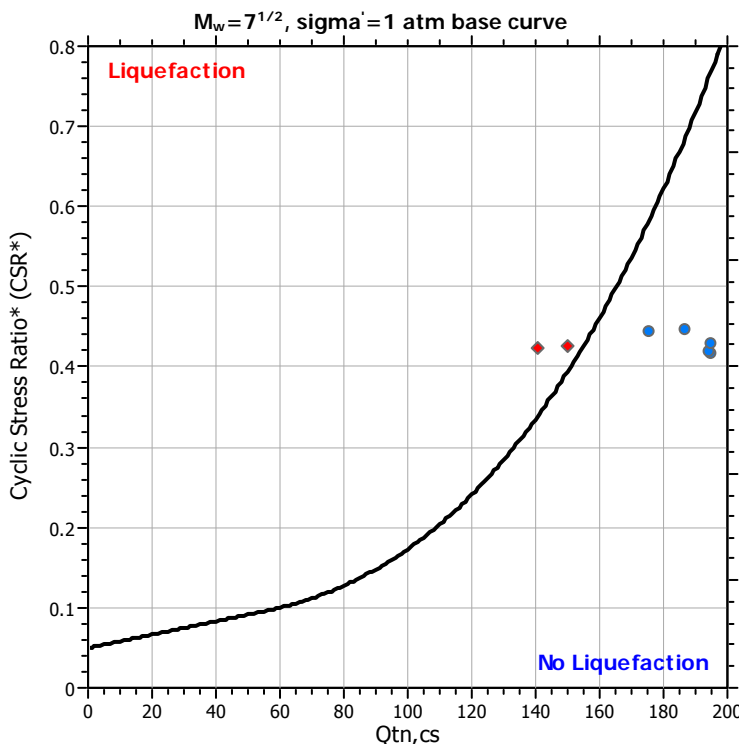
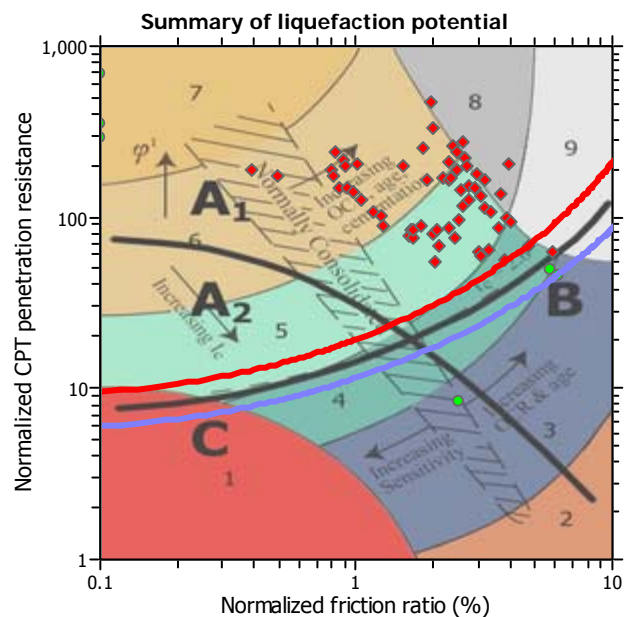
Input parameters and analysis data

Analysis method:	Robertson (2009)	G.W.T. (in-situ):	8.00 ft	Use fill:	No	Clay like behavior applied:	All soils
Fines correction method:	Robertson (2009)	G.W.T. (earthq.):	5.00 ft	Fill height:	N/A	Limit depth applied:	No
Points to test:	Based on Ic value	Average results interval:	1	Fill weight:	N/A	Limit depth:	N/A
Earthquake magnitude $M_w$ :	6.80	Ic cut-off value:	2.60	Trans. detect. applied:	Yes	MSF method:	Method based
Peak ground acceleration:	0.67	Unit weight calculation:	Based on SBT	$K_0$ applied:	Yes

Zone A<sub>1</sub>: Cyclic liquefaction likely depending on size and duration of cyclic loading  
 Zone A<sub>2</sub>: Cyclic liquefaction and strength loss likely depending on loading and ground geometry  
 Zone B: Liquefaction and post-earthquake strength loss unlikely, check cyclic softening  
 Zone C: Cyclic liquefaction and strength loss possible depending on soil plasticity, brittleness/sensitivity, strain to peak undrained strength and ground geometry

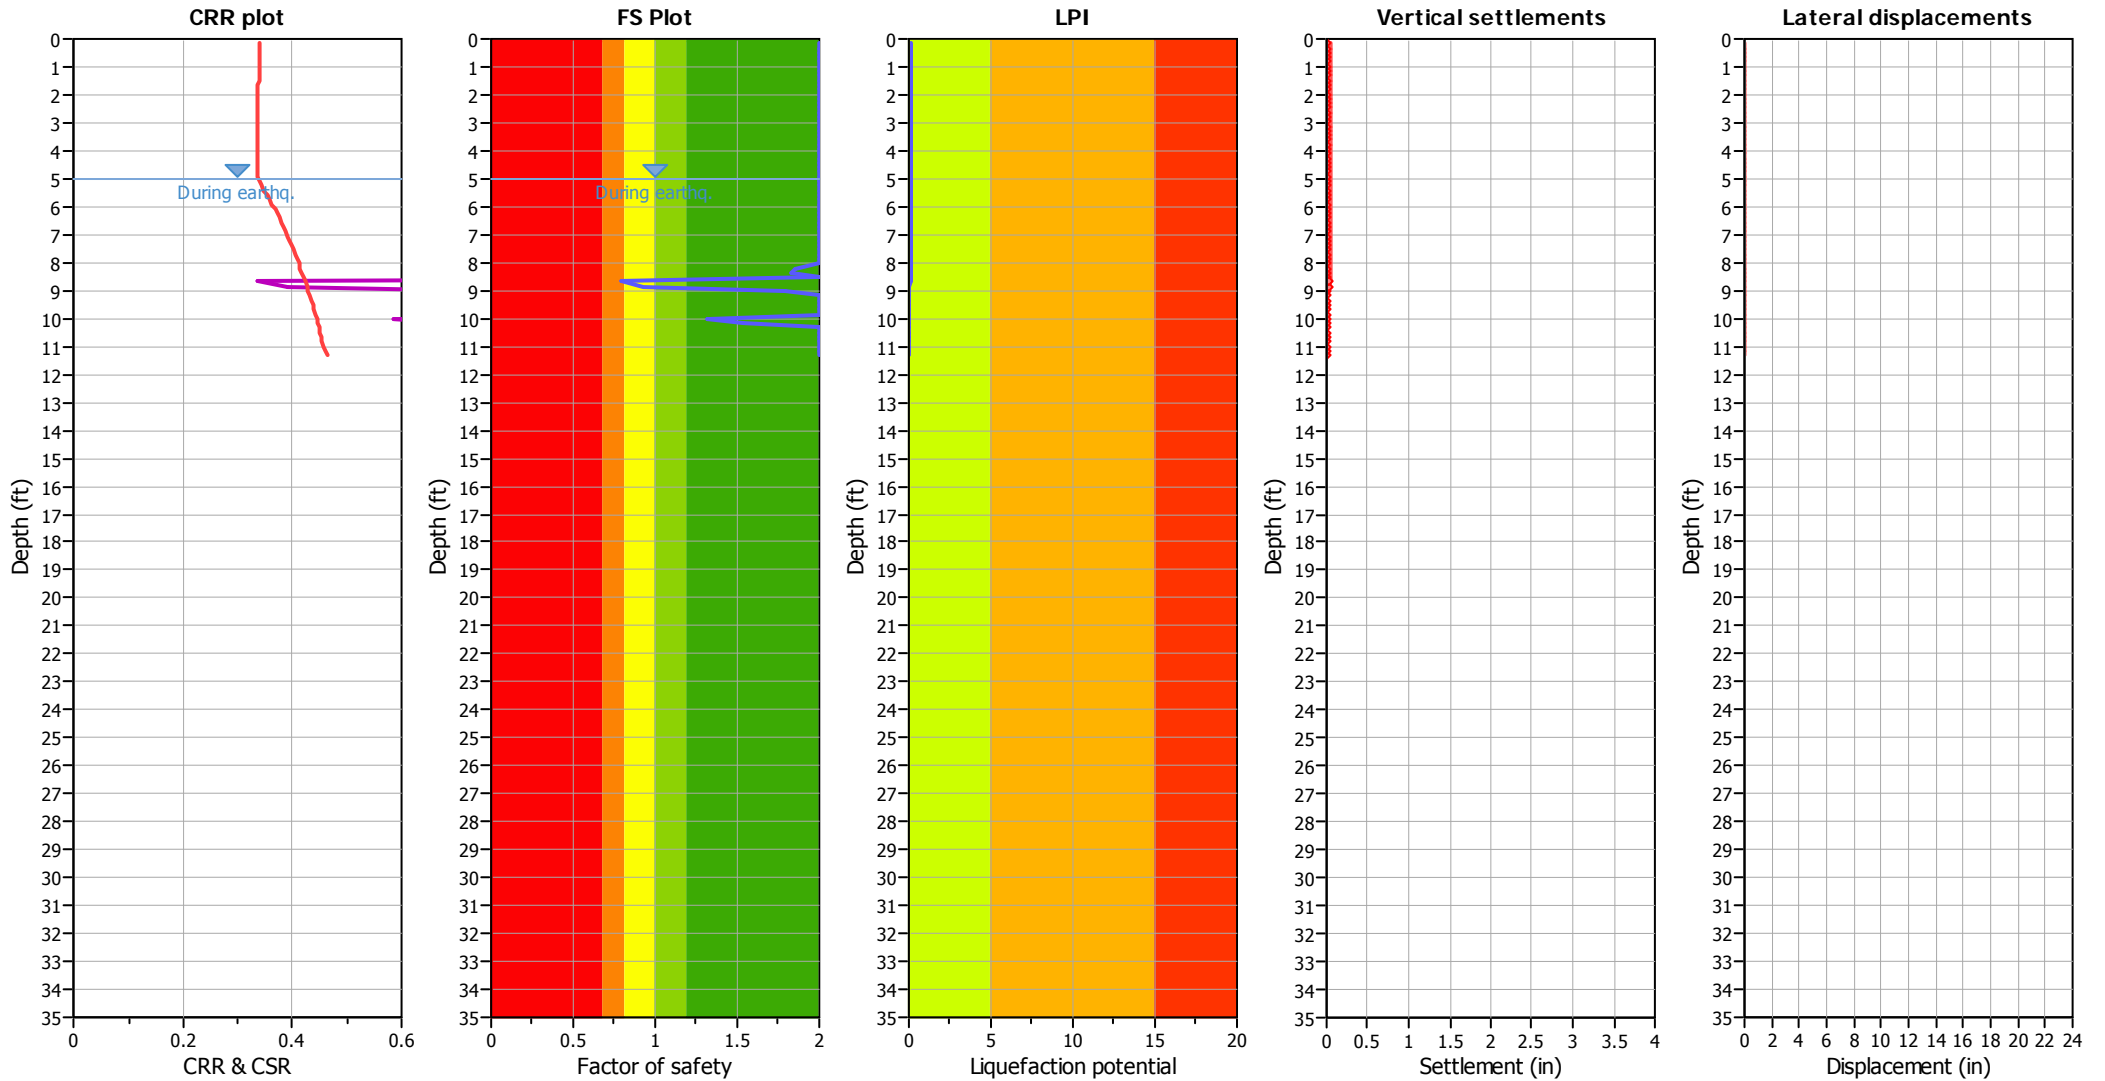
### Liquefaction analysis overall plots

#### Input parameters and analysis data

Analysis method:	Robertson (2009)	Depth to water table (earthq.):	5.00 ft	Fill weight:	N/A
Fines correction method:	Robertson (2009)	Average results interval:	1	Transition detect. applied:	Yes
Points to test:	Based on Ic value	Ic cut-off value:	2.60	K <sub>σ</sub> applied:	Yes
Earthquake magnitude M <sub>w</sub> :	6.80	Unit weight calculation:	Based on SBT	Clay like behavior applied:	All soils
Peak ground acceleration:	0.67	Use fill:	No	Limit depth applied:	No
Depth to water table (insitu):	8.00 ft	Fill height:	N/A	Limit depth:	N/A
