## PRELIMINARY GEOTECHNICAL INVESTIGATION

**Preliminary Geotechnical Investigation,  
Dana Point Harbor Revitalization,  
Hotel Component,  
City of Dana Point, California**

September 10, 2019

GMU Project No. 17-206-01

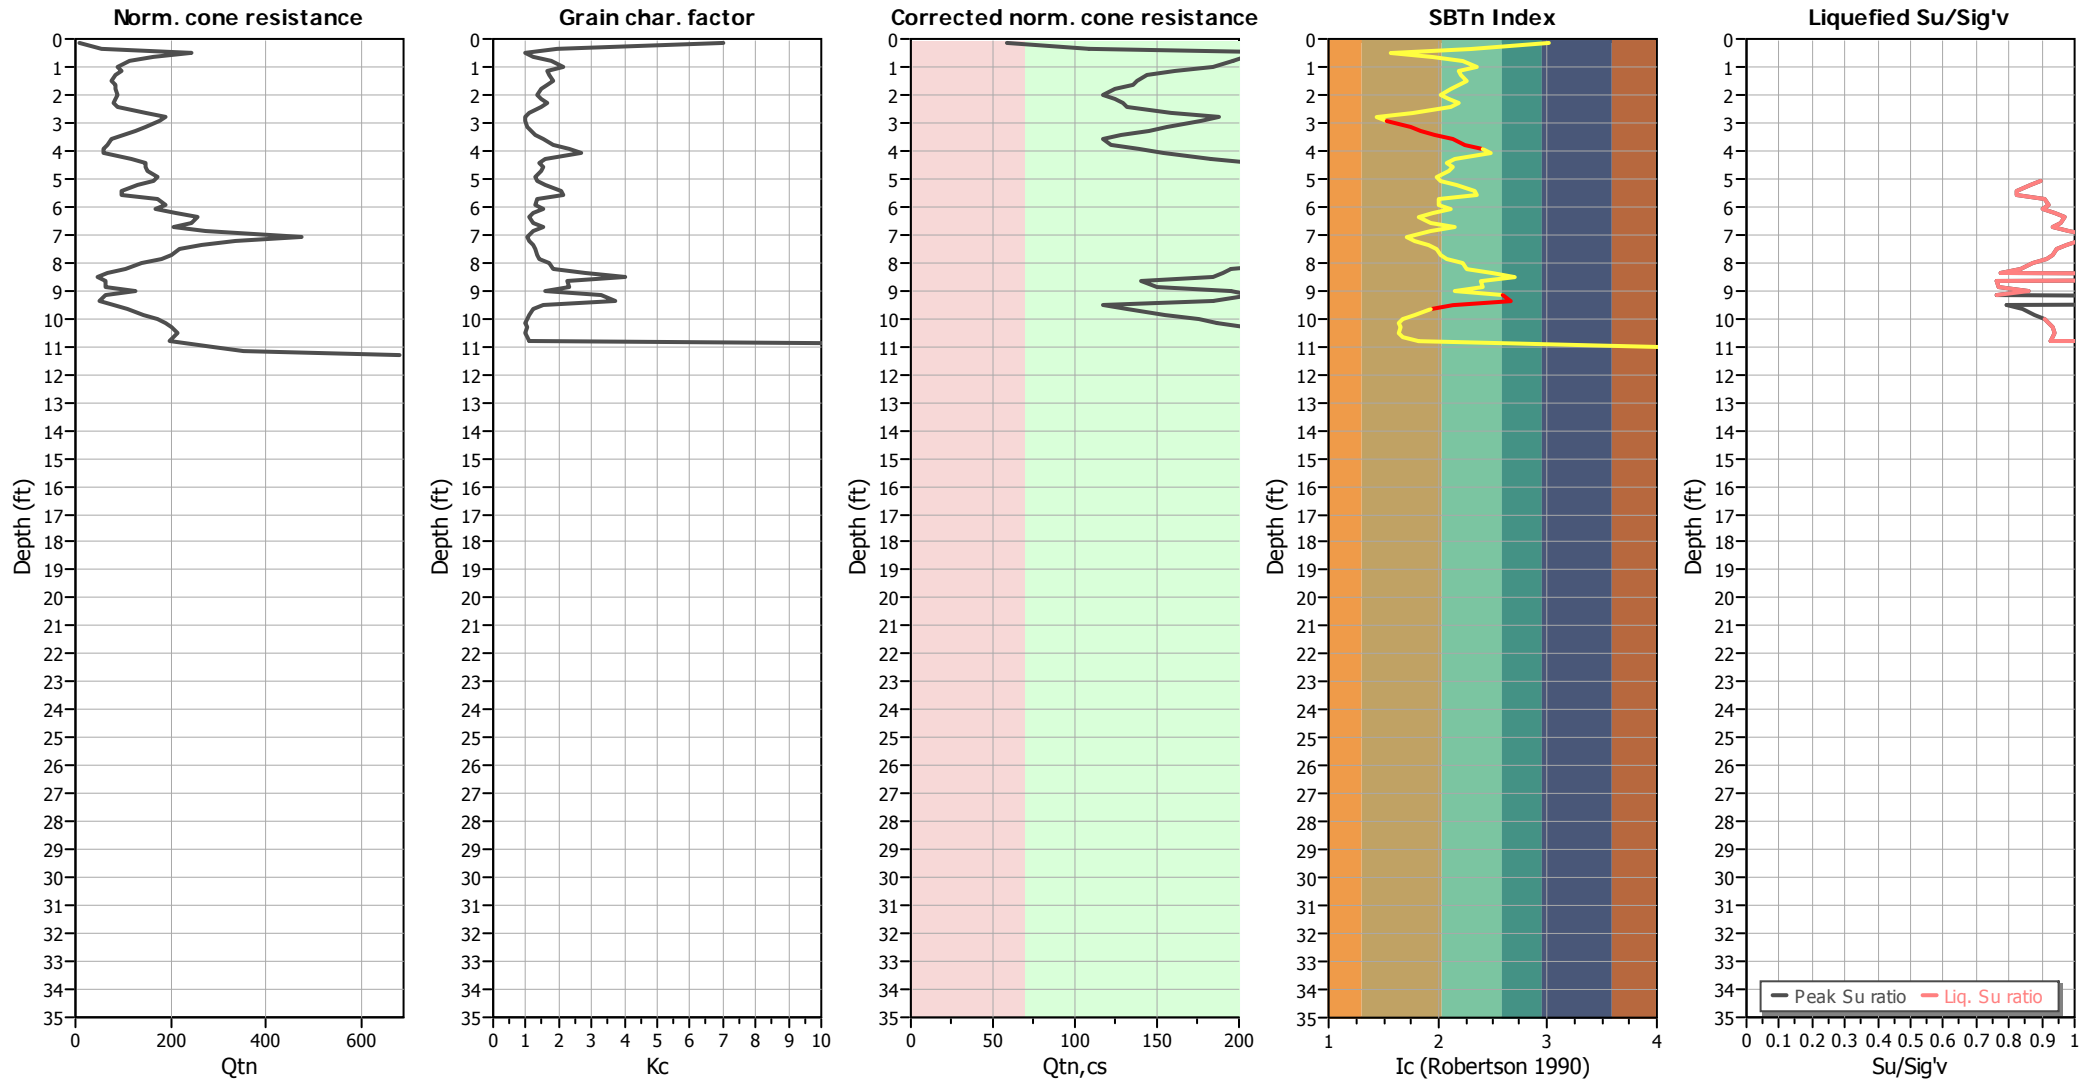
### Check for strength loss plots (Robertson (2010))

#### Input parameters and analysis data

Analysis method:	Robertson (2009)	Depth to water table (erthq.):	5.00 ft	Fill weight:	N/A
Fines correction method:	Robertson (2009)	Average results interval:	1	Transition detect. applied:	Yes
Points to test:	Based on Ic value	Ic cut-off value:	2.60	K <sub>cs</sub> applied:	Yes
Earthquake magnitude M <sub>w</sub> :	6.80	Unit weight calculation:	Based on SBT	Clay like behavior applied:	All soils
Peak ground acceleration:	0.67	Use fill:	No	Limit depth applied:	No
Depth to water table (insitu):	8.00 ft	Fill height:	N/A	Limit depth:	N/A

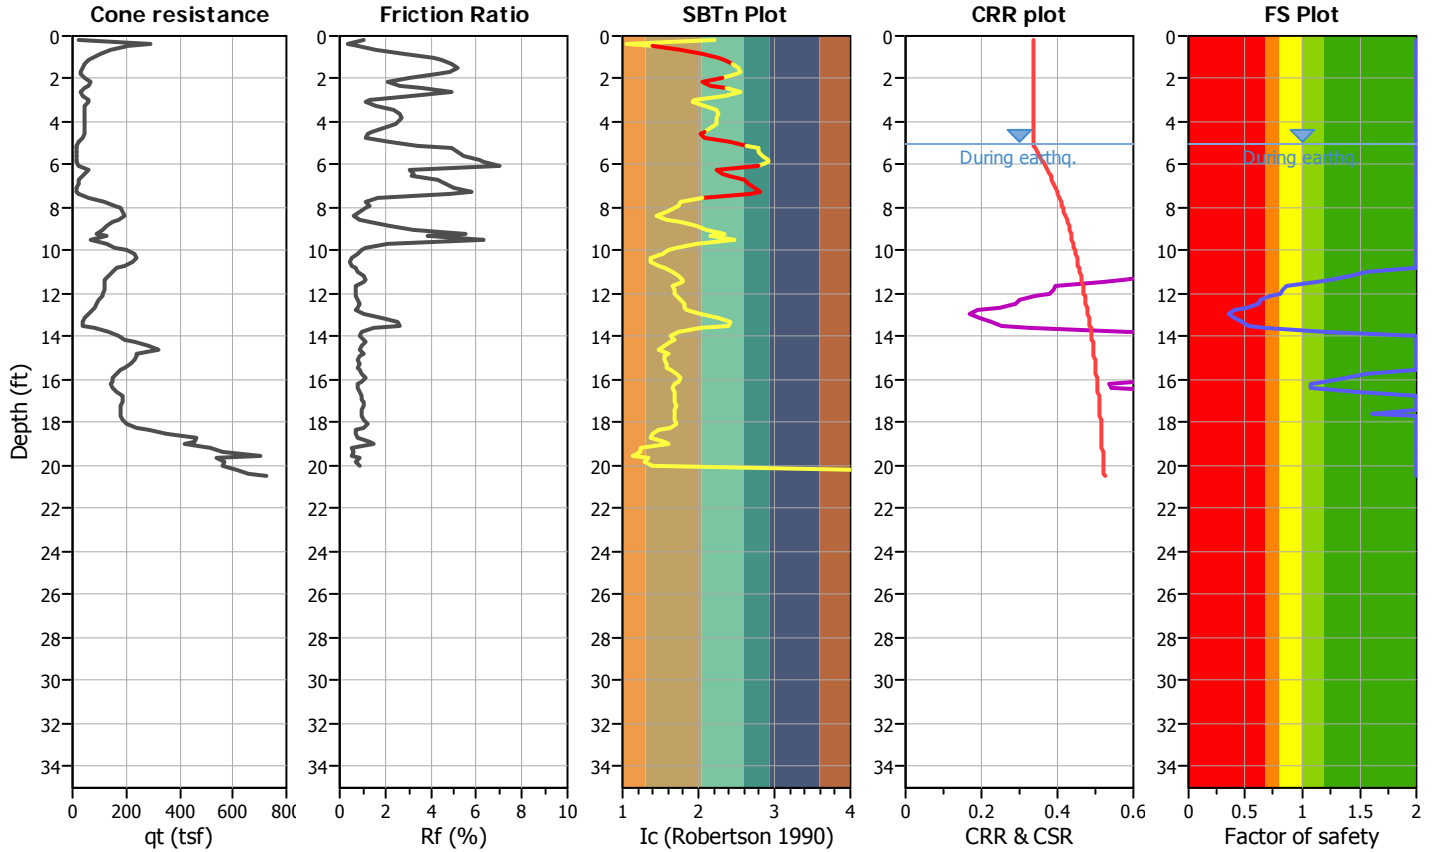
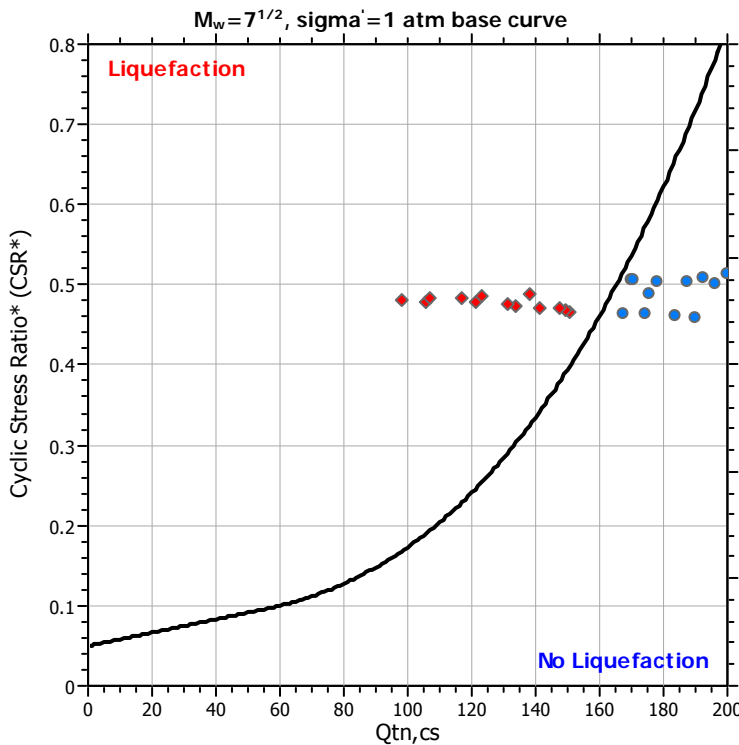
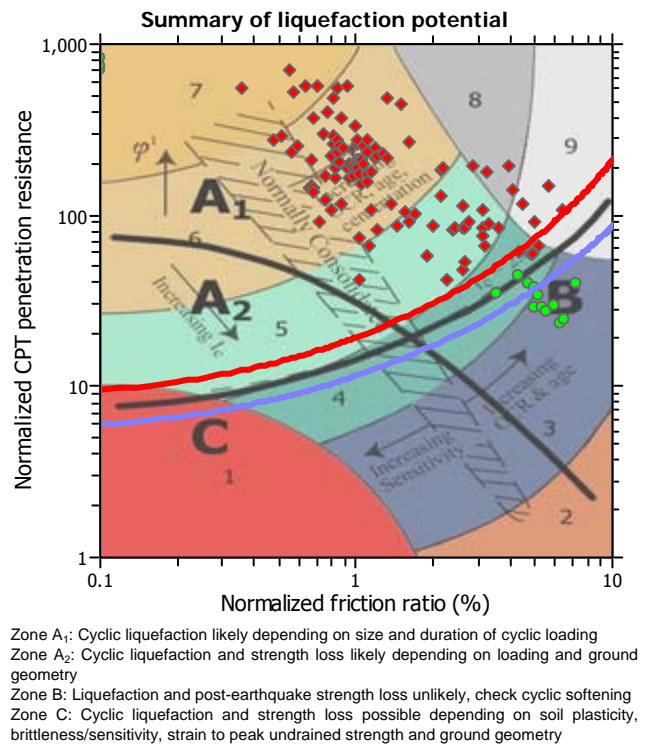
Input parameters and analysis data

Analysis method:	Robertson (2009)	G.W.T. (in-situ):	8.00 ft	Use fill:	No	Clay like behavior applied:	All soils
Fines correction method:	Robertson (2009)	G.W.T. (earthq.):	5.00 ft	Fill height:	N/A	Limit depth applied:	No
Points to test:	Based on Ic value	Average results interval:	1	Fill weight:	N/A	Limit depth:	N/A
Earthquake magnitude $M_w$ :	6.80	Ic cut-off value:	2.60	Trans. detect. applied:	Yes	MSF method:	Method based
Peak ground acceleration:	0.67	Unit weight calculation:	Based on SBT	$K_0$ applied:	Yes

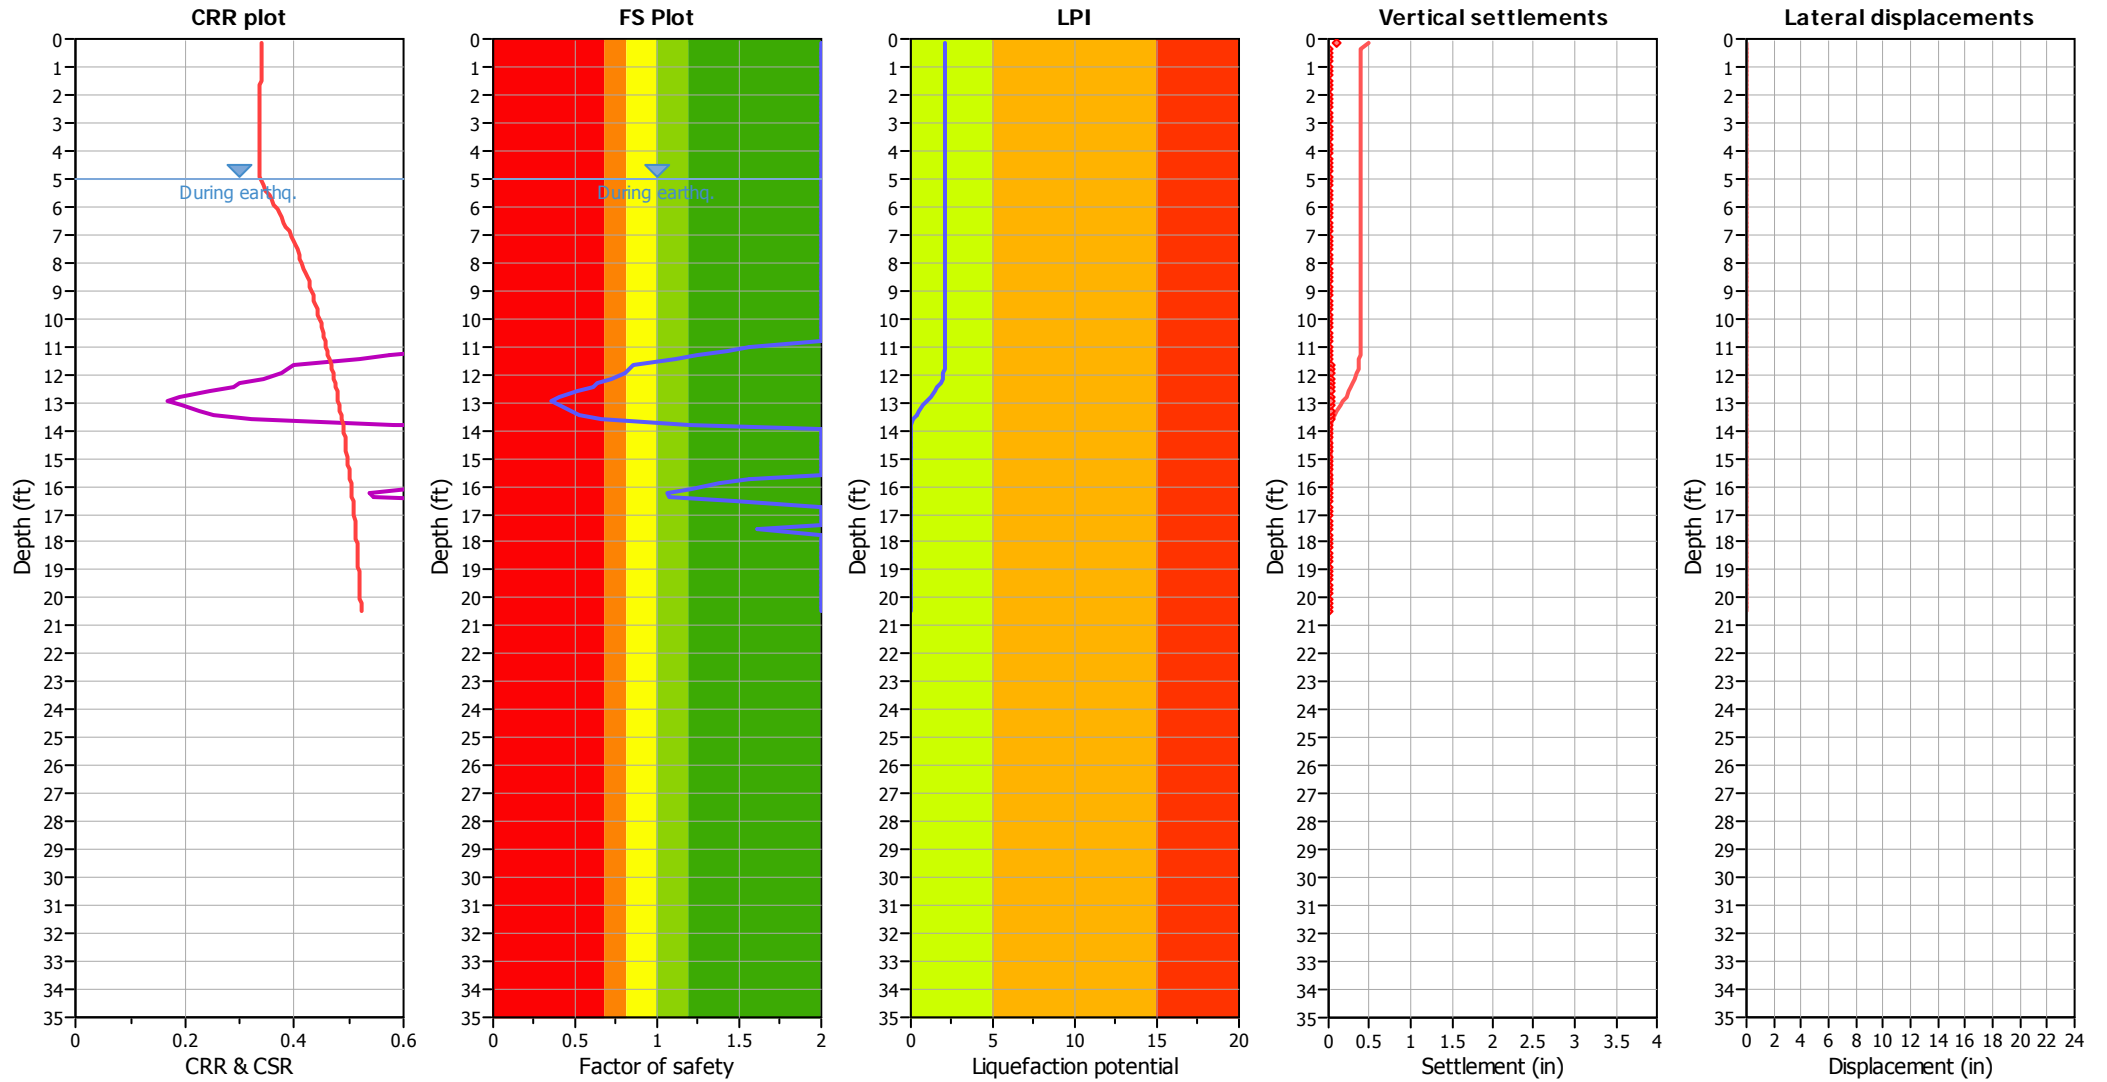
### Liquefaction analysis overall plots

**Input parameters and analysis data**

Analysis method:	Robertson (2009)	Depth to water table (earthq.):	5.00 ft	Fill weight:	N/A
Fines correction method:	Robertson (2009)	Average results interval:	1	Transition detect. applied:	Yes
Points to test:	Based on Ic value	Ic cut-off value:	2.60	$K_{\sigma}$ applied:	Yes
Earthquake magnitude $M_w$ :	6.80	Unit weight calculation:	Based on SBT	Clay like behavior applied:	All soils
Peak ground acceleration:	0.67	Use fill:	No	Limit depth applied:	No
Depth to water table (insitu):	8.00 ft	Fill height:	N/A	Limit depth:	N/A

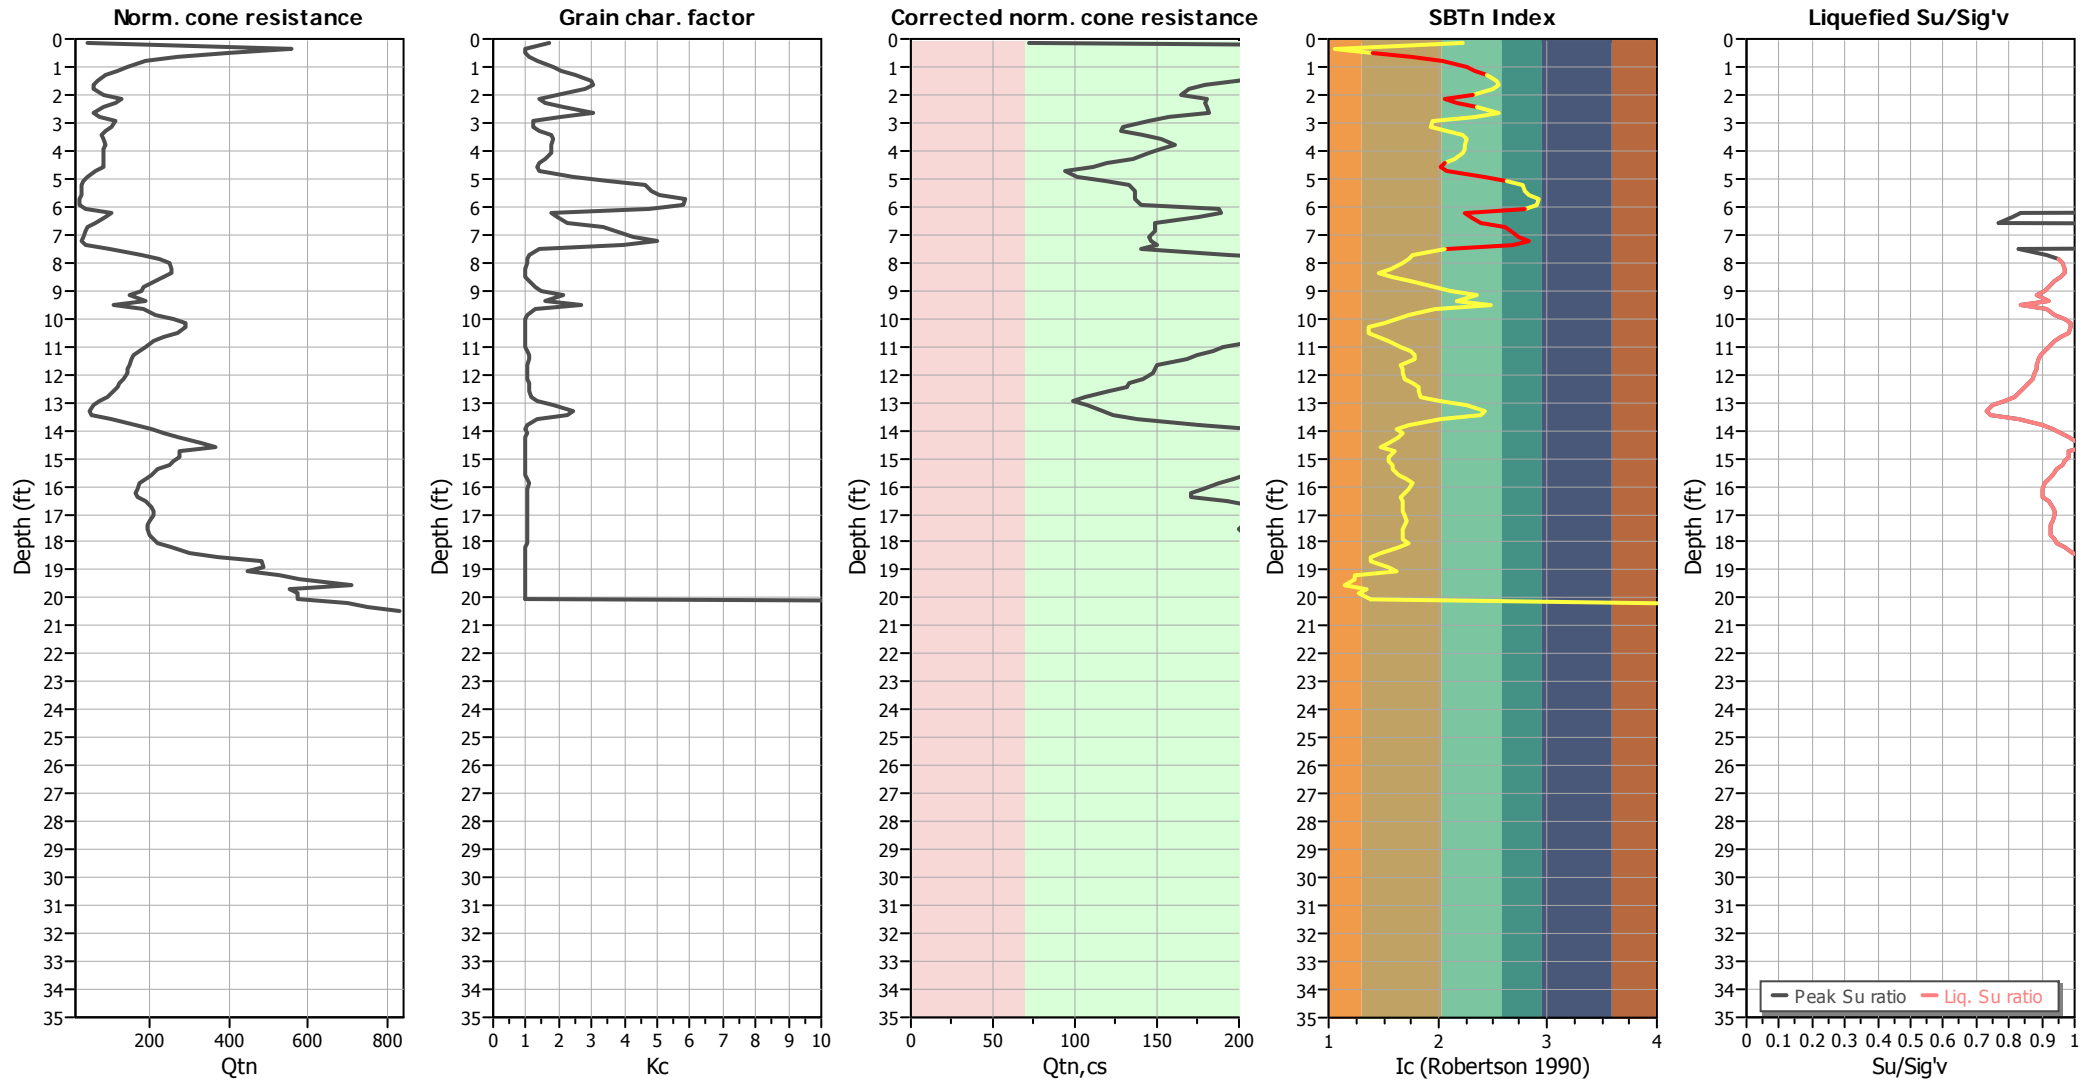
### Check for strength loss plots (Robertson (2010))

#### Input parameters and analysis data

Analysis method:	Robertson (2009)	Depth to water table (erthq.):	5.00 ft	Fill weight:	N/A
Fines correction method:	Robertson (2009)	Average results interval:	1	Transition detect. applied:	Yes
Points to test:	Based on Ic value	Ic cut-off value:	2.60	K <sub>cs</sub> applied:	Yes
Earthquake magnitude M <sub>w</sub> :	6.80	Unit weight calculation:	Based on SBT	Clay like behavior applied:	All soils
Peak ground acceleration:	0.67	Use fill:	No	Limit depth applied:	No
Depth to water table (insitu):	8.00 ft	Fill height:	N/A	Limit depth:	N/A

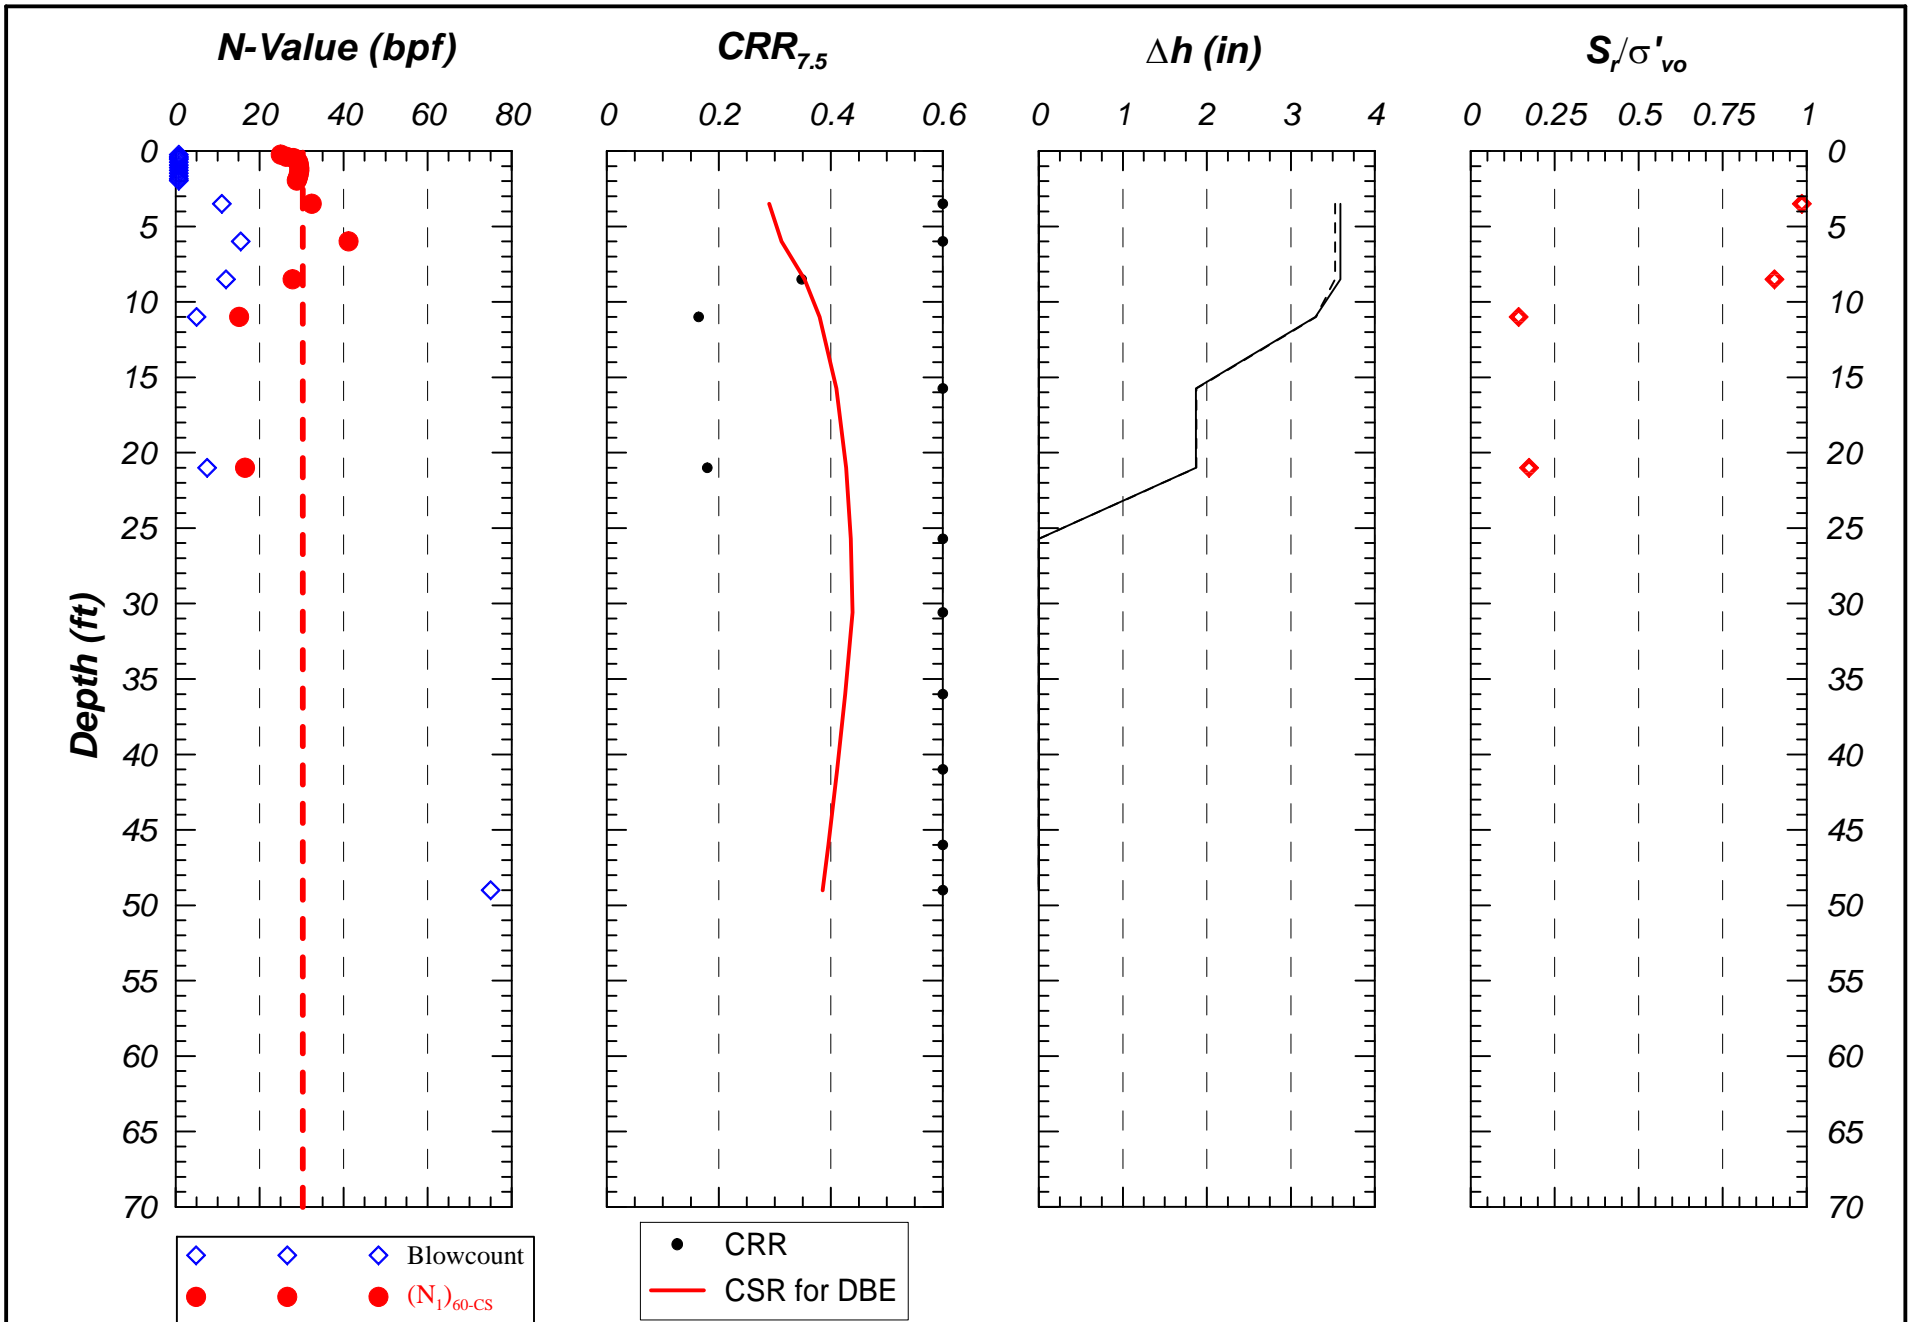
Project Name Dana Point Harbor Hotel Component	<b>Integrated SPT Method for Estimating          Subsurface Stratification &amp; Liquefaction</b> <b>Drill Hole DH-1</b>	<b>Figure D-1</b>
	Project No. 17-206-01

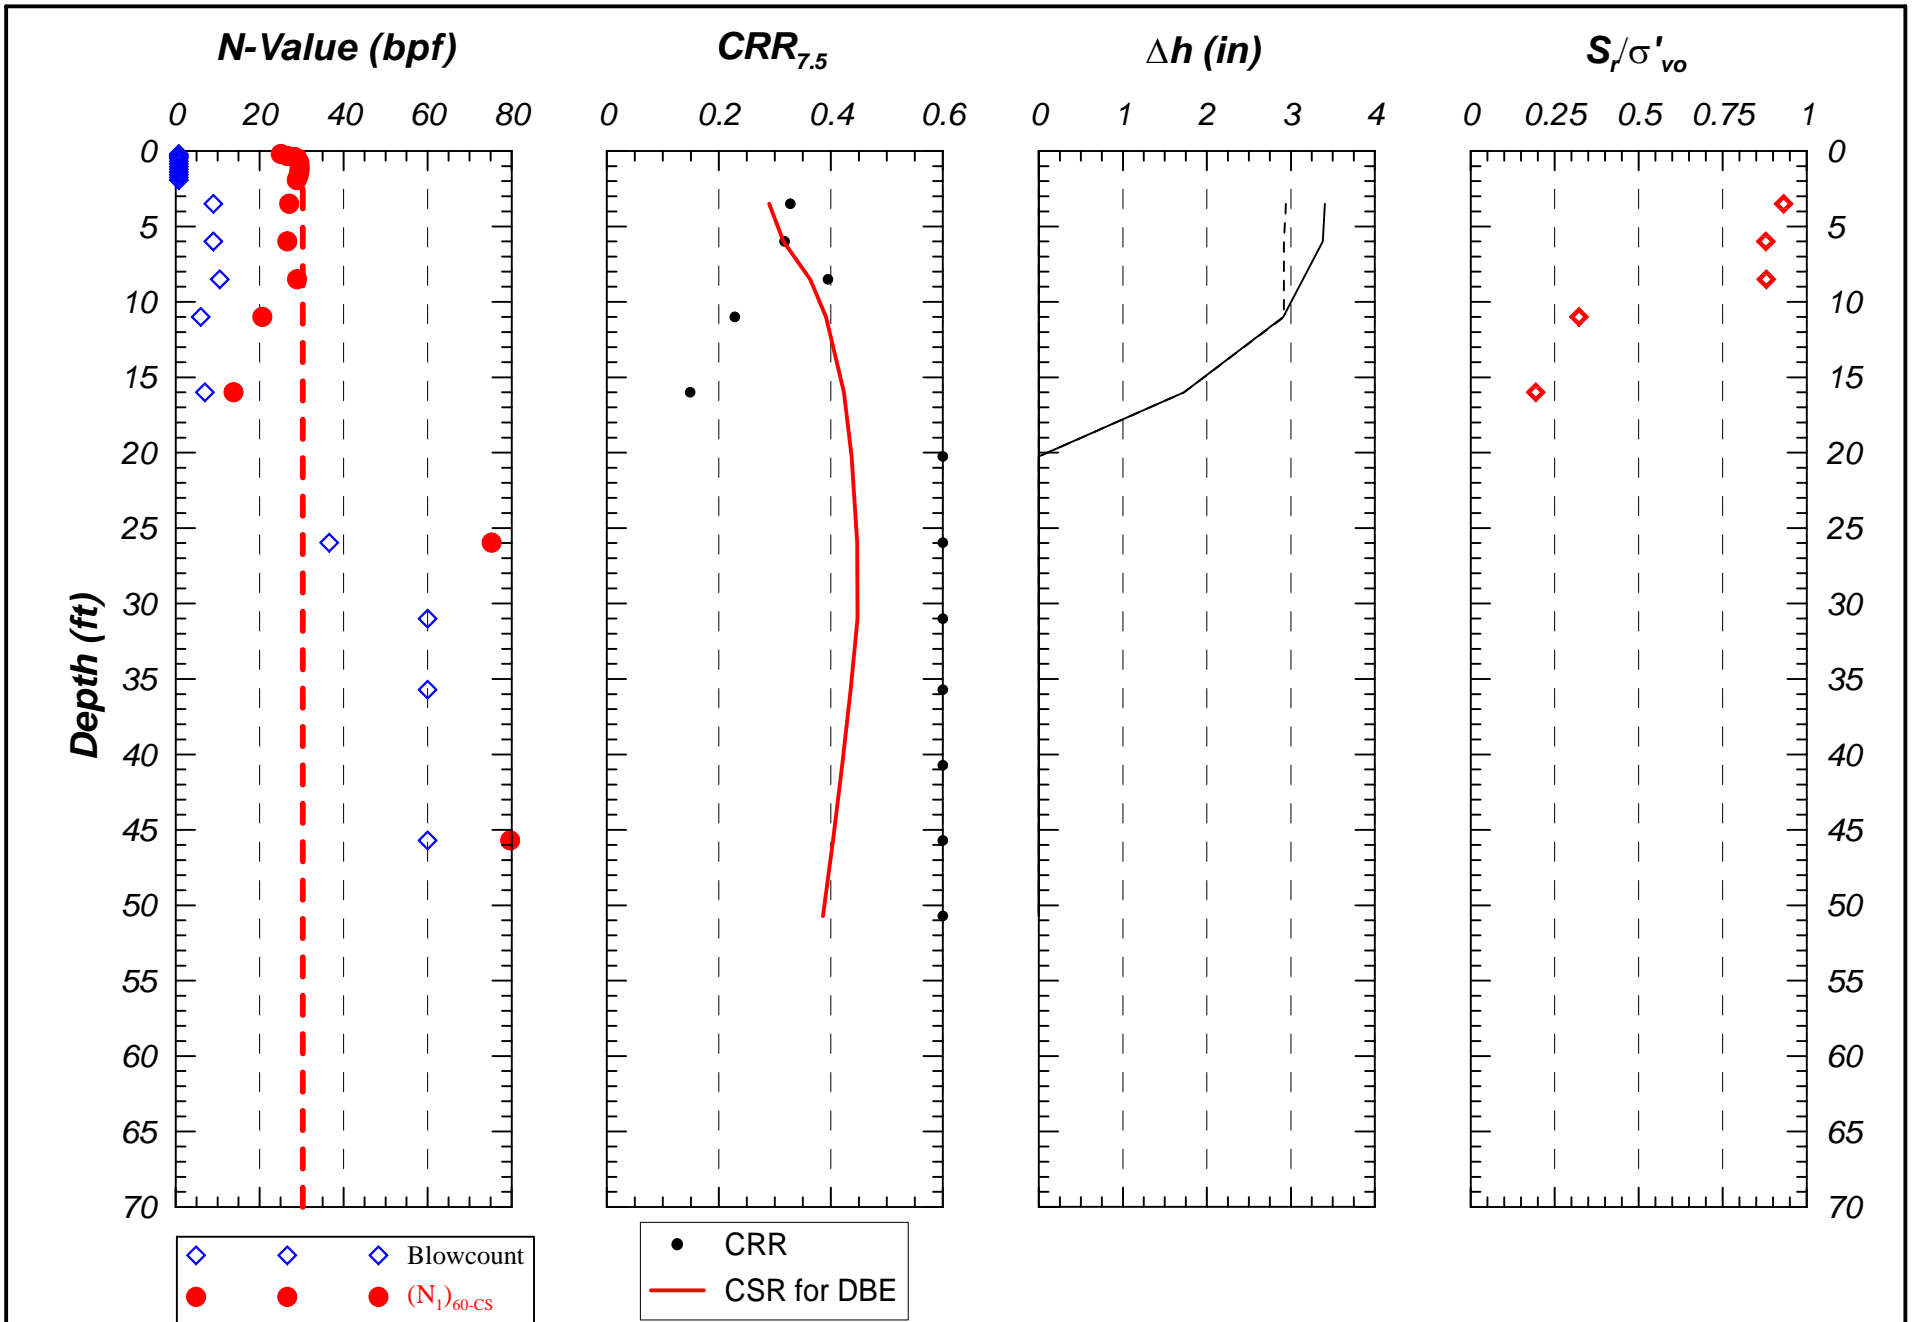
Project Name Dana Point Harbor Hotel Component	<b>Integrated SPT Method for Estimating          Subsurface Stratification &amp; Liquefaction</b> <b>Drill Hole DH-6</b>	<b>Figure D-2</b>
	Project No. 17-206-01

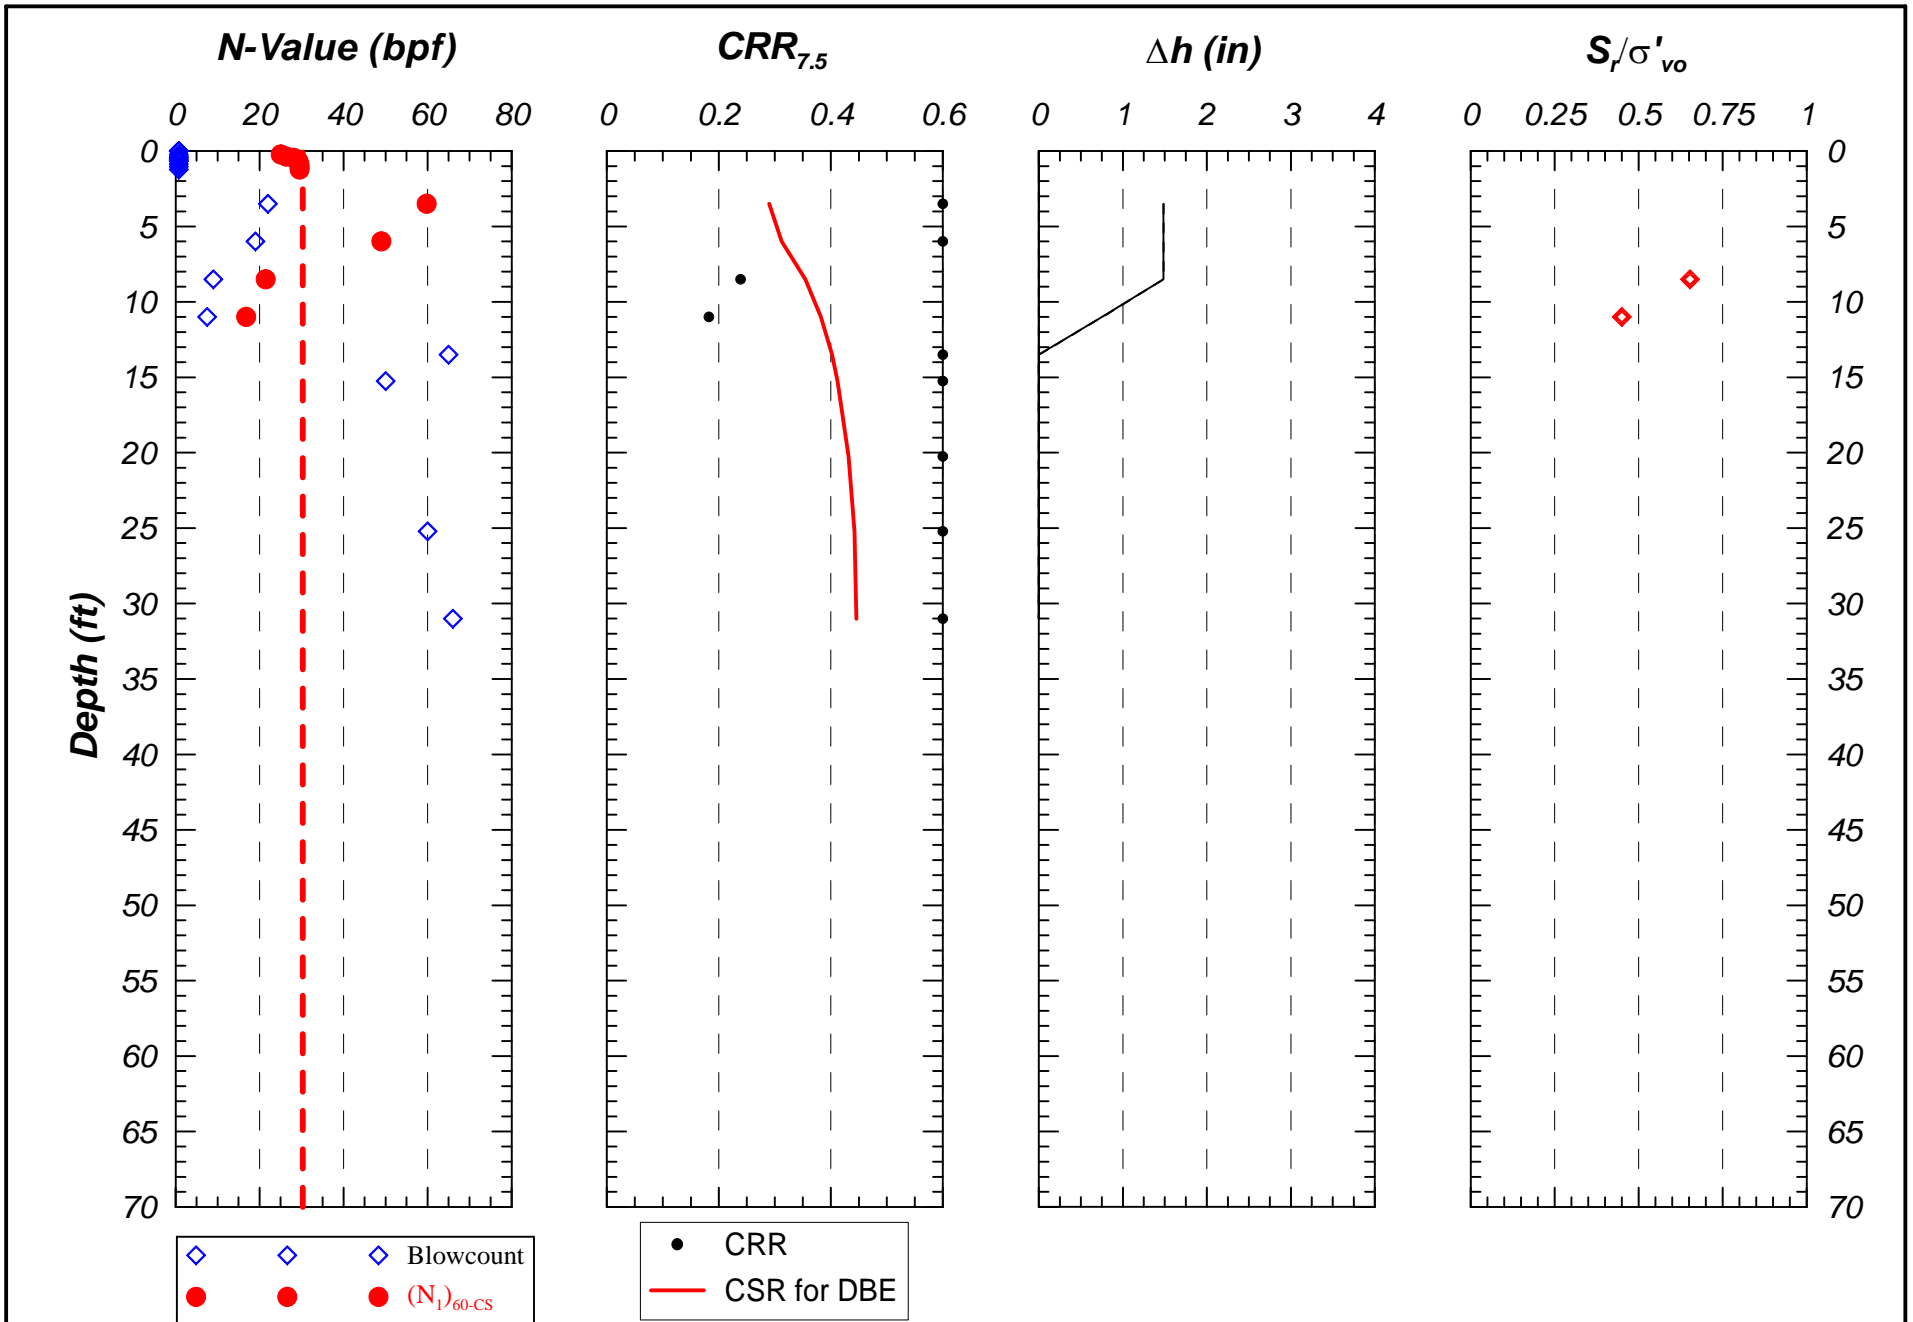
Project Name Dana Point Harbor Hotel Component	<b>Integrated SPT Method for Estimating          Subsurface Stratification &amp; Liquefaction</b> <b>Drill Hole DH-45</b>	<b>Figure D-3</b>
	Project No. 17-206-01

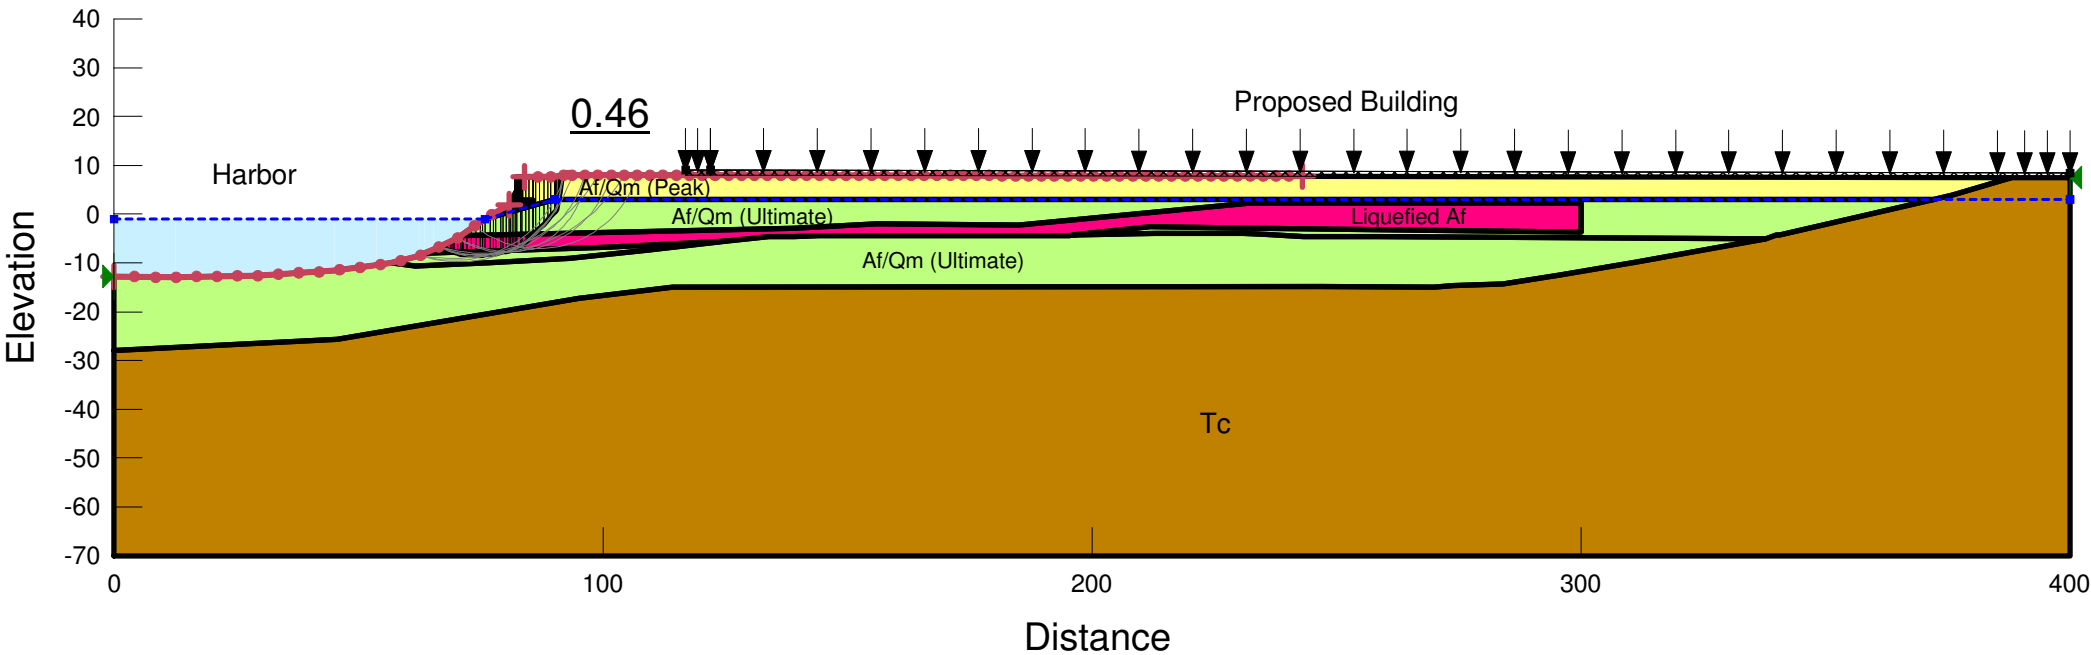
Project No. 17-206-01  
Section A-A'  
December, 2018

Static Analysis, Run 1.1  
 Post Earthquake Condition  
 Horz Seismic Coef.: 0  
 Entry and Exit

Name: Tc  
 Model: Mohr-Coulomb  
 Unit Weight: 125 pcf  
 Cohesion': 695 psf  
 Phi': 34 °

Name: Liquefied Af  
 Model: S=f(overburden)  
 Unit Weight: 125 pcf  
 Tau/Sigma Ratio: 0.05

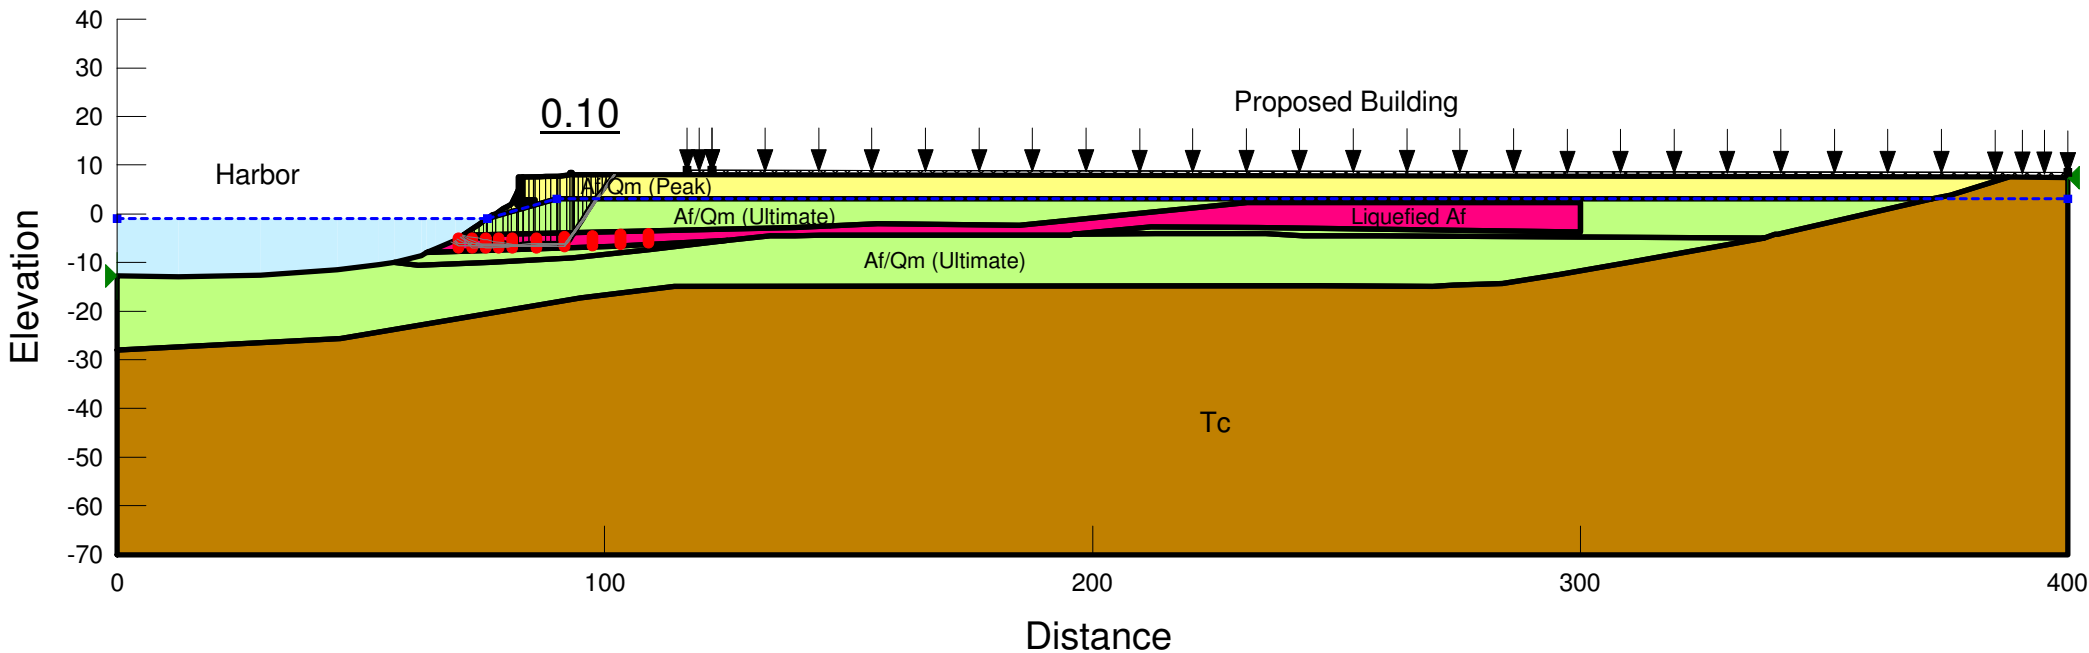
Project No. 17-206-01  
Section A-A'  
December, 2018

Static Analysis, Run 1.2  
Post Earthquake Condition  
Horz Seismic Coef.: 0  
Block Search

Name: Tc  
Model: Mohr-Coulomb  
Unit Weight: 125 pcf  
Cohesion': 695 psf  
Phi': 34 °

Name: Liquefied Af  
Model: S=f(overburden)  
Unit Weight: 125 pcf  
Tau/Sigma Ratio: 0.05

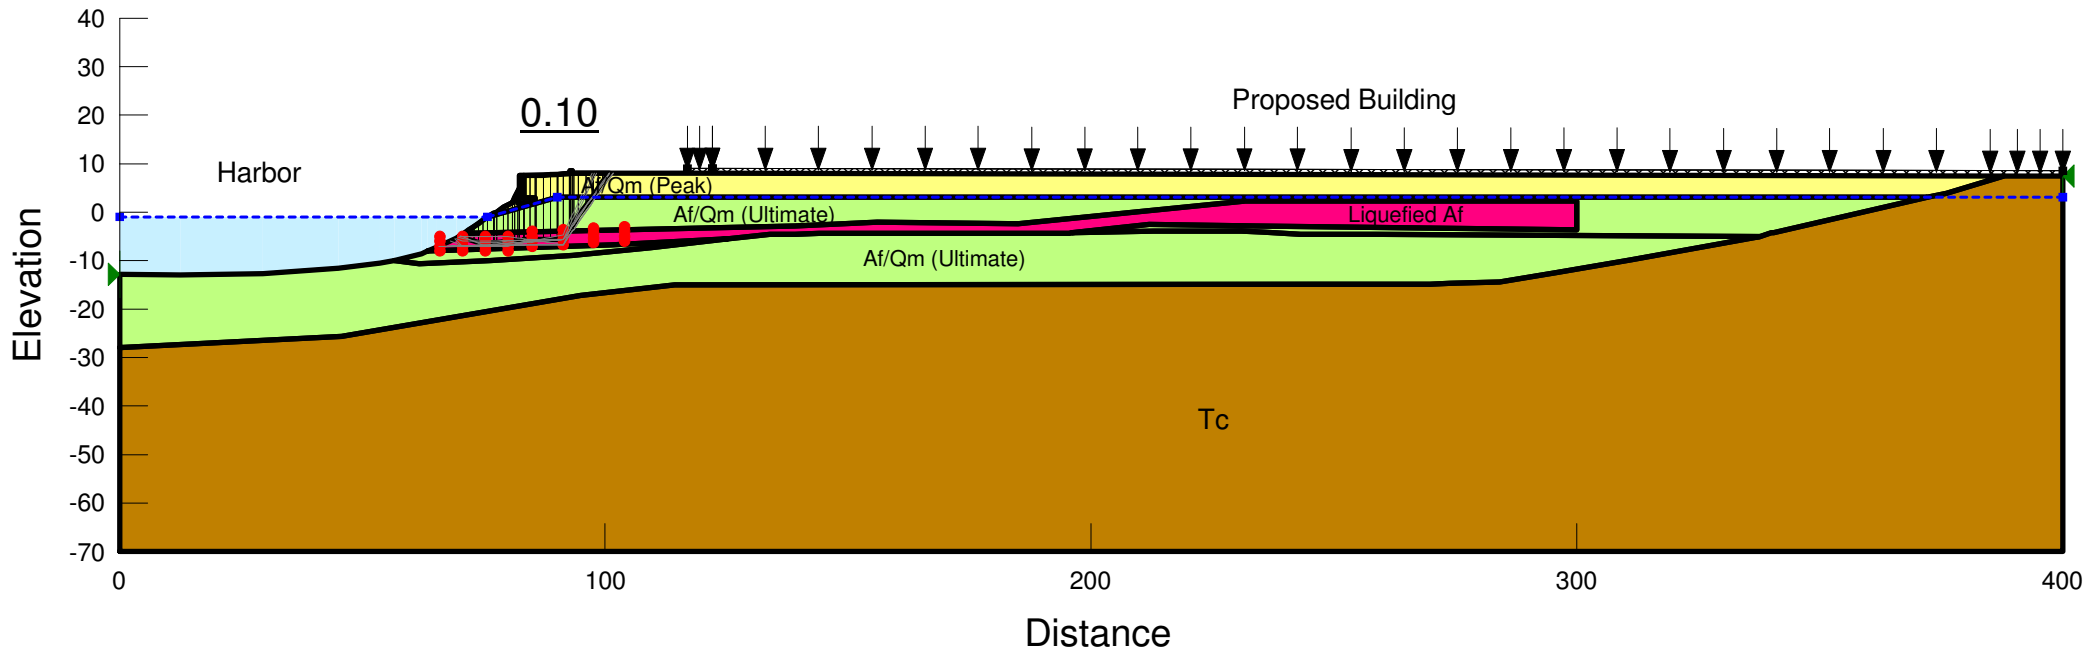
Project No. 17-206-01  
Section A-A'  
December, 2018

Pseudo-Static Analysis, Run 1.2  
Horz Seismic Coef.: 0.15  
Block Search

Name: Tc  
Model: Mohr-Coulomb  
Unit Weight: 125 pcf  
Cohesion': 695 psf  
Phi': 34 °

Name: Liquefied Af  
Model: S=f(overburden)  
Unit Weight: 125 pcf  
Tau/Sigma Ratio: 0.05
