## PRELIMINARY GEOTECHNICAL INVESTIGATION

**Preliminary Geotechnical Investigation,  
Dana Point Harbor Revitalization,  
Hotel Component,  
City of Dana Point, California**

September 10, 2019

GMU Project No. 17-206-01

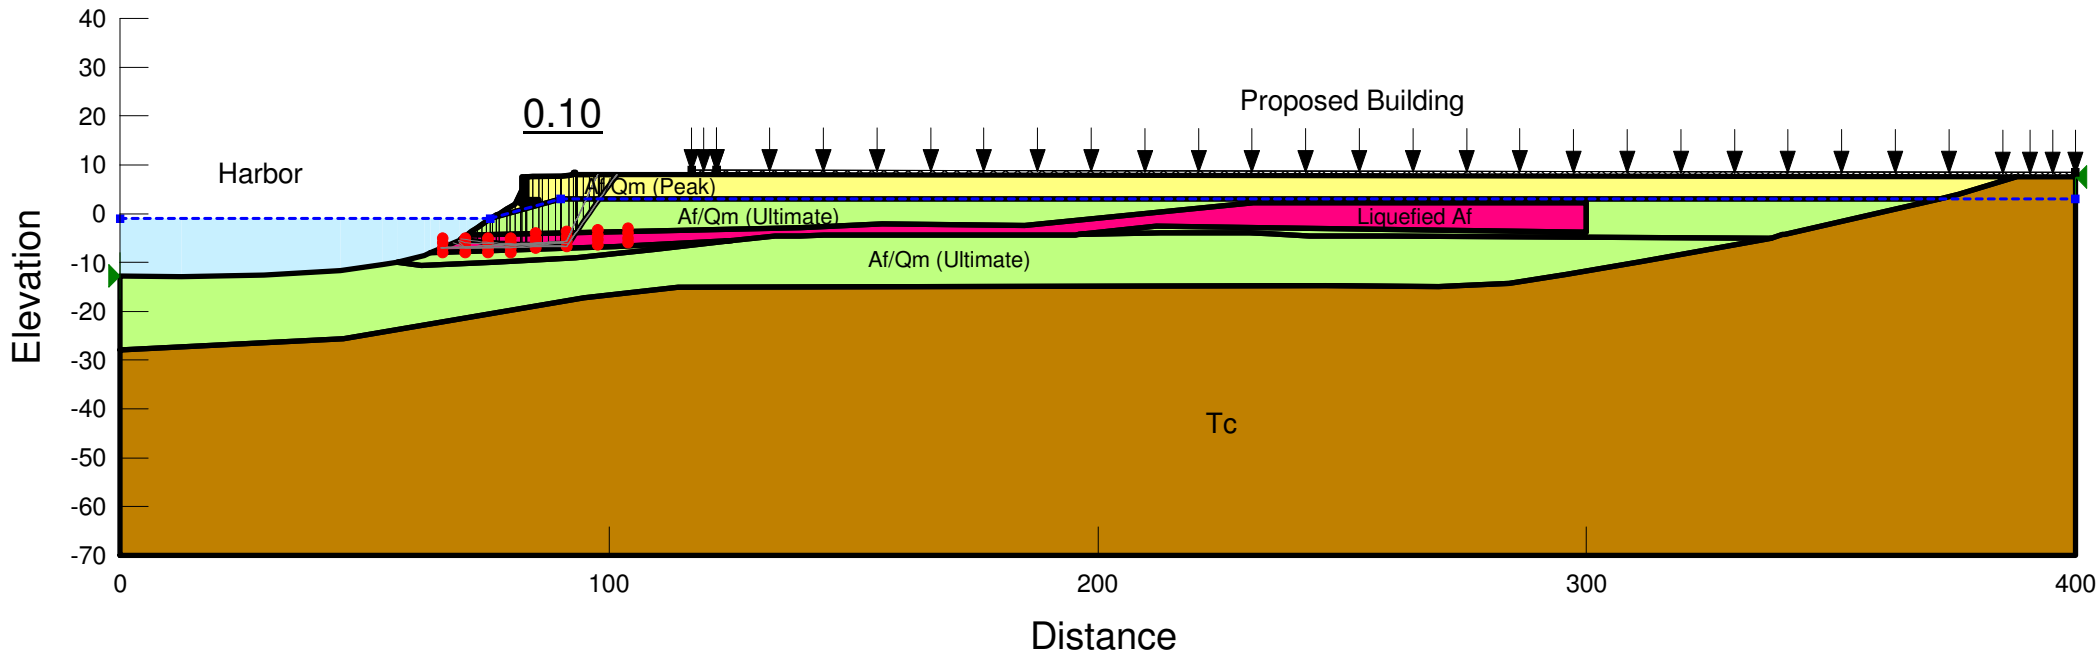
Project No. 17-206-01  
 Section A-A'  
 December, 2018

Deformation Analysis, Run 1.2  
Horz Seismic Coef.: 0  
Deformation > 92 inches  
Block Search

Name: Af/Qm (Peak)  
Model: Mohr-Coulomb  
Unit Weight: 125 pcf  
Cohesion': 395 psf  
Phi': 31 °

Name: Liquefied Af  
Model: S=f(overburden)  
Unit Weight: 125 pcf  
Tau/Sigma Ratio: 0.05

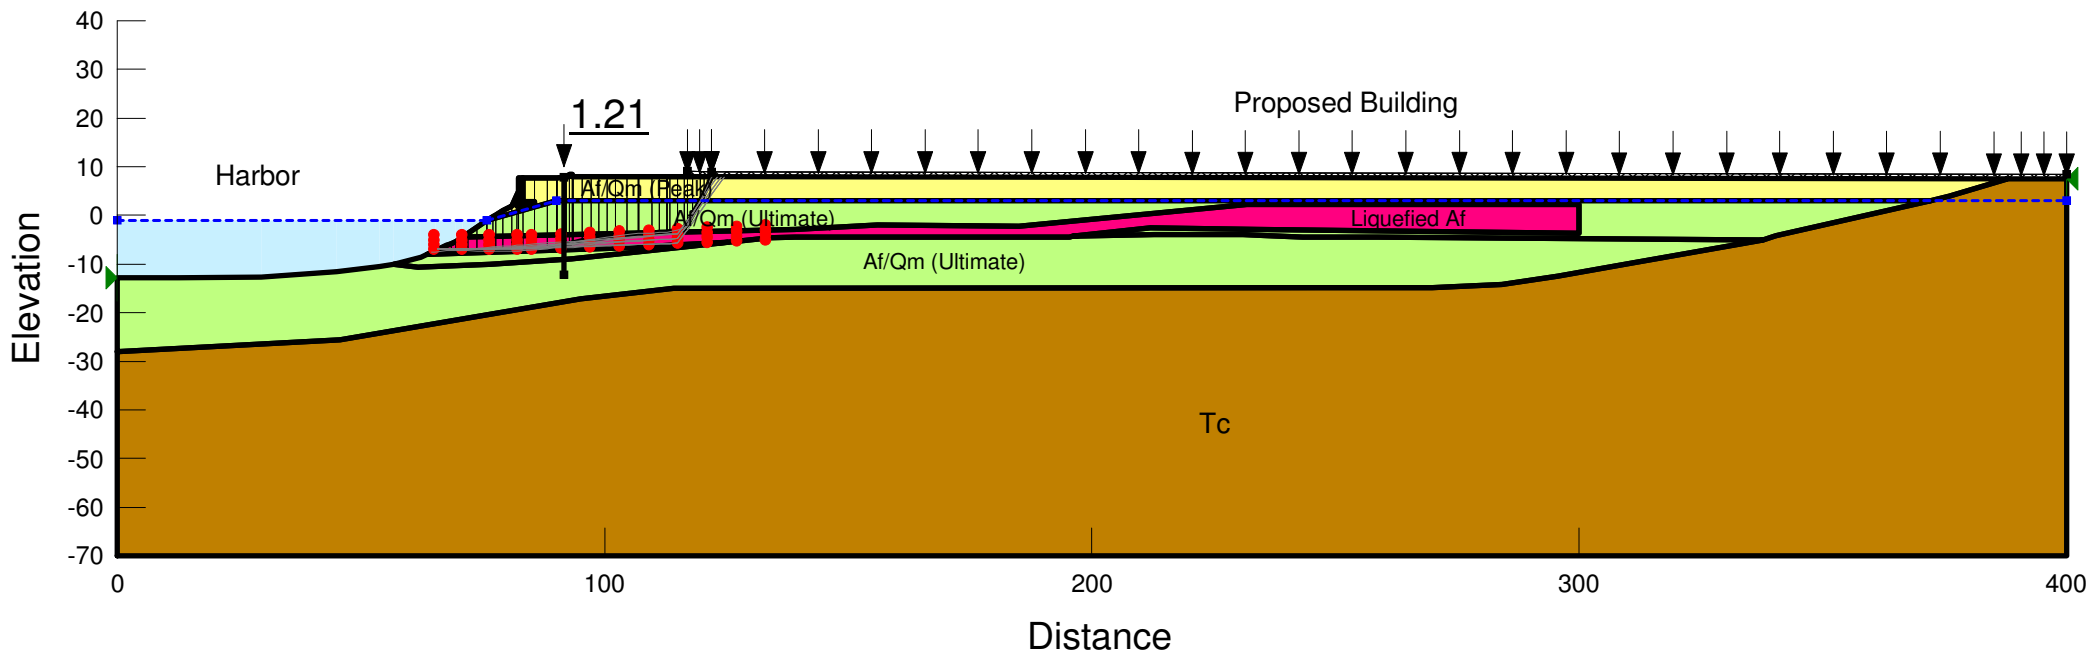
Project No. 17-206-01  
Section A-A'  
December, 2018

Static Analysis, Run 1.3  
 Post Earthquake Condition  
 with Mitigation  
 Horz Seismic Coef.: 0  
 Block Search

Name: Af/Qm (Peak)  
 Model: Mohr-Coulomb  
 Unit Weight: 125 pcf  
 Cohesion': 395 psf  
 Phi': 31 °

Name: Liquefied Af  
 Model: S=f(overburden)  
 Unit Weight: 125 pcf  
 Tau/Sigma Ratio: 0.05

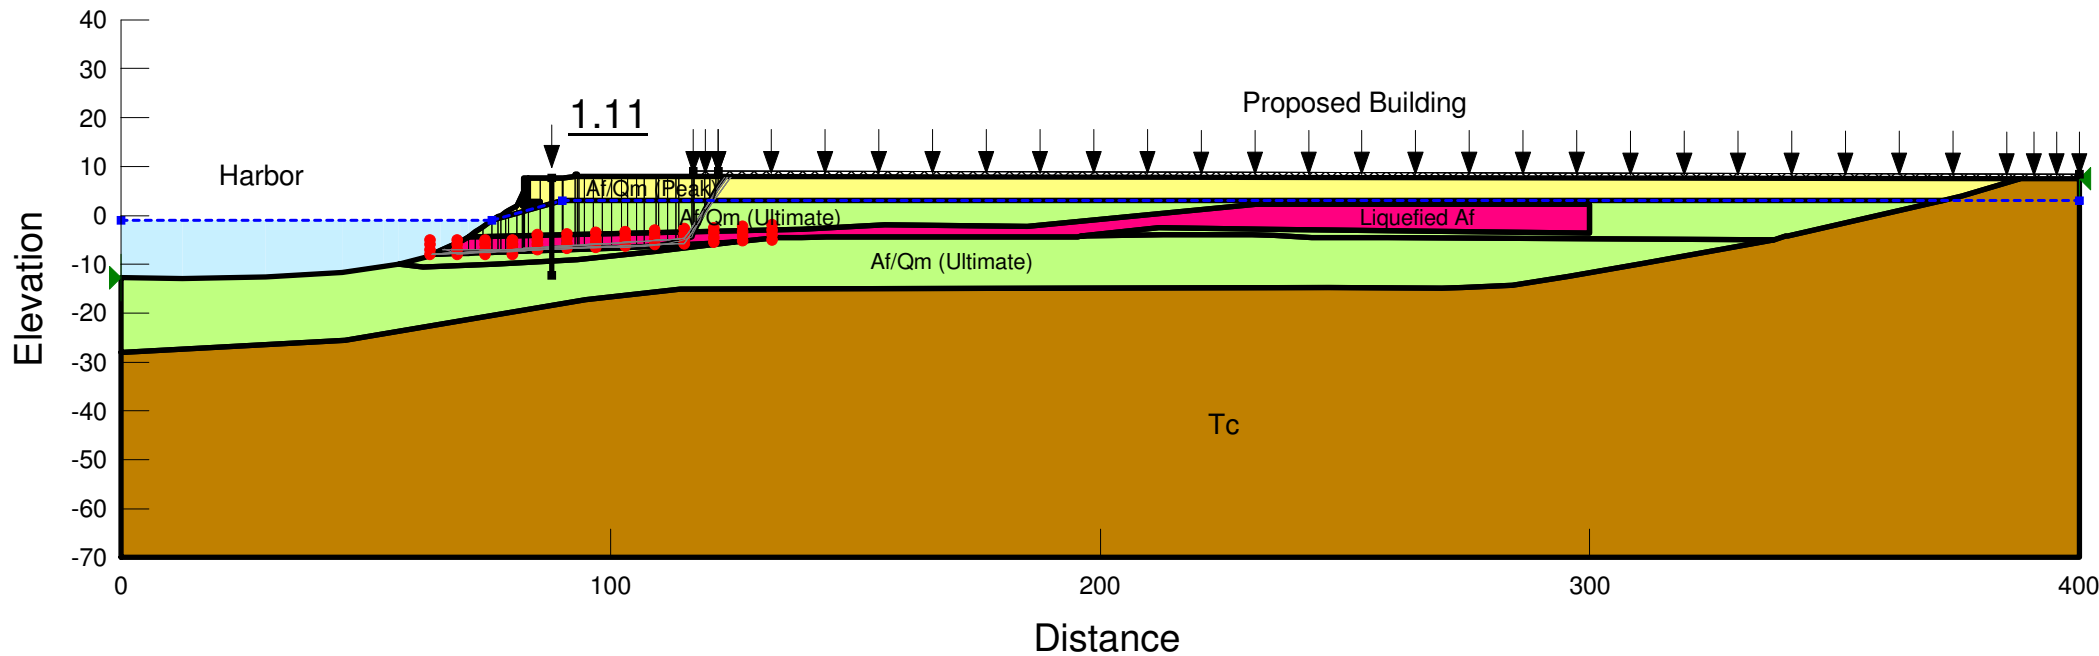
Project No. 17-206-01  
 Section A-A'  
 December, 2018

Pseudo-Static Analysis, Run 1.3  
with Mitigation  
Horz Seismic Coef.: 0.15  
Block Search

Name: Liquefied Af  
Model: S=f(overburden)  
Unit Weight: 125 pcf  
Tau/Sigma Ratio: 0.05

Type: Pile  
Total Length: 20 ft  
Shear Force: 28,600 lbs  
Pile Spacing: 1 ft

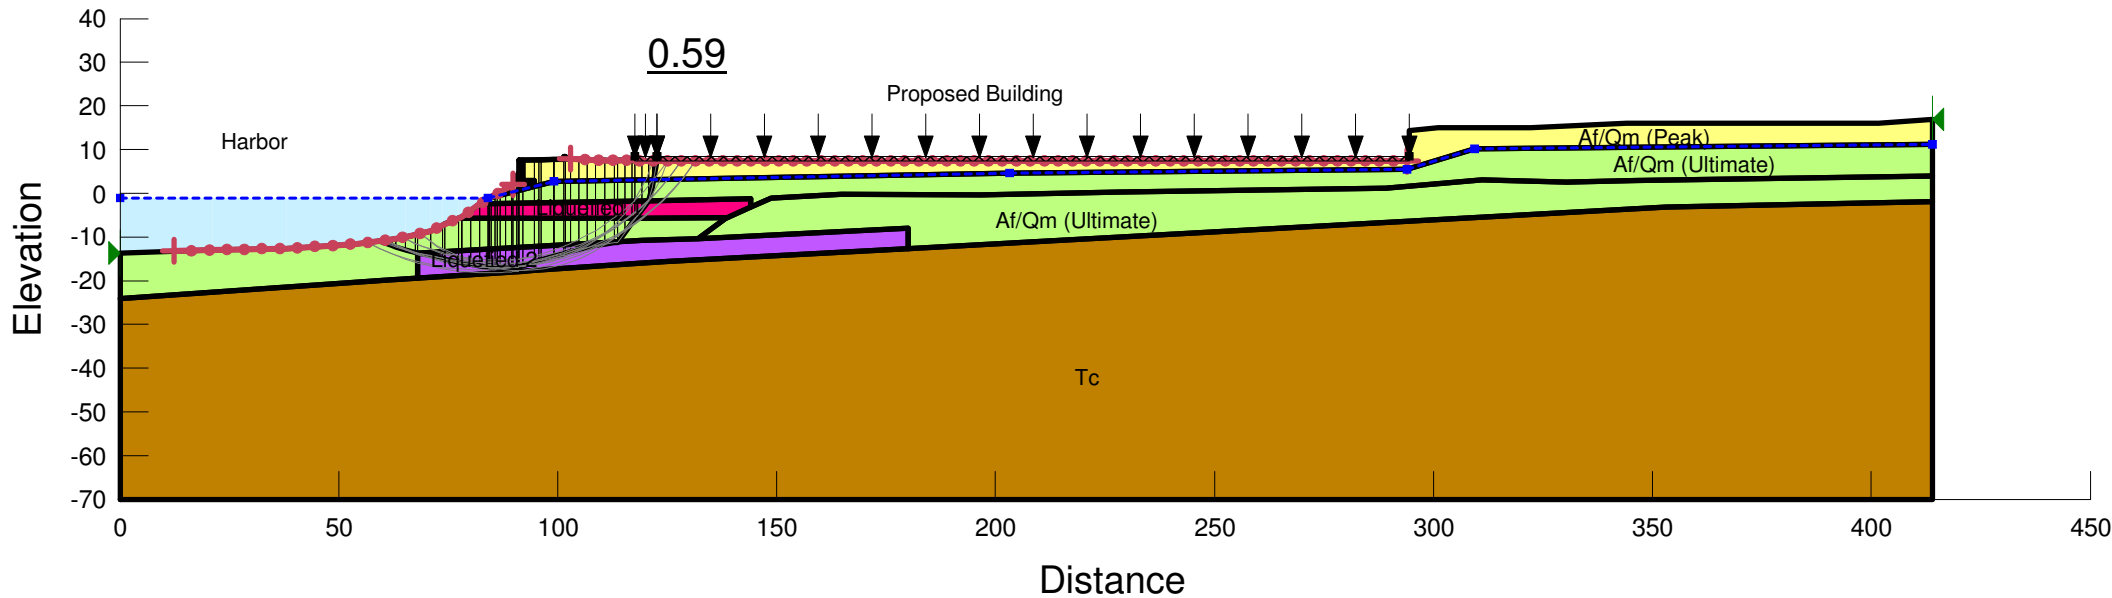
Name: Liquefied 2  
Model: S=f(overburden)  
Unit Weight: 125 pcf  
Tau/Sigma Ratio: 0.17

Name: Tc  
Model: Mohr-Coulomb  
Unit Weight: 125 pcf  
Cohesion': 695 psf  
Phi': 34 °

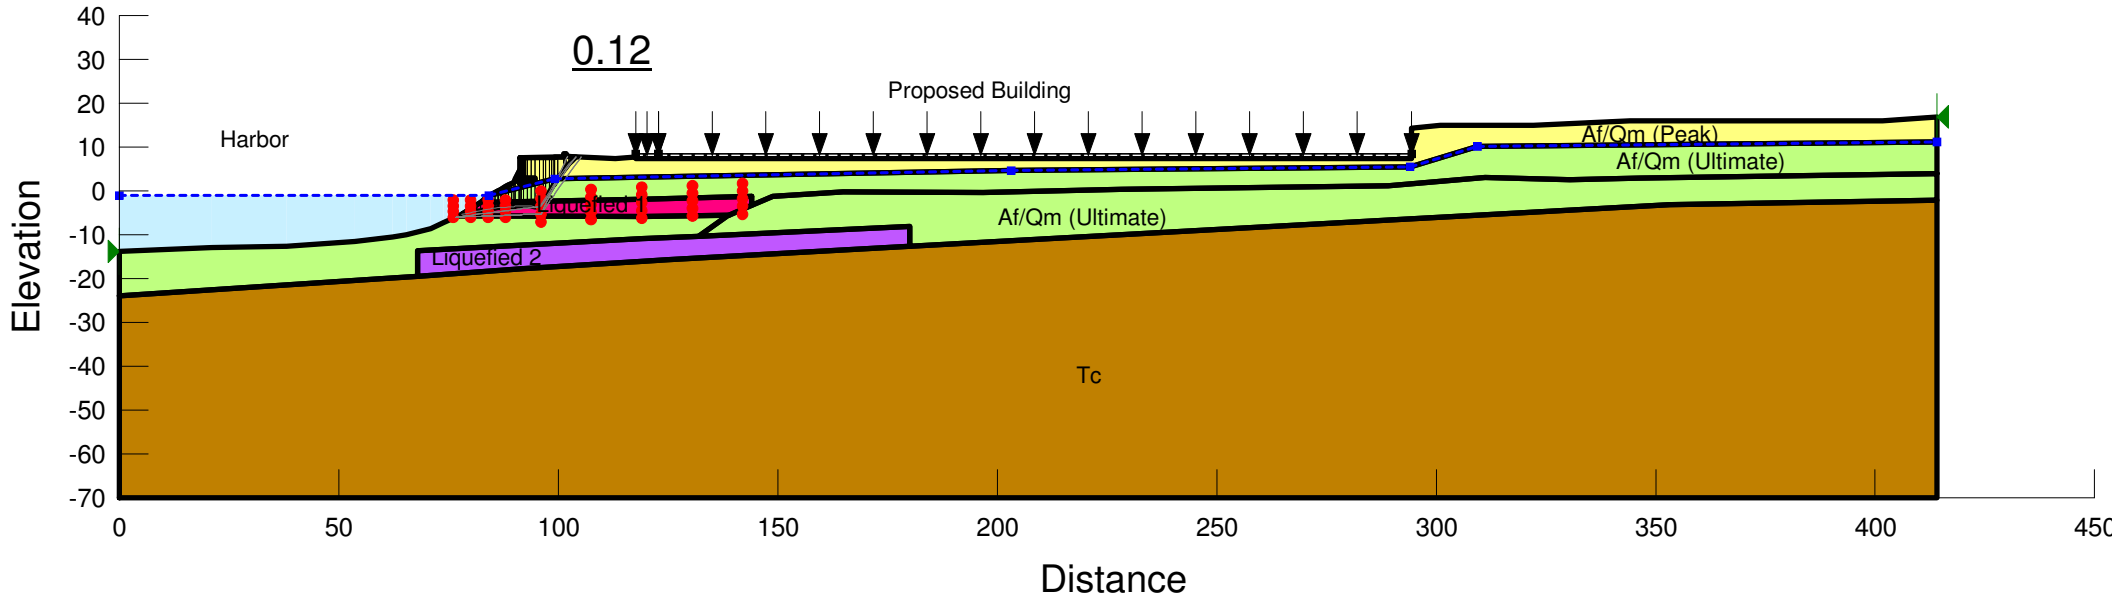
Project No. 17-206-01  
 Section B-B'  
 December, 2018

Static Analysis, Run 1.2  
 Post Earthquake Condition  
 Liquefied Layer 1  
 Horz Seismic Coef.: 0  
 Block Search

Name: Liquefied 2  
 Model: S=f(overburden)  
 Unit Weight: 125 pcf  
 Tau/Sigma Ratio: 0.17

Name: Tc  
 Model: Mohr-Coulomb  
 Unit Weight: 125 pcf  
 Cohesion': 695 psf  
 Phi': 34 °

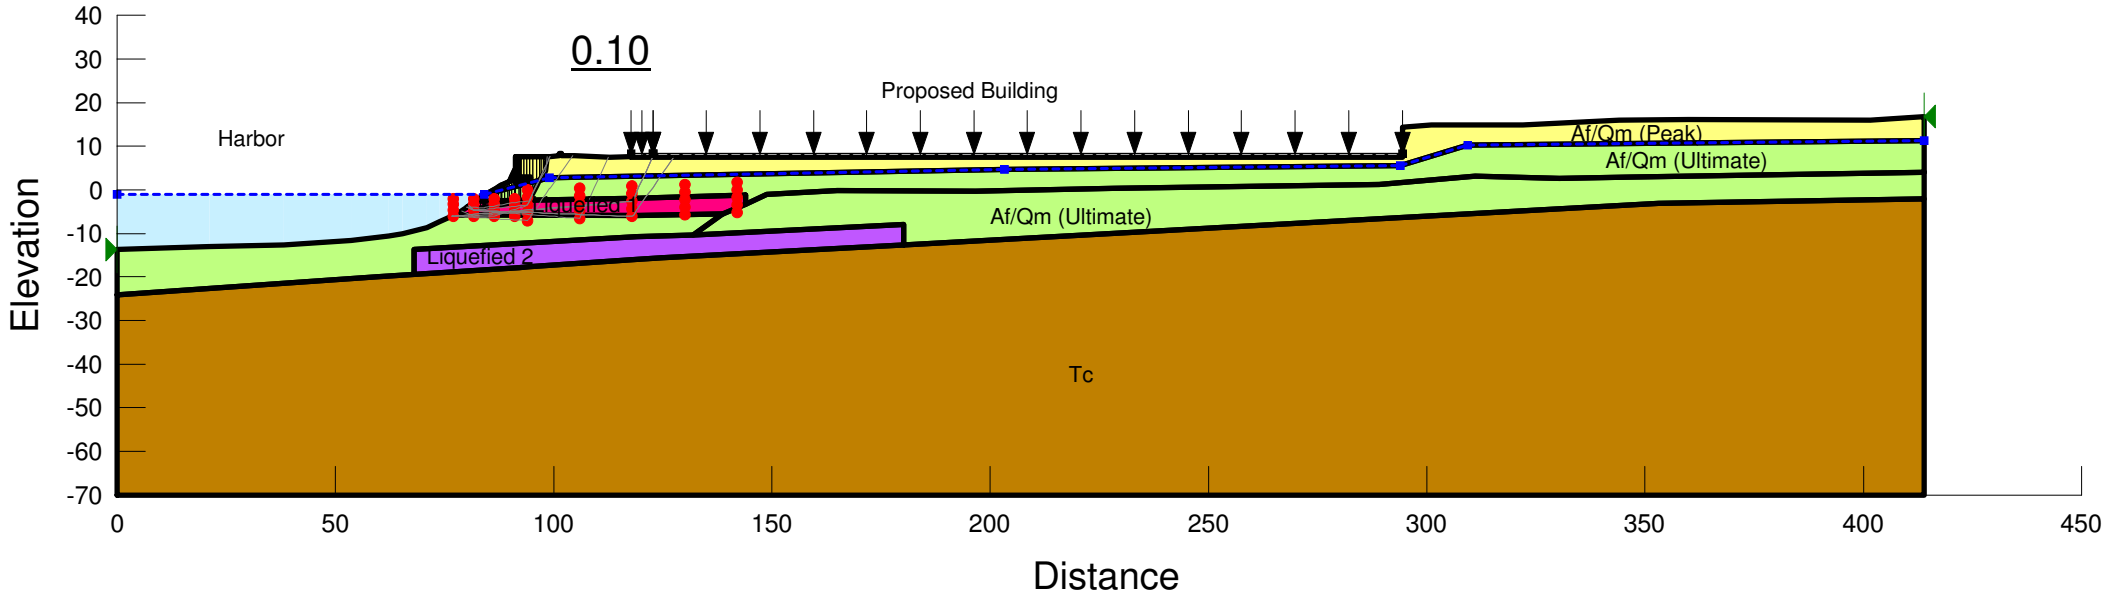
Project No. 17-206-01  
Section B-B'  
December, 2018

Pseudo-Static Analysis, Run 1.2  
Liquefied Layer 1  
Horz Seismic Coef.: 0.15  
Block Search

Name: Liquefied 2  
Model: S=f(overburden)  
Unit Weight: 125 pcf  
Tau/Sigma Ratio: 0.17

Name: Tc  
Model: Mohr-Coulomb  
Unit Weight: 125 pcf  
Cohesion': 695 psf  
Phi': 34 °

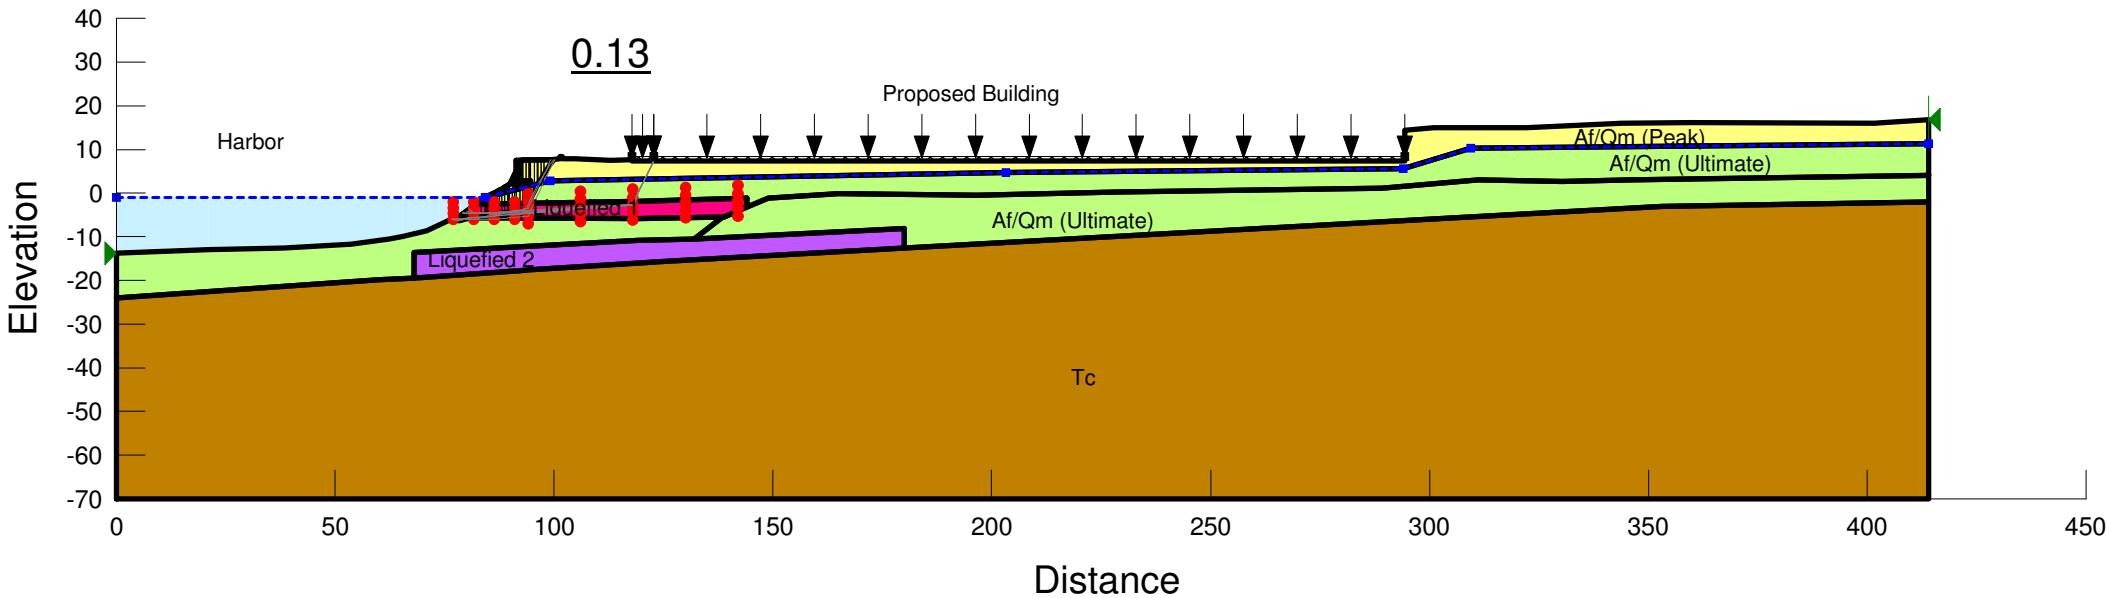
Project No. 17-206-01  
Section B-B'  
December, 2018

Deformation Analysis, Run 1.2  
Liquefied Layer 1  
Horz Seismic Coef.: 0  
Deformation > 124 inches  
Block Search

Name: Liquefied 2  
Model: S=f(overburden)  
Unit Weight: 125 pcf  
Tau/Sigma Ratio: 0.17

Name: Tc  
Model: Mohr-Coulomb  
Unit Weight: 125 pcf  
Cohesion': 695 psf  
Phi': 34 °

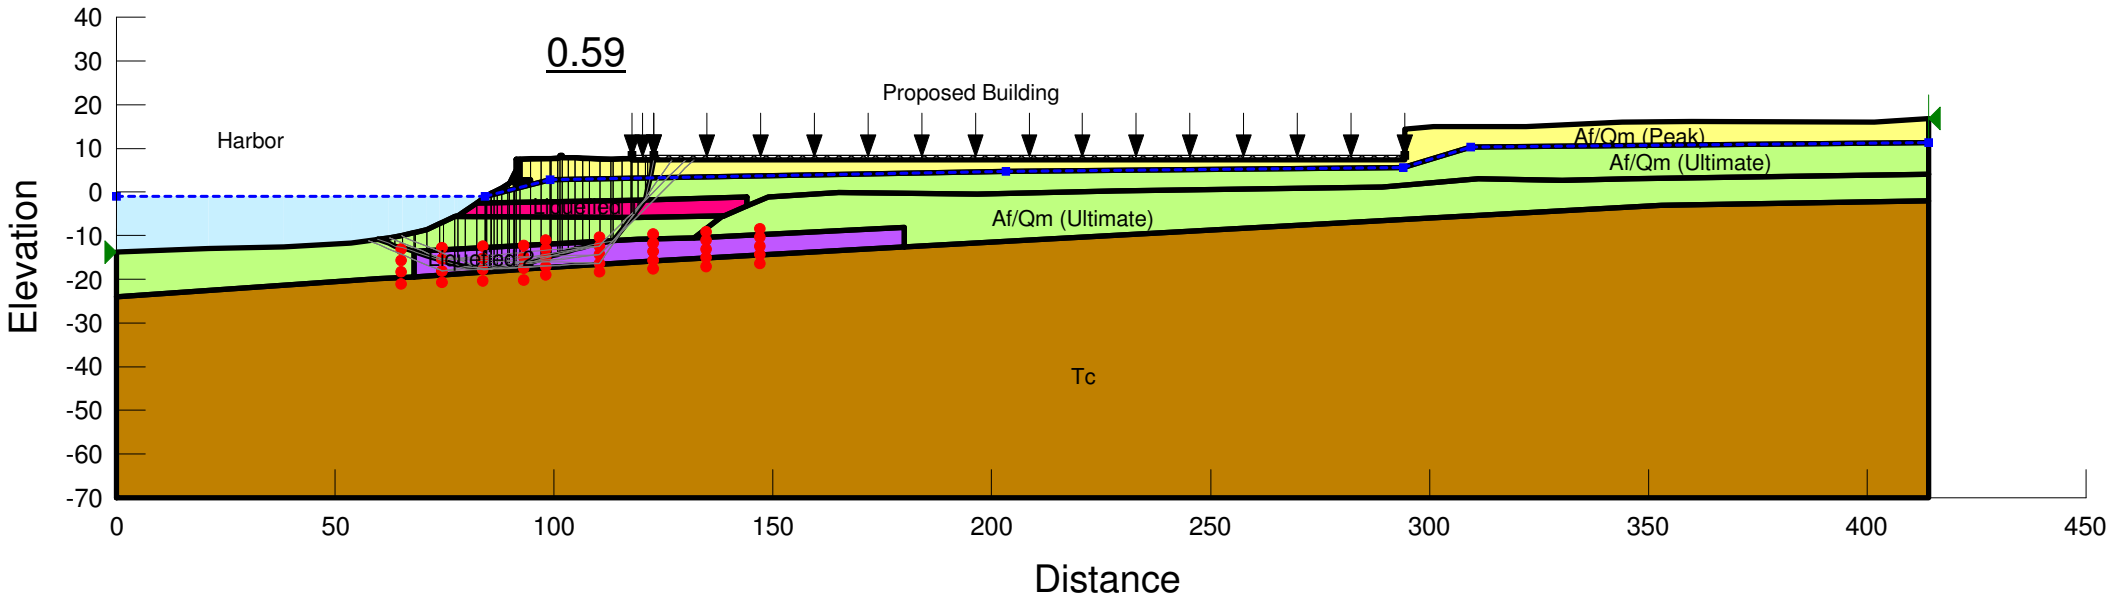
Project No. 17-206-01  
 Section B-B'  
 December, 2018

Static Analysis, Run 1.3  
 Post Earthquake Condition  
 Liquefied Layer 2  
 Horz Seismic Coef.: 0  
 Block Search

Name: Liquefied 2  
 Model: S=f(overburden)  
 Unit Weight: 125 pcf  
 Tau/Sigma Ratio: 0.17

Name: Tc  
 Model: Mohr-Coulomb  
 Unit Weight: 125 pcf  
 Cohesion': 695 psf  
 Phi': 34 °

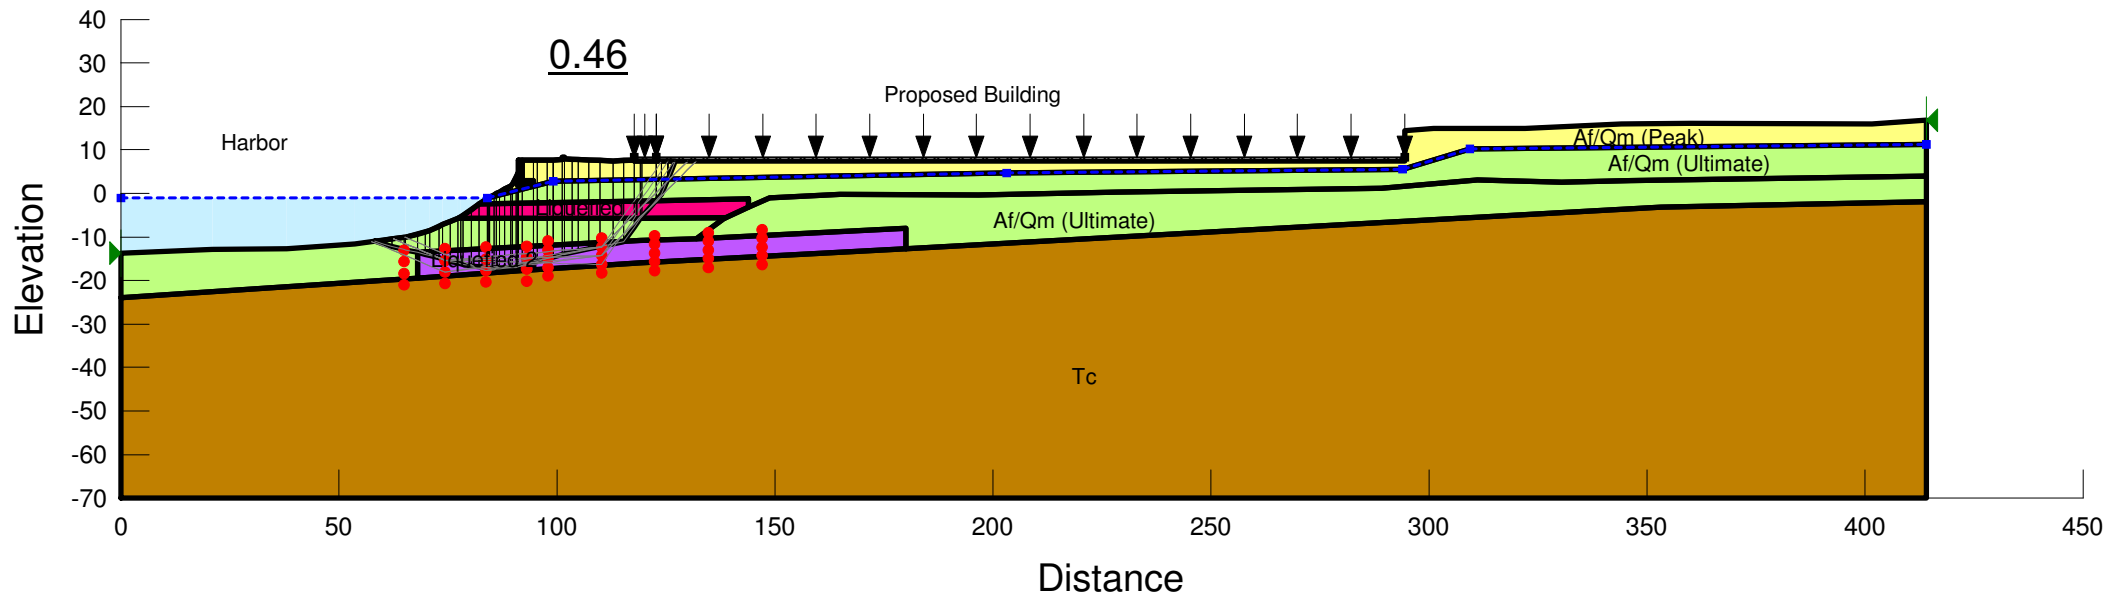
Project No. 17-206-01  
Section B-B'  
December, 2018

Pseudo-Static Analysis, Run 1.3  
Liquefied Layer 2  
Horz Seismic Coef.: 0.15  
Block Search

Name: Liquefied 2  
Model: S=f(overburden)  
Unit Weight: 125 pcf  
Tau/Sigma Ratio: 0.17

Name: Tc  
Model: Mohr-Coulomb  
Unit Weight: 125 pcf  
Cohesion': 695 psf  
Phi': 34 °

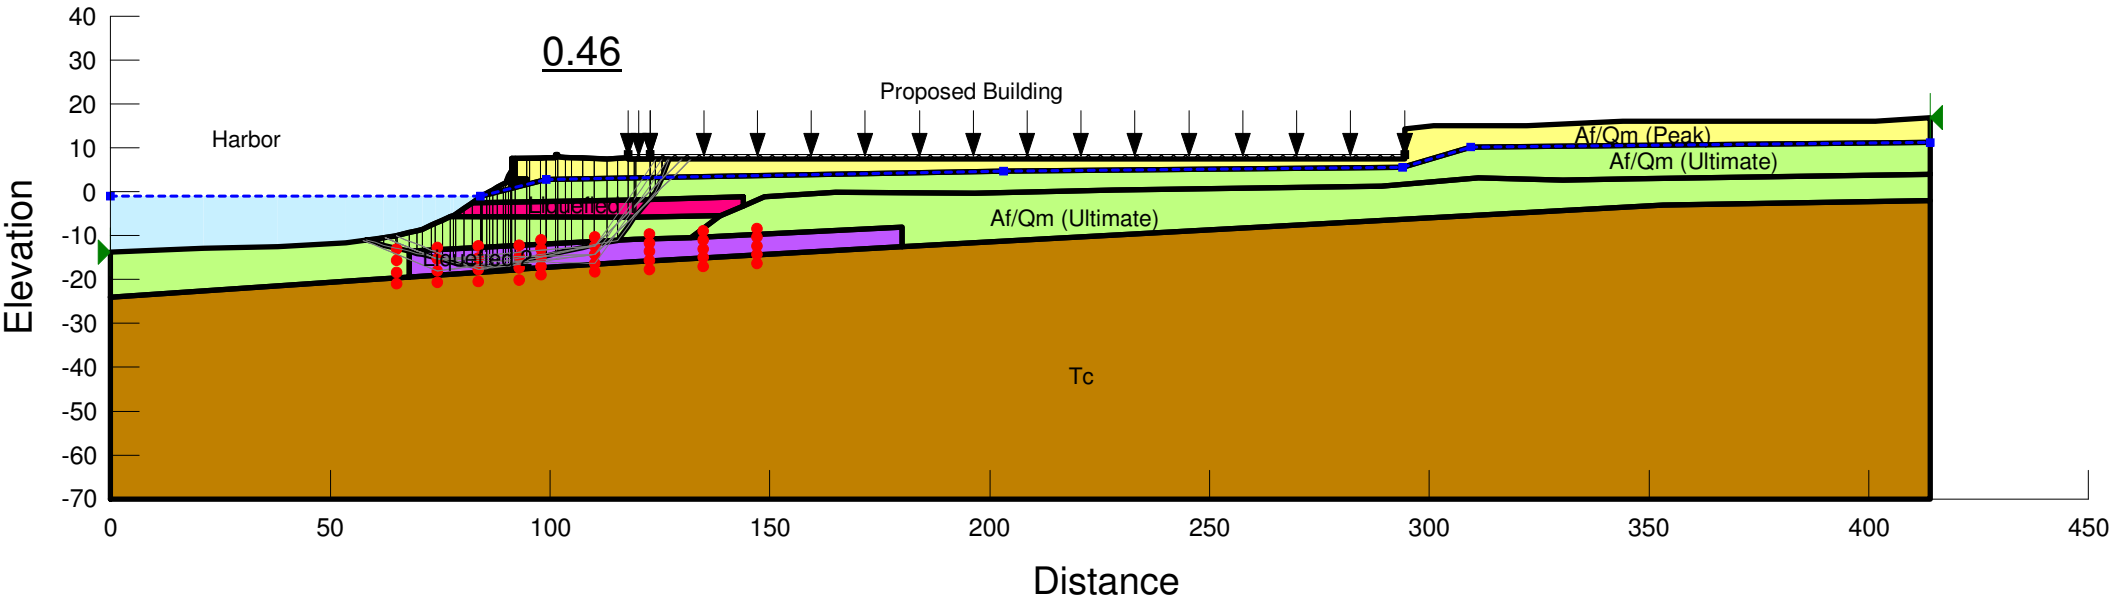
Project No. 17-206-01  
Section B-B'  
December, 2018

Deformation Analysis, Run 1.3  
Liquefied Layer 2  
Horz Seismic Coef.: 0.15  
Deformation > 99.17  
Block Search

Name: Liquefied 2  
Model: S=f(overburden)  
Unit Weight: 125 pcf  
Tau/Sigma Ratio: 0.17

Name: Tc  
Model: Mohr-Coulomb  
Unit Weight: 125 pcf  
Cohesion': 695 psf  
Phi': 34 °

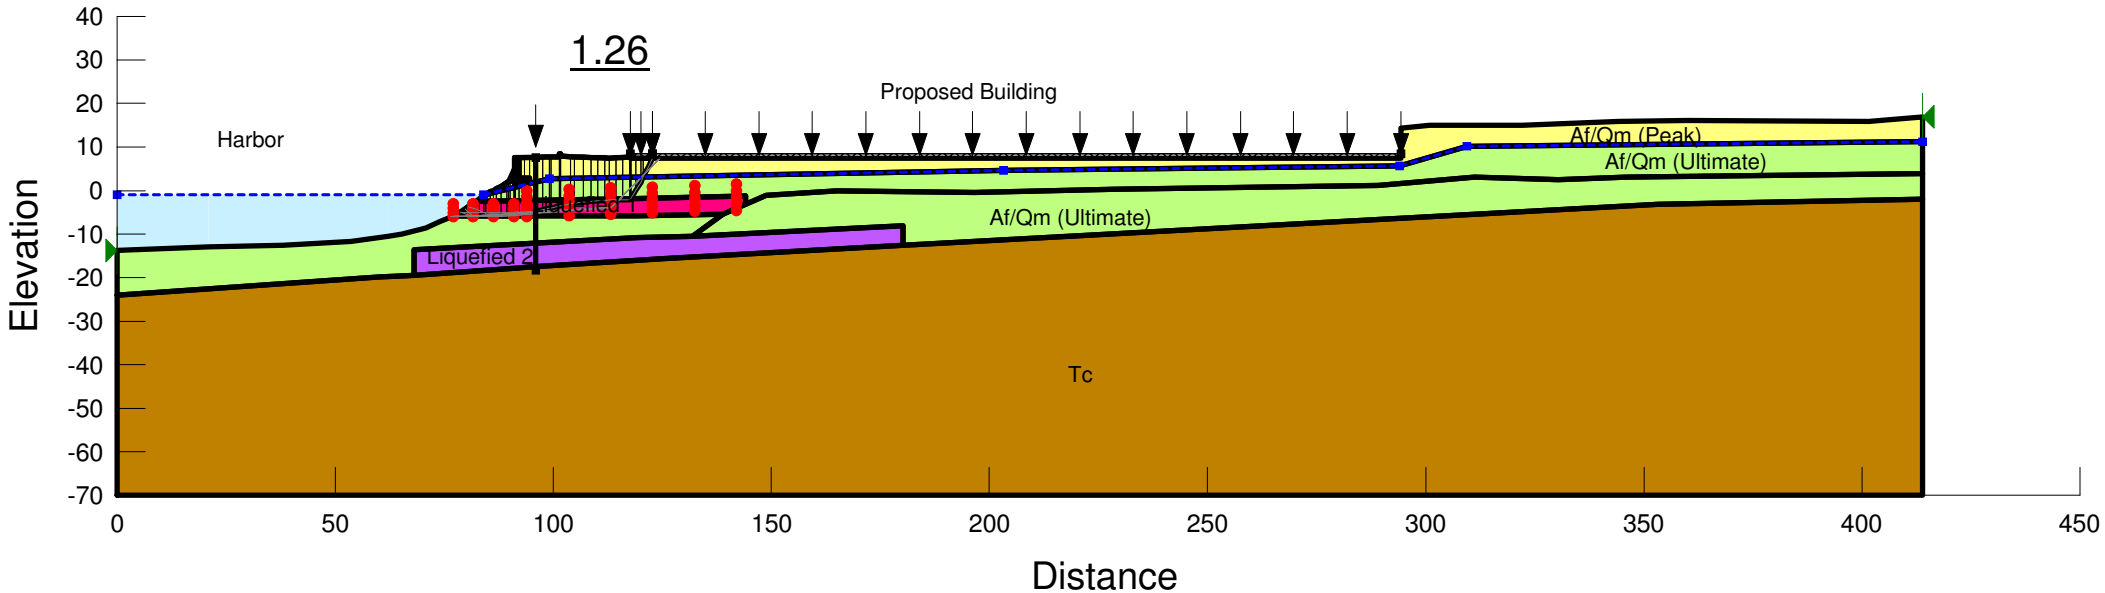
Project No. 17-206-01  
 Section B-B'  
 December, 2018

Static Analysis, Run 1.4  
 Liquefied Layer 1  
 with Mitigation  
 Horz Seismic Coef.: 0  
 Block Search

Name: Liquefied 2  
 Model: S=f(overburden)  
 Unit Weight: 125 pcf  
 Tau/Sigma Ratio: 0.17

Type: Pile  
 Total Length: 26 ft  
 Shear Force: 16,000 lbs  
 Pile Spacing: 1 ft

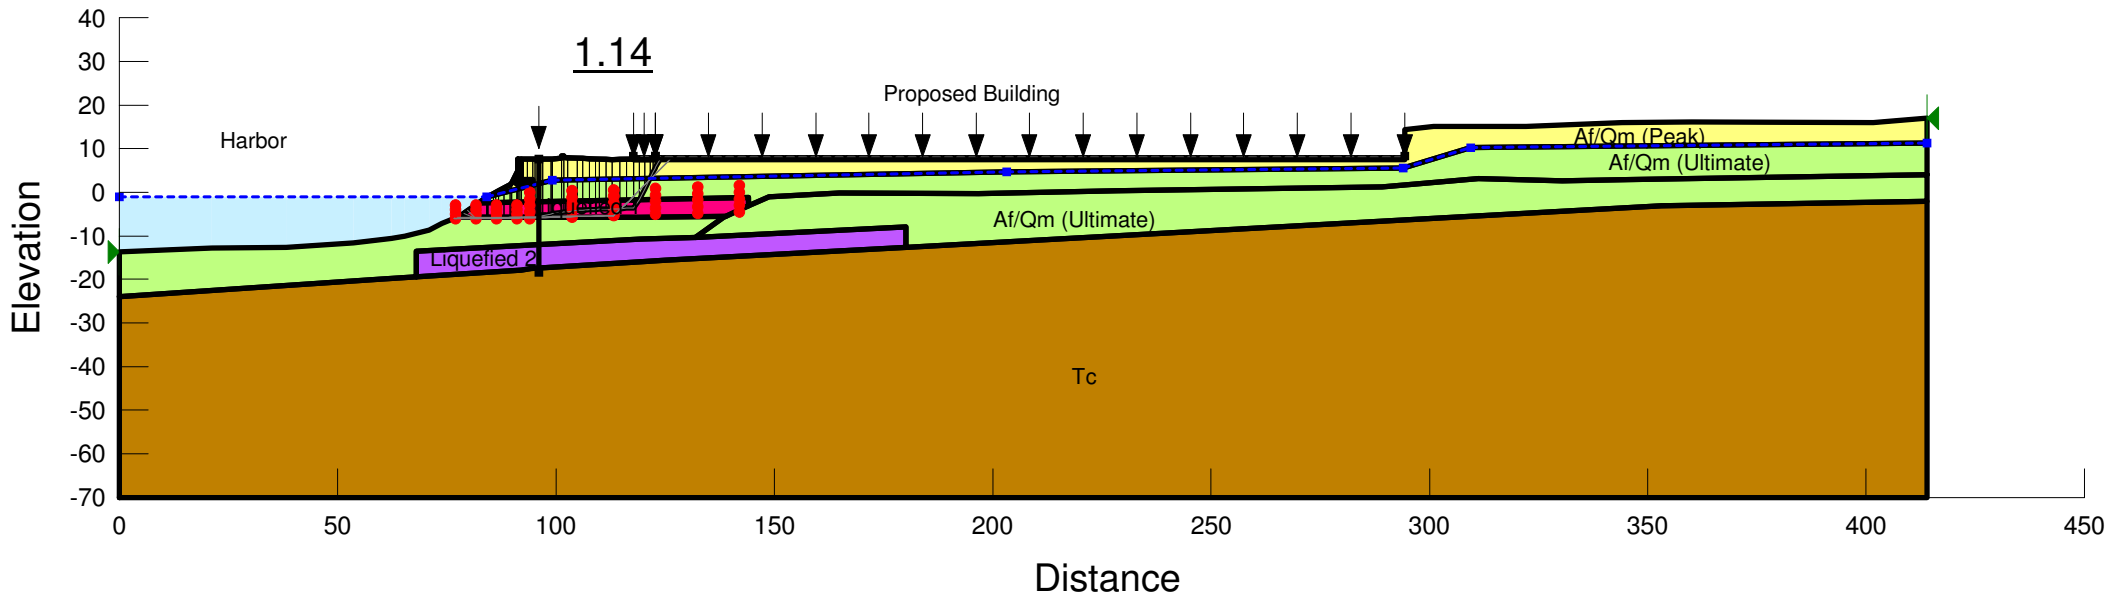
Project No. 17-206-01  
Section B-B'  
December, 2018

Pseudo-Static Analysis, Run 1.4  
Liquefied Layer 1  
with Mitigation  
Horz Seismic Coef.: 0.15  
Block Search

Name: Liquefied 2  
Model: S=f(overburden)  
Unit Weight: 125 pcf  
Tau/Sigma Ratio: 0.17

Type: Pile  
Total Length: 26 ft  
Shear Force: 23,000 lbs  
Pile Spacing: 1 ft

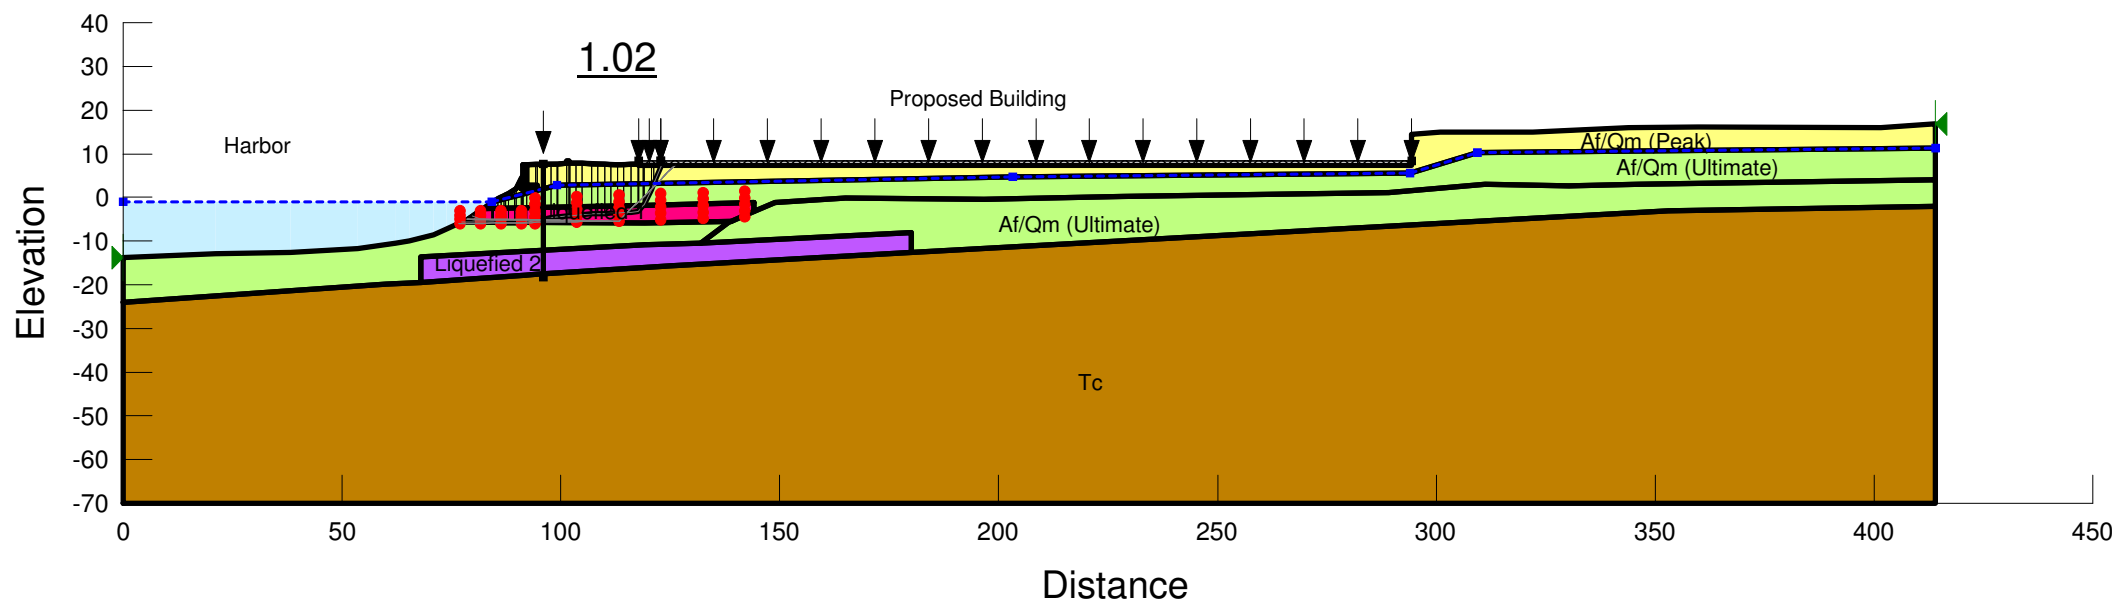
Project No. 17-206-01  
 Section B-B'  
 December, 2018

Deformation Analysis, Run 1.4  
 Liquefied Layer 1  
 with Mitigation  
 Horz Seismic Coef.: 0.215  
 Deformation = 12 inches  
 Block Search

Name: Liquefied 2  
 Model: S=f(overburden)  
 Unit Weight: 125 pcf  
 Tau/Sigma Ratio: 0.17

Type: Pile  
 Total Length: 26 ft  
 Shear Force: 24,700 lbs  
 Pile Spacing: 1 ft

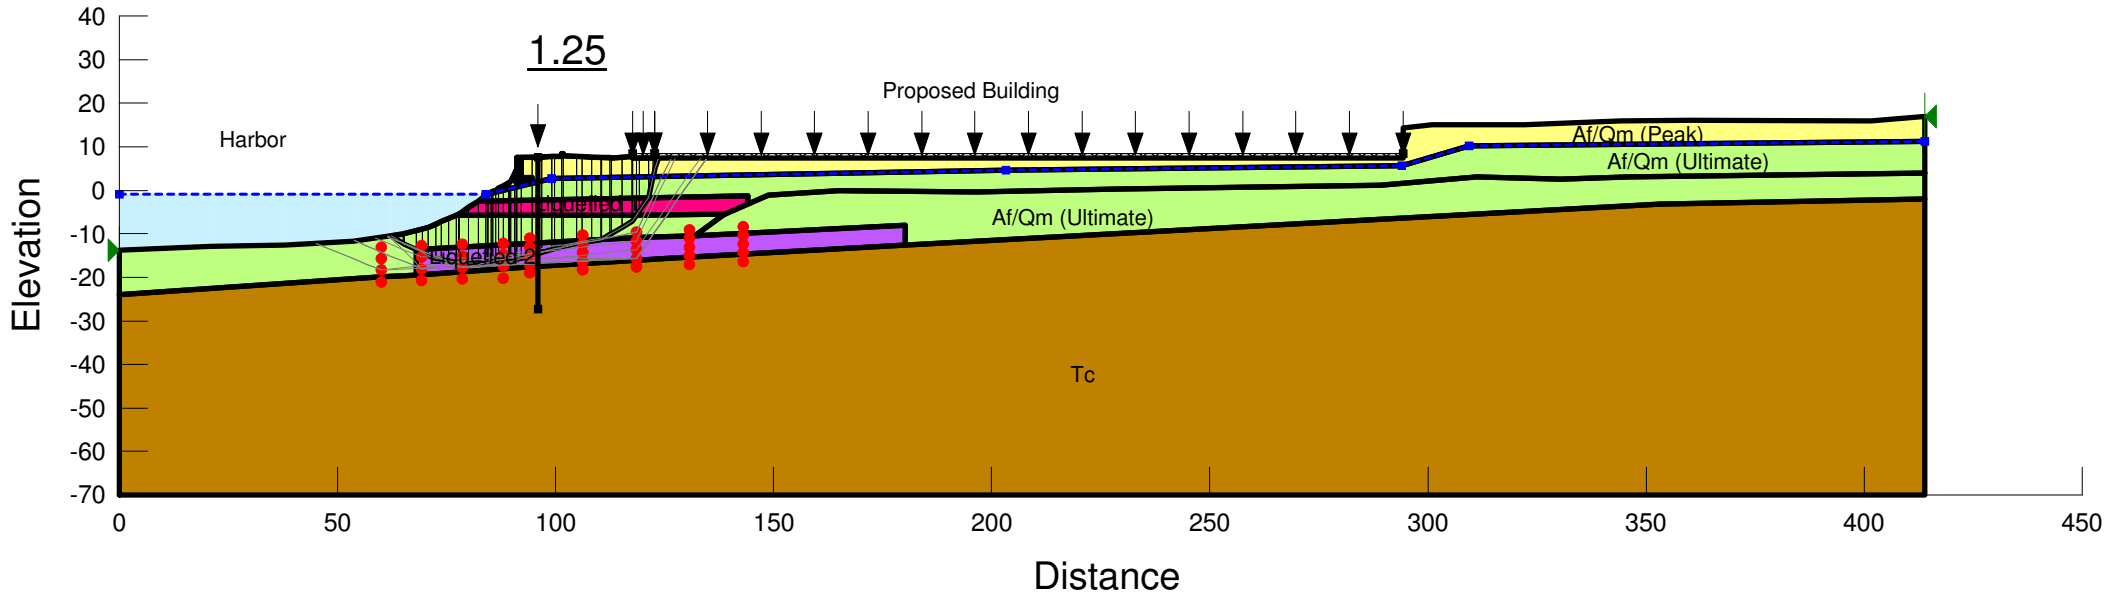
Project No. 17-206-01  
Section B-B'  
December, 2018

Static Analysis, Run 1.5  
Liquefied Layer 2  
with Mitigation  
Horz Seismic Coef.: 0  
Block Search

Name: Liquefied 2  
Model: S=f(overburden)  
Unit Weight: 125 pcf  
Tau/Sigma Ratio: 0.17

Type: Pile  
Total Length: 35 ft  
Shear Force: 22,000 lbs  
Pile Spacing: 1 ft

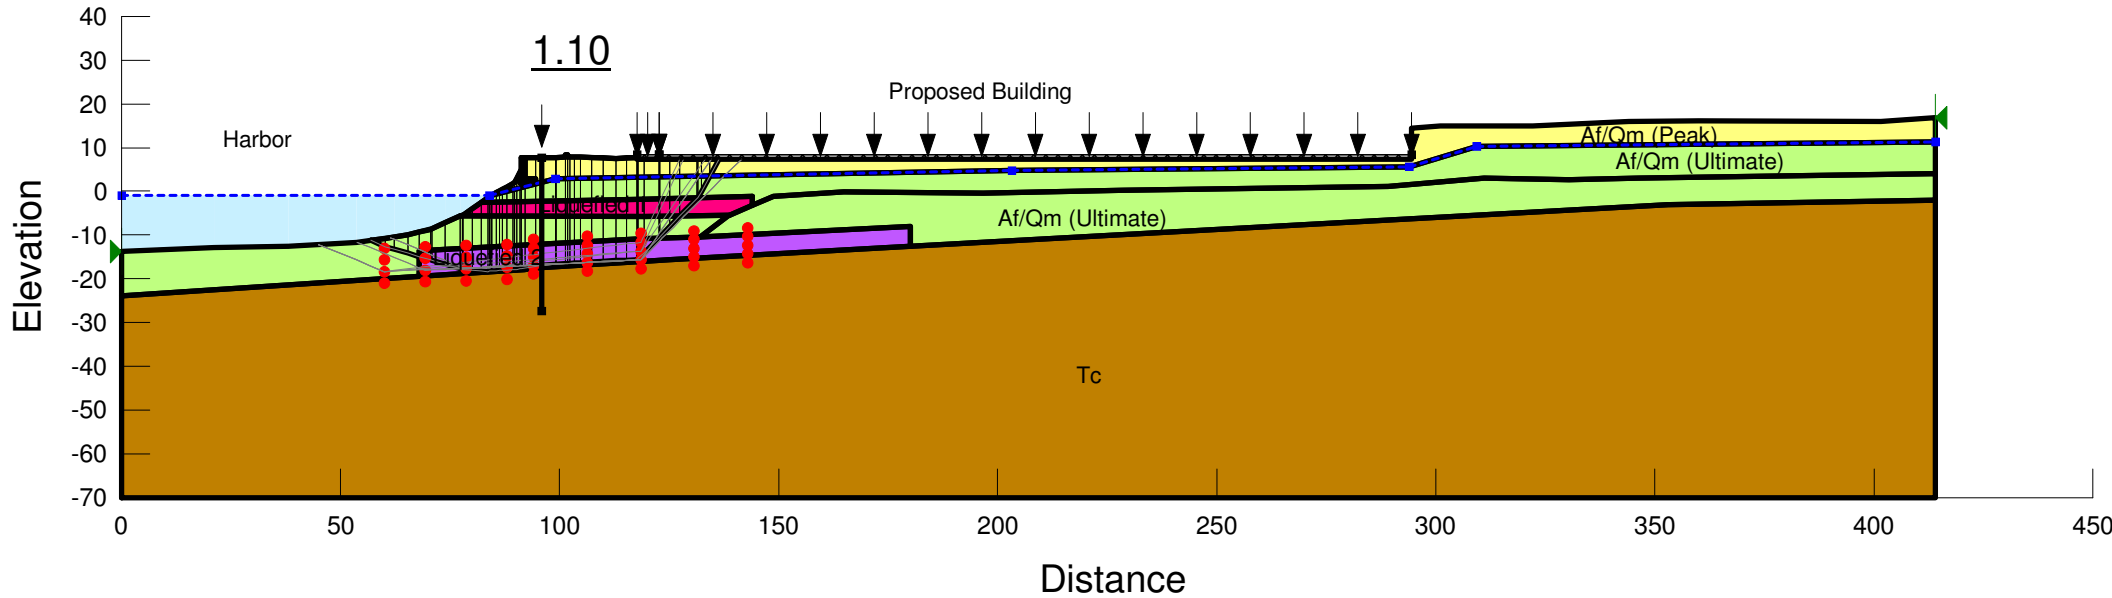
Project No. 17-206-01  
 Section B-B'  
 December, 2018

Pseudo-Static Analysis, Run 1.5  
 Liquefied Layer 2  
 with Mitigation  
 Horz Seismic Coef.: 0.15  
 Block Search

Name: Liquefied 2  
 Model: S=f(overburden)  
 Unit Weight: 125 pcf  
 Tau/Sigma Ratio: 0.17

Type: Pile  
 Total Length: 35 ft  
 Shear Force: 33,000 lbs  
 Pile Spacing: 1 ft

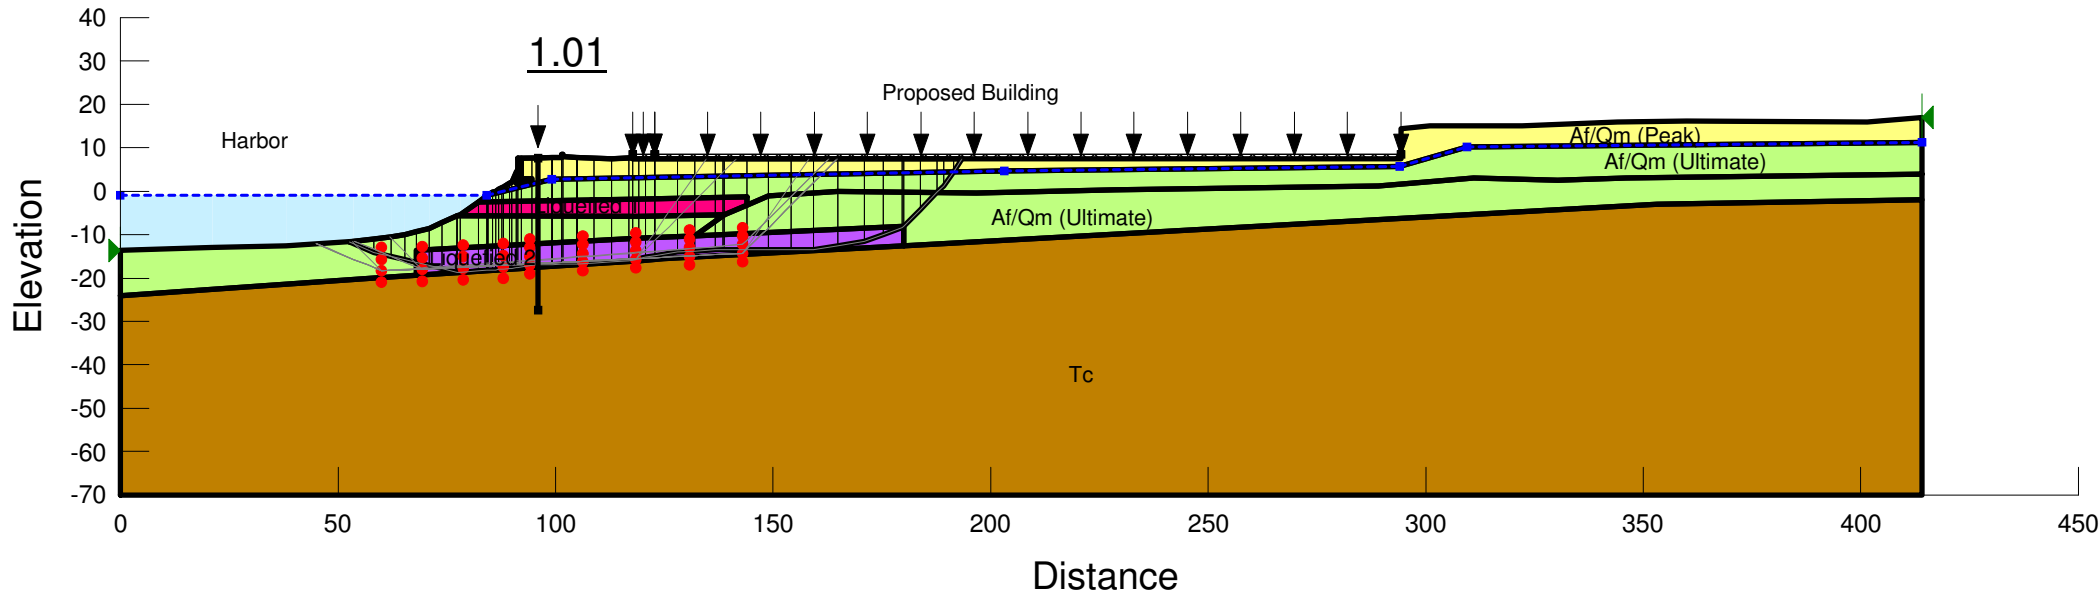
Project No. 17-206-01  
Section B-B'  
December, 2018

Deformation Analysis, Run 1.5  
Liquefied Layer 2  
with Mitigation  
Horz Seismic Coef.: 0.21  
Deformation = 12 inches  
Block Search

Name: Liquefied 2  
Model: S=f(overburden)  
Unit Weight: 125 pcf  
Tau/Sigma Ratio: 0.17

Type: Pile  
Total Length: 35 ft  
Shear Force: 49,000 lbs  
Pile Spacing: 1 ft
