## PRELIMINARY GEOTECHNICAL INVESTIGATION

**Preliminary Geotechnical Investigation,  
Dana Point Harbor Revitalization,  
Hotel Component,  
City of Dana Point, California**

September 10, 2019

GMU Project No. 17-206-01

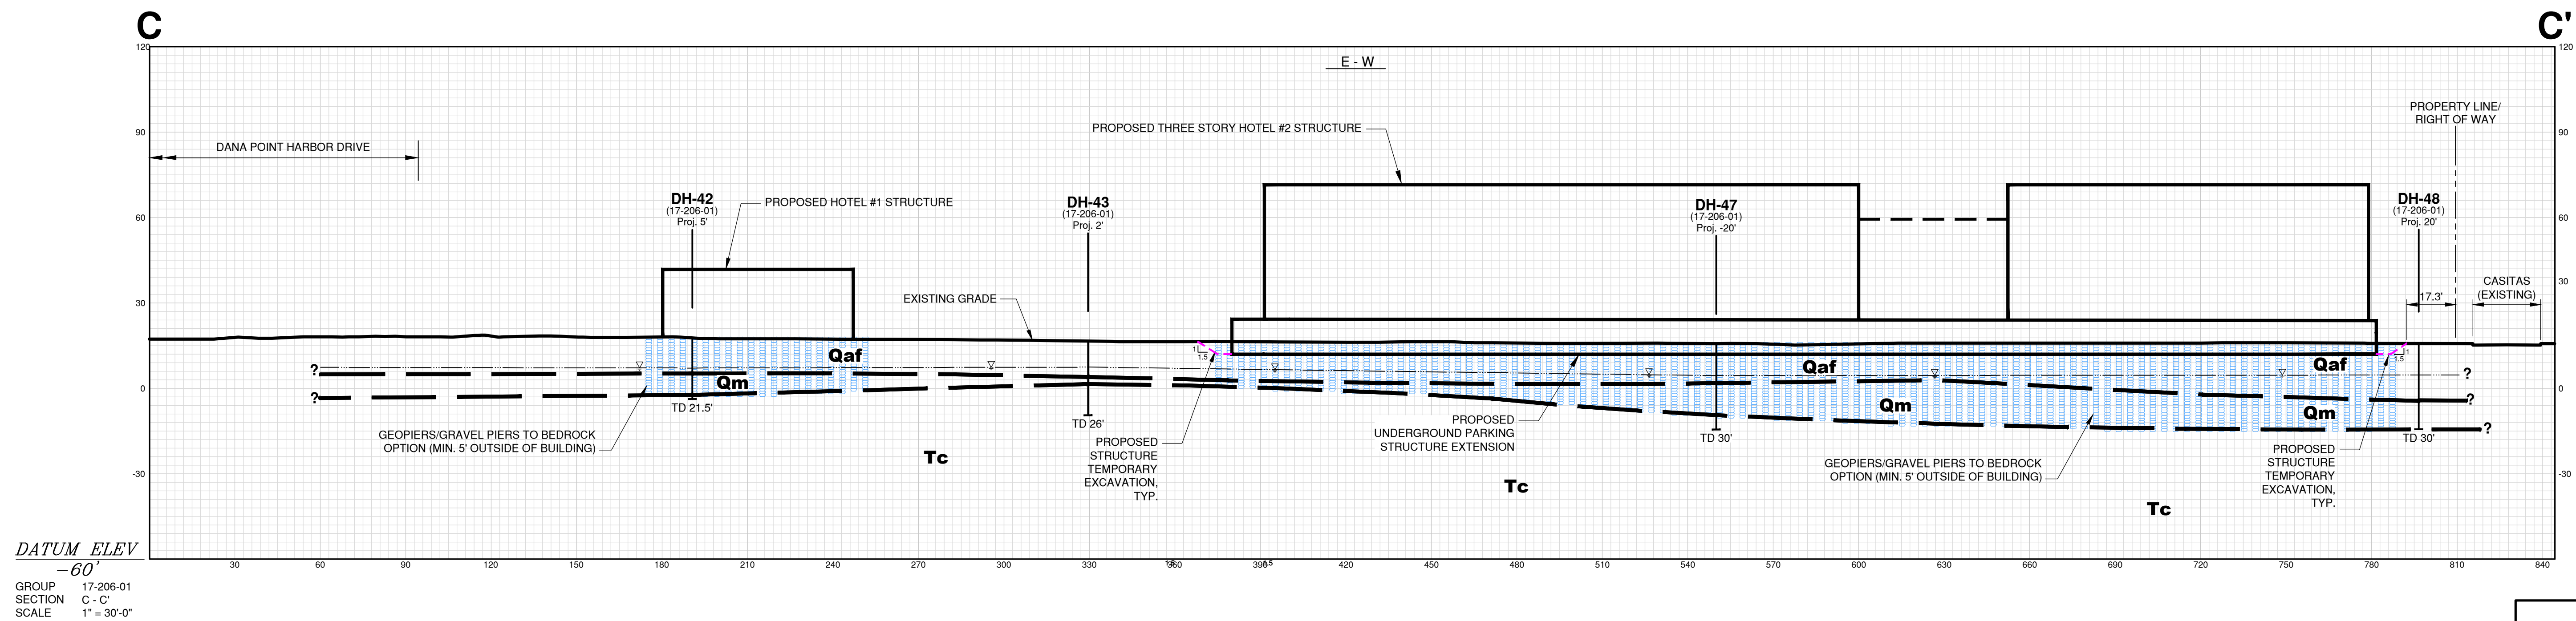
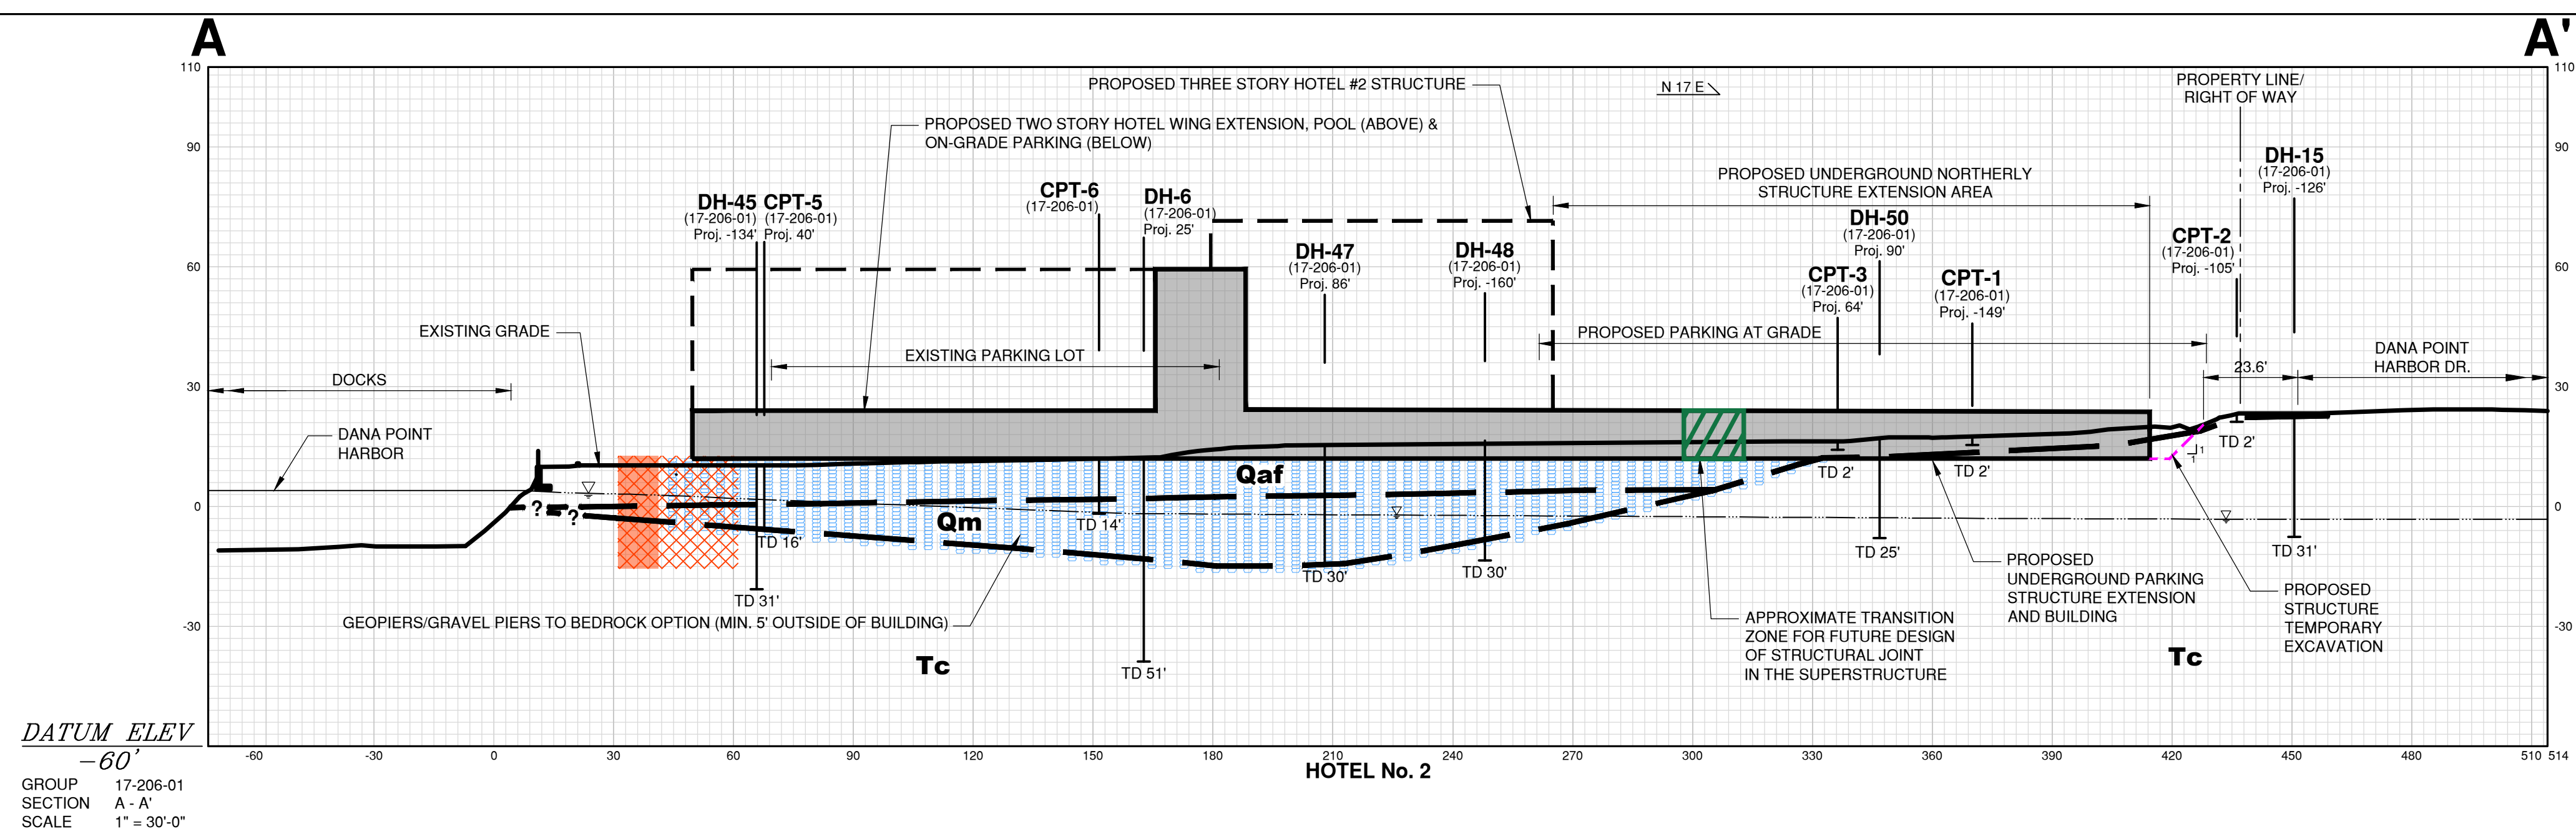
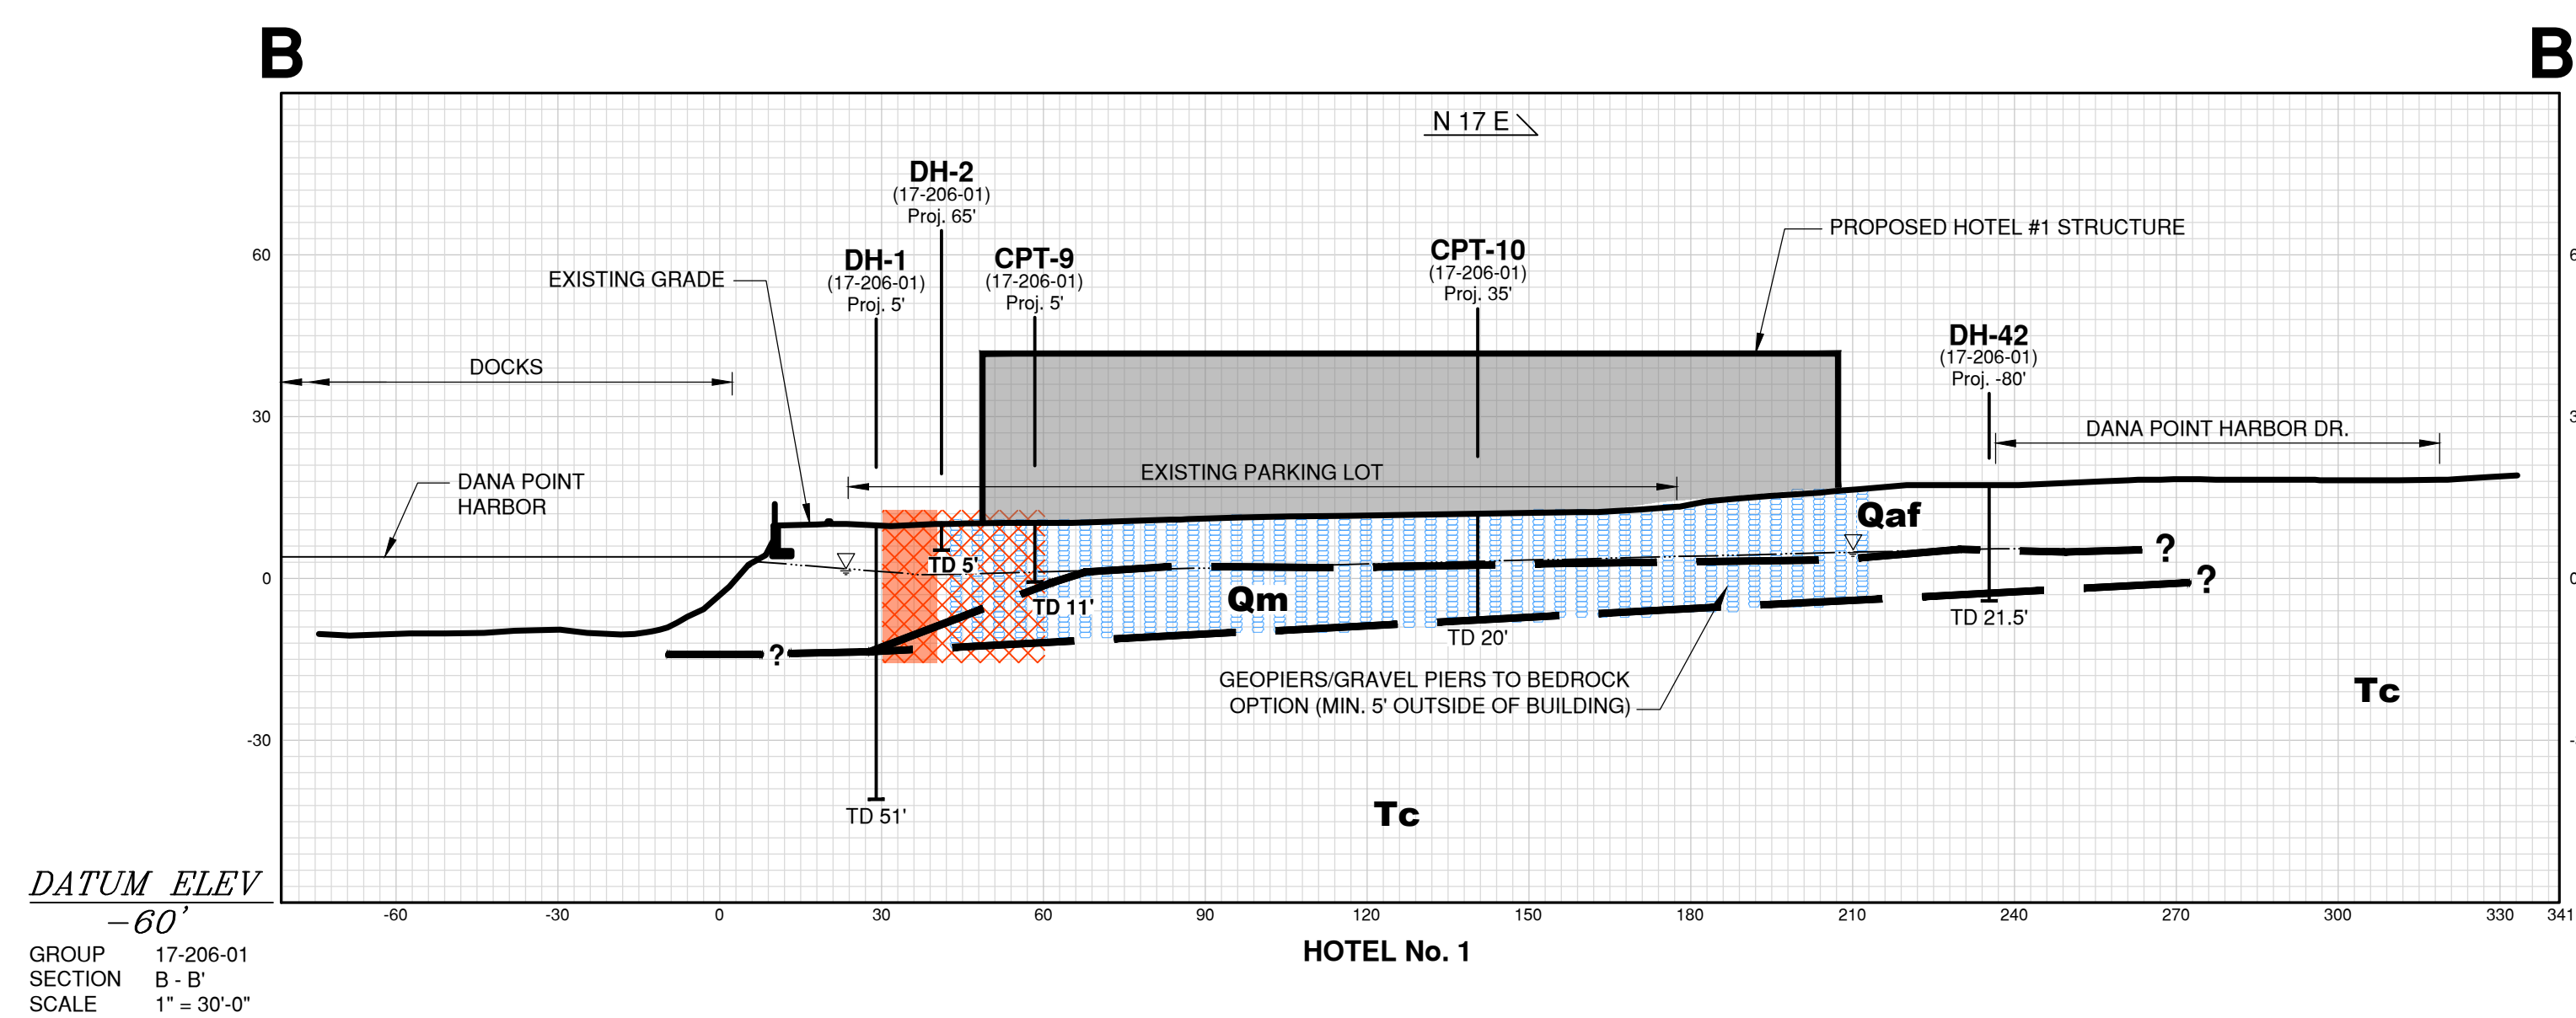
(UNDERGROUND PARKING STRUCTURE)  
FF = 12.0'

Qaf  
Tc

*With regard to set-back of DSM columns from the seawall, the DSM columns will need to be 20 feet away from the seawall (see Plates 2 & 3). With regard to the set-back of the DSM columns from existing structures, it is anticipated that all significant structures in the vicinity of the planned DSM columns will be demolished prior to construction. Consequently, given the circular configuration of the piles as well as the anticipated demolition, set-back from existing structures is not anticipated to be as significant design constraint. It should be further noted that it is unknown at this time, what the exact construction timing is of the DSM columns which are needed to minimize lateral spreading. Set-back will be re-evaluated once the*
