**Final Environmental Impact Report  
Volume III - Appendices E - J  
South Shores Church Master Plan  
City of Dana Point**

SCH No. 2009041129

**Dated: May 22, 2013**

**Project No. 10132-01**

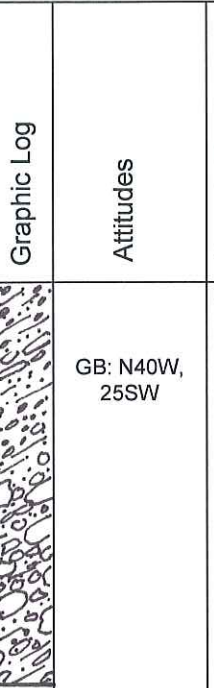
Date : 5/14/2012	Page 2 of 2	Drilling Company : Al Roy Drilling
Project Name : South Shores Church	Type of Rig : Bucket Auger	
Project Number : 10132-01	Drop : 30"	Hole Diameter : 26"
Elevation of Top of Hole : ~ 252 ' MSL	Drive Weight : Between 0' and 30' = 2400 pounds Between 31' and 60' = 1550 pounds	
Hole Location : See Geotechnical Map

GB: N40W, 25SW	R-7	30	N/A	5.6	[SM]	Logged by KTM Sampled by KTM	
220	35			R-8	14/6"	N/A	7.9	[GM-GC]		
215	40								@30' R-7 Light yellowish brown, SANDY SILTSTONE/SILTY SANDSTONE with GRAVELS, slightly moist, very dense. Clasts oxidized, meta, angular. @31' Generalized Bedding, well defined by fabric of elongate/flat clasts. Gradual increase in rock content (gravels and cobbles) to about 50%. @35' Becomes clast-supported, up to 1' dia., both angular (elongate & flat) metamorphic & subrounded granitic. Clayey matrix becomes light gray with some white mineral, micaceous. Belling of borehole walls up to 1 foot. @40' R-8 (disturbed) Note drive weight decreased to 1550 pounds. Light brown, GRAVELS with CLAY and SAND, slightly moist, very dense.	
210	45								Total Depth = 40' No Ground Water Encountered Backfilled with Tamped Cuttings and Capped with AC to 4 inches on 5/14/2012
