Design Objectives

Description

Approach

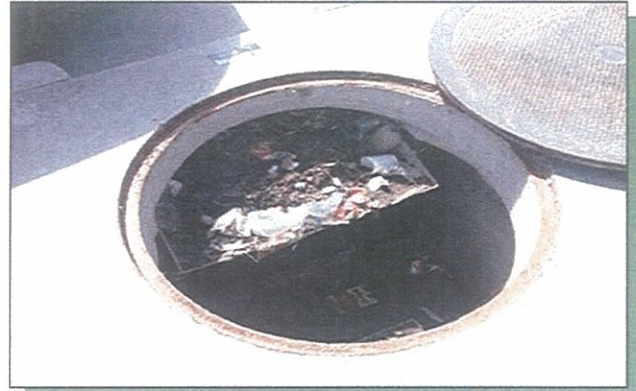
Screening Device

The screening device is located directly under the manhole or grate over the Pre-Treatment Chamber. It's mounted directly underneath for easy access and cleaning. Device can be cleaned by hand or with a vacuum truck.

1. Remove grate or manhole cover to gain access to the screening device in the Pre-Treatment Chamber. Vault type units do not have screening device. Maintenance can be performed without entry.
2. Remove all pollutants collected by the screening device. Removal can be done manually or with the use of a vacuum truck. The hose of the vacuum truck will not damage the screening device.
3. Screening device can easily be removed from the Pre-Treatment Chamber to gain access to separation chamber and media filters below. Replace grate or manhole cover when completed.

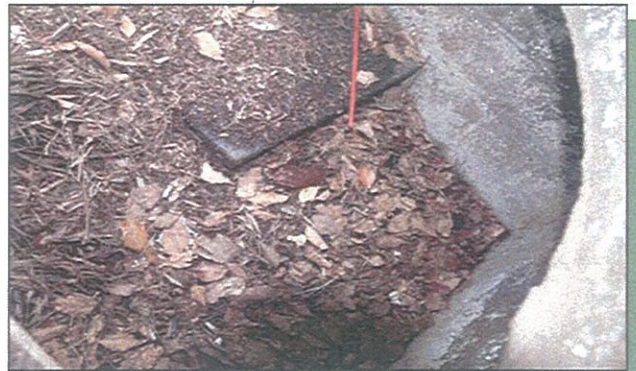
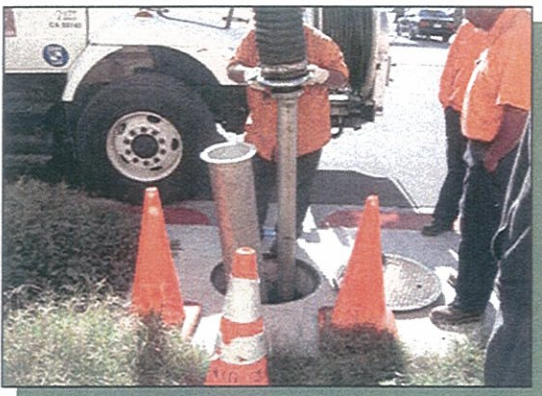
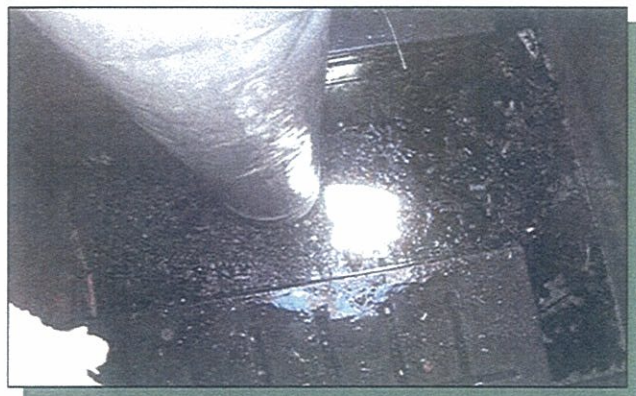
The separation chamber is located directly beneath the screening device. It can be quickly cleaned using a vacuum truck or by hand. A pressure washer is useful to assist in the cleaning process.

1. Perform maintenance procedures of screening device listed above before maintaining the separation chamber.
2. With a pressure washer spray down pollutants accumulated on walls and cartridge filters.
3. Vacuum out Separation Chamber and remove all accumulated pollutants. Replace screening device, grate or manhole cover when completed.

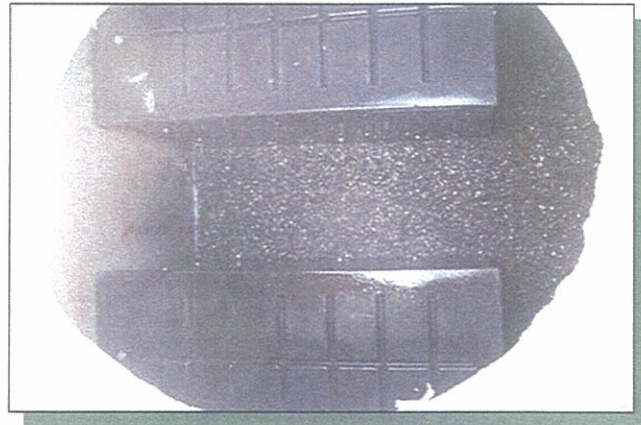
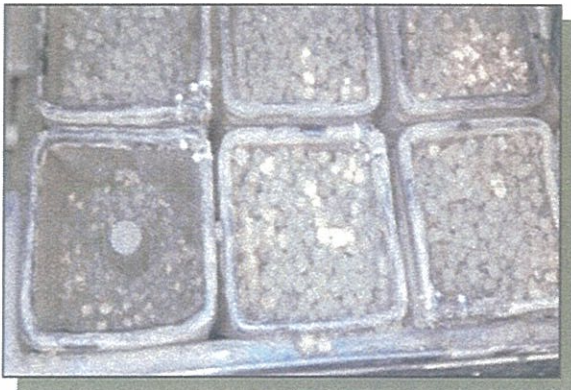
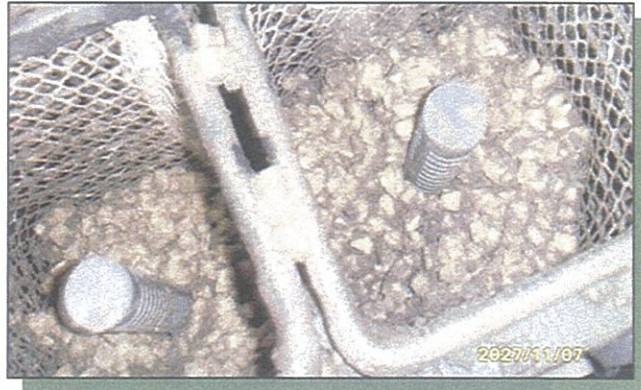
Cartridge Filters

The cartridge filters are located in the Pre-Treatment chamber connected to the wall adjacent to the biofiltration chamber. The cartridges have removable tops to access the individual media filters. Once the cartridge is open media can be easily removed and replaced by hand or a vacuum truck.

1. Perform maintenance procedures on screening device and separation chamber before maintaining cartridge filters.
2. Enter separation chamber.
3. Unscrew the two bolts holding the lid on each cartridge filter and remove lid.
4. Remove each of 4 to 8 media cages holding the media in place.
5. Spray down the cartridge filter to remove any accumulated pollutants.
6. Vacuum out old media and accumulated pollutants.
7. Reinstall media cages and fill with new media from manufacturer or outside supplier. Manufacturer will provide specification of media and sources to purchase.
8. Replace the lid and tighten down bolts. Replace screening device, grate or manhole cover when completed.

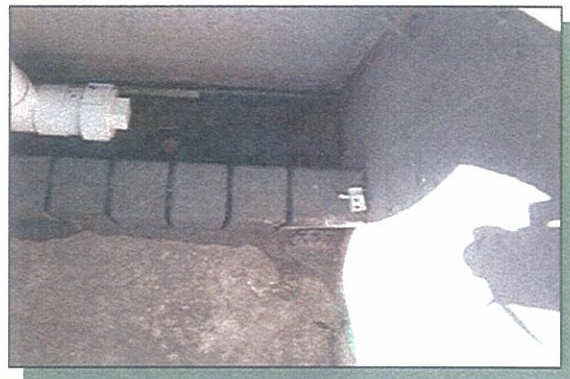
Drain Down Filter

The drain down filter is located in the Discharge Chamber. The drain filter unlocks from the wall mount and hinges up. Remove filter block and replace with new block.

1. Remove hatch or manhole cover over discharge chamber and enter chamber.
2. Unlock and lift drain down filter housing and remove old media block. Replace with new media block. Lower drain down filter housing and lock into place.
3. Exit chamber and replace hatch or manhole cover.

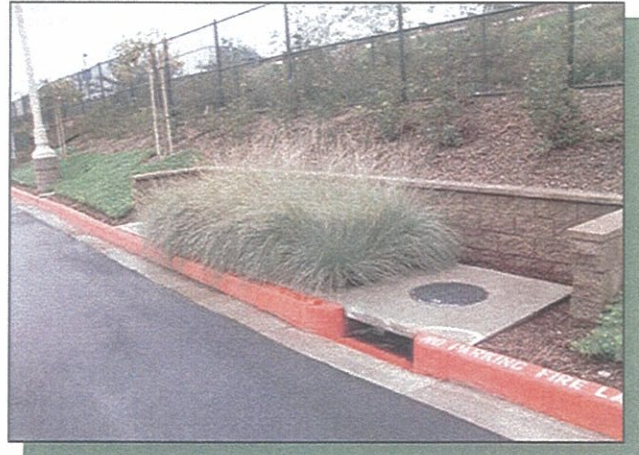
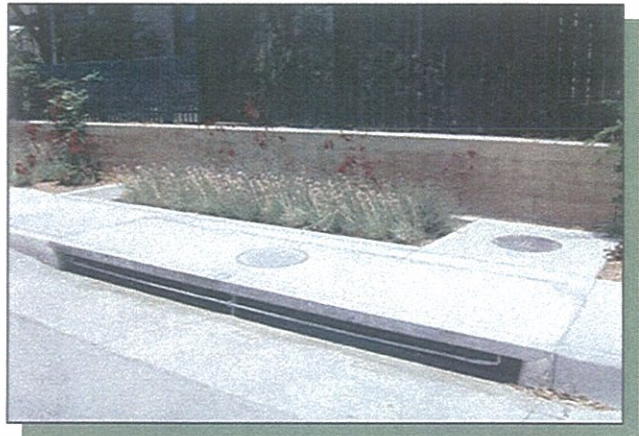
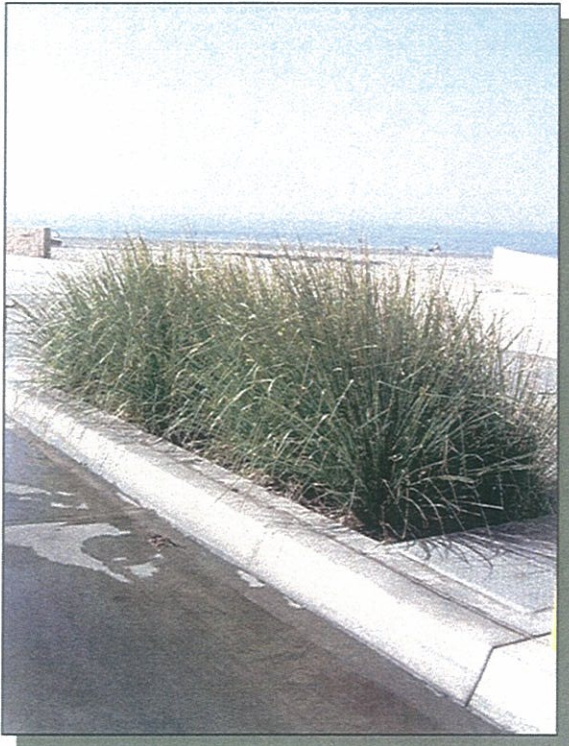
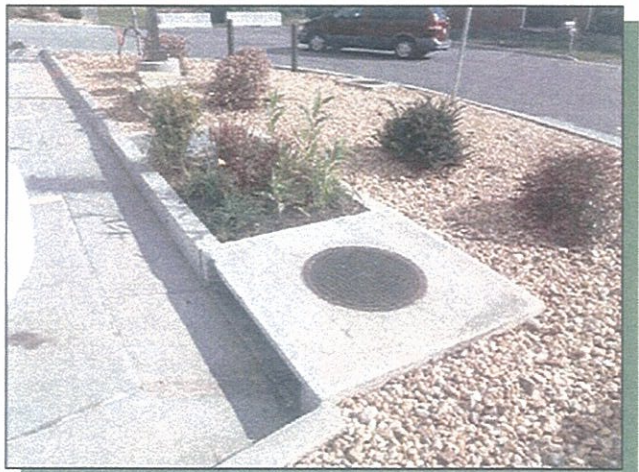
Trim Vegetation

Vegetation should be maintained in the same manner as surrounding vegetation and trimmed as needed. No fertilizer shall be used on the plants. Irrigation per the recommendation of the manufacturer and or landscape architect. Different types of vegetation requires different amounts of irrigation.

5. No fertilizer shall be used in the Biofiltration Chamber.
6. Irrigation should be provided as recommended by manufacturer and/or landscape architect. Amount of irrigation required is dependent on plant species. Some plants may require irrigation.
